Allision of the Passenger Vessel *Seastreak Wall Street*
with Pier 11, Lower Manhattan,
New York, New York
January 9, 2013

NTSB/MAR-14/01
PB2014-105712

**National
Transportation
Safety Board**

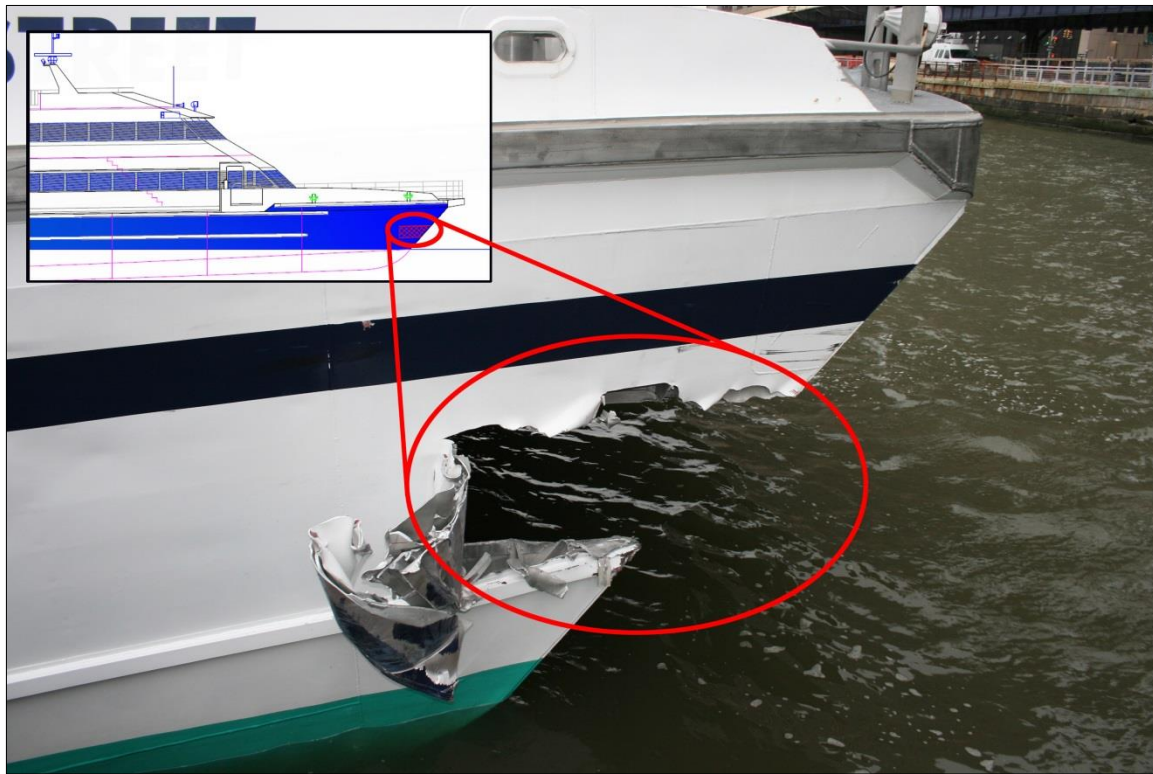
The *Seastreak Wall Street* sustained damage to the bow of its starboard hull and minor damage to the passenger cabin, and its port propeller was fouled with debris. The total estimated cost of repairs was about \$166,200.

One interior window at the bottom of a stairwell was broken, broken glass was found in the main deck forward stairwell and at the second deck starboard aft door, and a passenger seat back rest on the main deck was broken. Damage to the vessel hull was principally to the starboard bow and to the cross-member connecting the two hulls. Impact to the starboard hull at the point where it struck the pier resulted in a 30-inch opening beginning about 30 inches above the waterline and extending 45 inches at the lower side and 76 inches at the upper side. In this area, the side shell was crushed and peeled away from the hull, and internal frames were displaced (see figure 5).

Figure 5. Damage to the *Seastreak Wall Street* starboard bow.

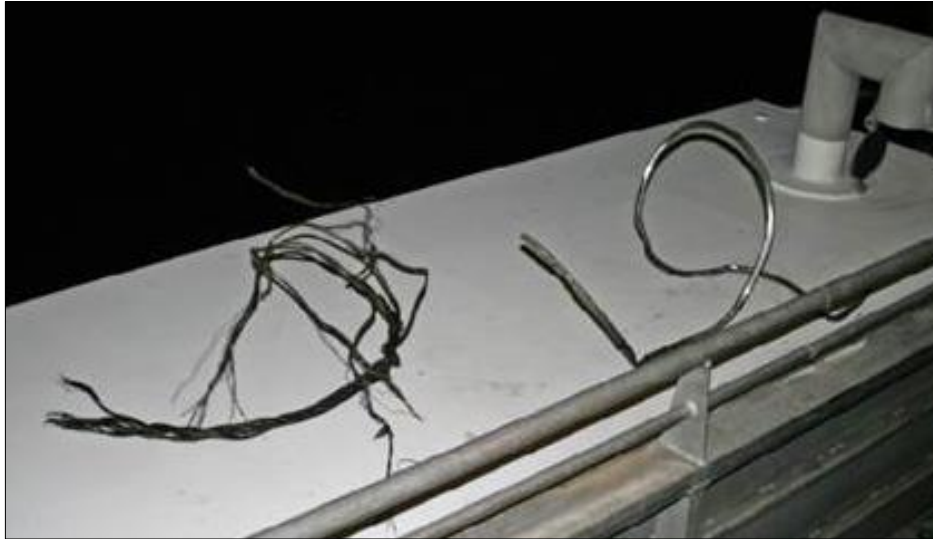
After the accident, a diver found the port propeller was fouled with a 4-foot steel bar and a 3-foot length of stranded wire cable of unknown origin (see figure 6). When the vessel was hauled out of the water for hull repairs, both the port and starboard propellers were found to be damaged, and the port propeller cone was missing (see figure 10 in section 1.6.2 for an illustration of a propeller and cone). Damage to the port propeller consisted of gouges and dents at blade tips, with significant deep scratches on the faces of the blades near their leading edges. The starboard propeller was similarly bent and gouged at the tips of all four blades.

Figure 6. Debris found in ferry propeller, a 3-foot length of wire cable and 4-foot steel bar, both about half an inch in diameter.

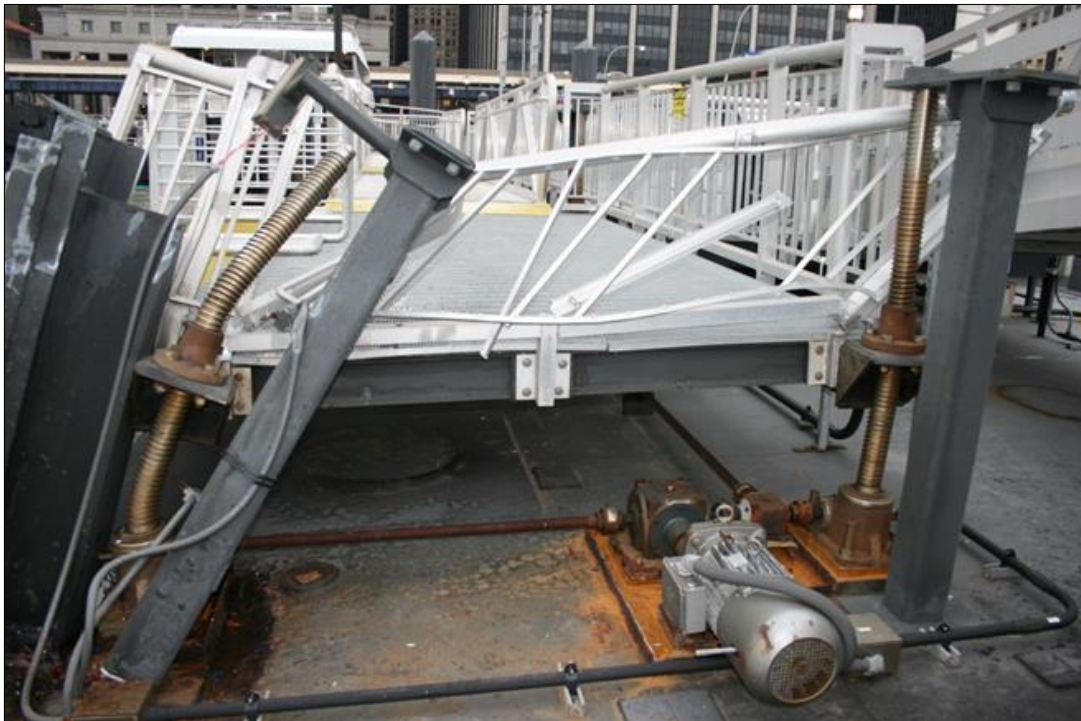
The dock barge *Desiree M* served as Slip D2 of Pier 11. The barge, 108.5 feet long and 35 feet wide, sustained an 8-inch-wide puncture of its hull and deck distortion in the area of the point of impact as well as damage to the fender, sideloader screw jack, platform, and gangway from the barge to the pier. A portion of the damage is shown in figure 7. The total cost of repairs was \$333,349.

Figure 7. Damage to the Slip D2 dock barge, gangway, and upright supports.

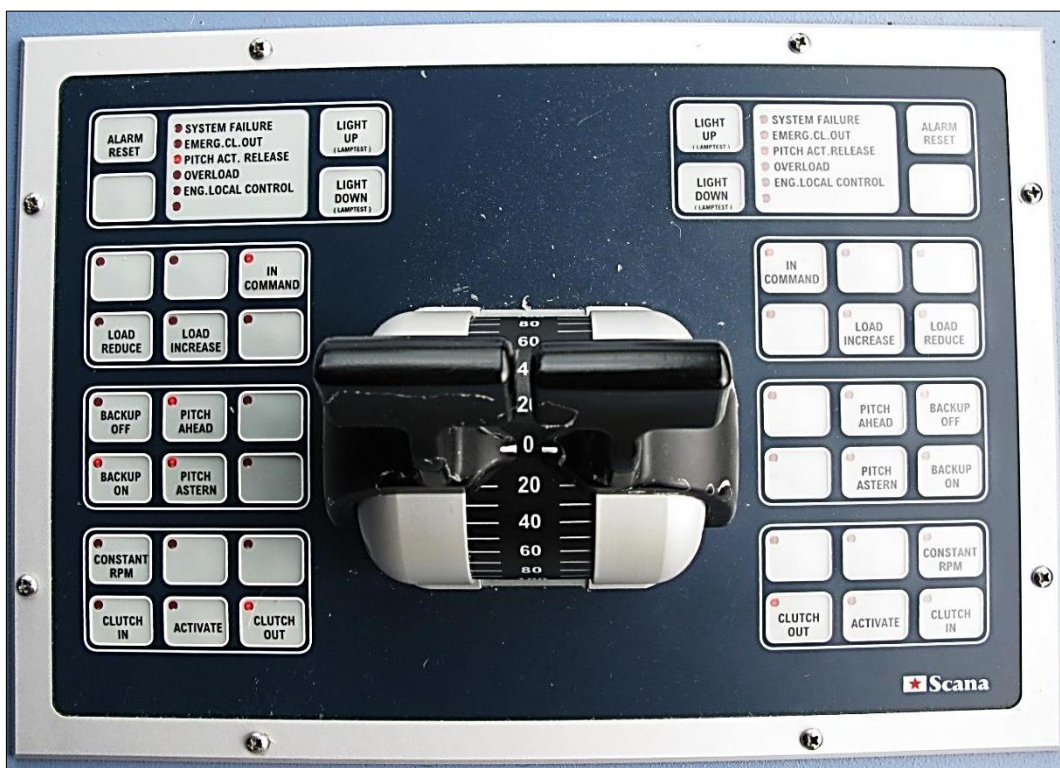
Figure 13. Closeup of bridge control panel order levers and command buttons.

Audible alerts and alarms also could be improved. As currently designed, engaging Backup mode triggers a constant audible alert that could only be reset by the operator. After the reset silenced the alert, no further alarm would sound to remind the operator that Backup mode was still active. If the operator approached a dock without realizing the propulsion system was in Backup mode, the vessel would not respond as expected, thus posing a safety hazard.

In addition, the NTSB recommends that Scana Mar-El AS modify its design for new Neptune Compact propulsion control systems to include clearly identifiable audible alerts and easily visible and understandable displays that will remind the operator when Backup mode is engaged and revise its owner's manual accordingly. The NTSB also recommends that Scana Mar-El AS design a solution for existing Neptune Compact propulsion control systems to include clearly identifiable audible alerts and easily visible and understandable displays to indicate to operators when Backup mode is engaged, revise its owner's manual accordingly, and alert its customers to the circumstances of this accident and to the availability of the retrofit solution.

The NTSB further recommends that Seastreak LLC work with Scana Mar-El AS to implement a modification to the Neptune Compact propulsion control system that includes clearly identifiable audible alerts and easily visible and understandable displays to remind the operator when Backup mode is engaged.

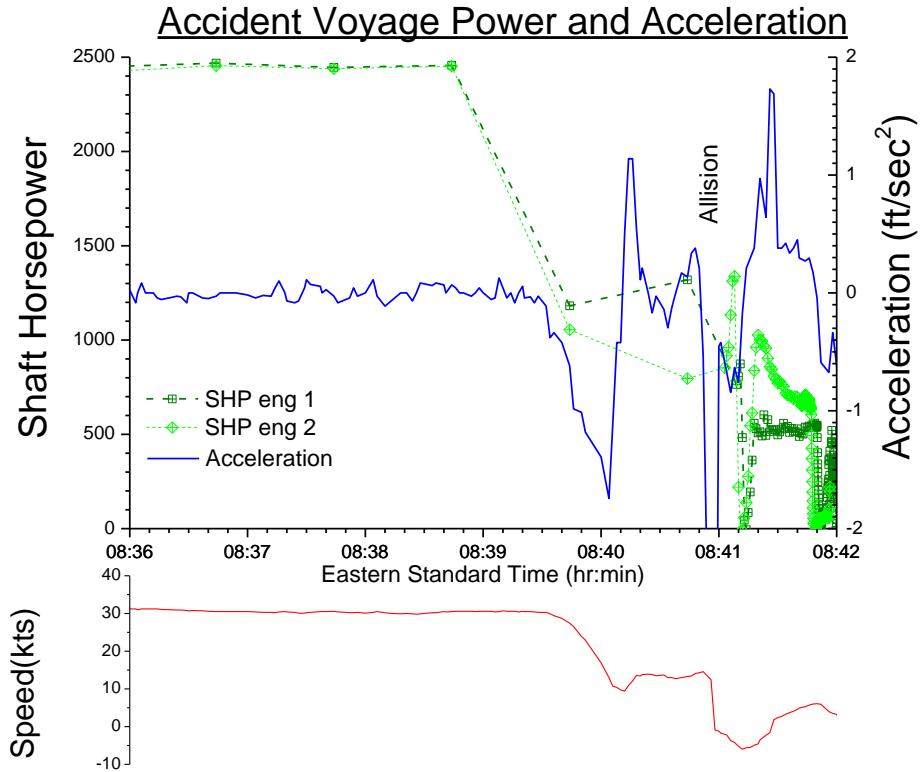
Engine data were recorded once per minute before the allision. Acceleration is plotted with shaft horsepower in figure C-3 to indicate the power change trends required for the recorded speed. The acceleration curve indicates that the power reduction occurred about 0839:30, approximately 40 seconds after the last recorded 2500-horsepower engine data point. The acceleration curve also shows that forward power was increased about a minute before the allision. This would require an increase in rpm and, thus, rpm control.

Figure C-3. Power, speed, and acceleration.

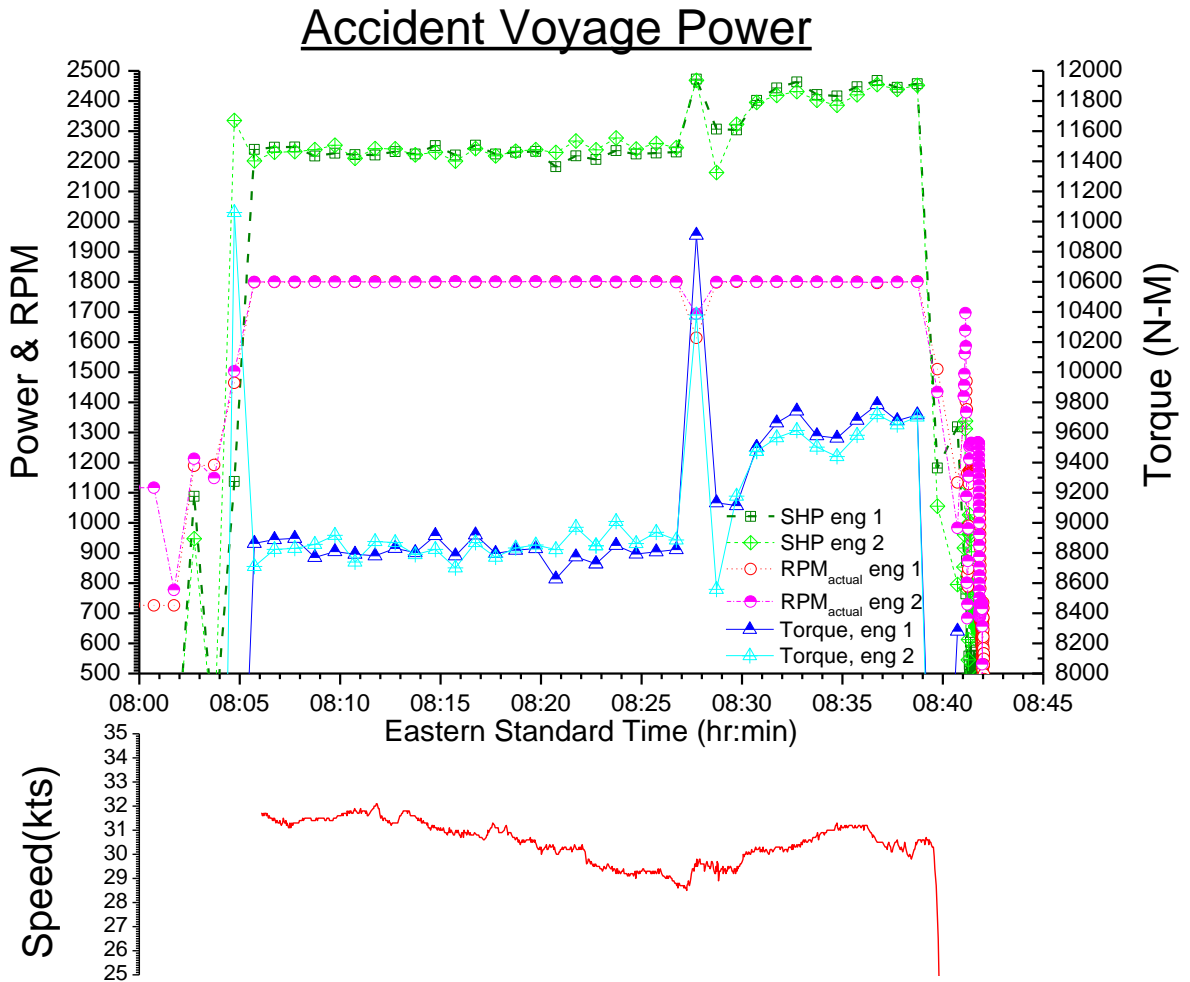
The data were also examined to check whether the power parameter relationships earlier in the voyage could provide insight into the propulsion control mode (Combinator or Backup). Calculated power, recorded rpm, torque, and speed are plotted in figure C-4 for the accident voyage. Note that AIS speed data were not available before about 0805. The engine traces indicate acceleration to cruise beginning about 2 minutes earlier and accompanied by a power spike to about 2335 shaft horsepower.

Figure C-4. Engine rpm, power, torque, and speed for the accident voyage.

In Combinator mode, the order levers controlled engine rpm and propeller pitch, and thus power. Until about 0820, a fixed relationship existed between the three parameters. About 0820, the port and starboard torque and power separated while engine rpm remained constant at 1800 rpm. The steady rpm indicates that the command lever position must have been constant through this period. At 0827, torque and power increased while rpm decreased. This was not possible in Combinator mode, indicating that the vessel was in Backup mode by this time. After 0827, the engines returned to 1800 rpm while torque decreased briefly below the earlier cruise value before increasing to a value significantly above the earlier cruise value at 0831. These torque changes
