GREEN SHEET

San Francisco Fire Department (SFFD)

Preliminary Summary Report of SFFD Line of Duty Death

Firefighter Fatality

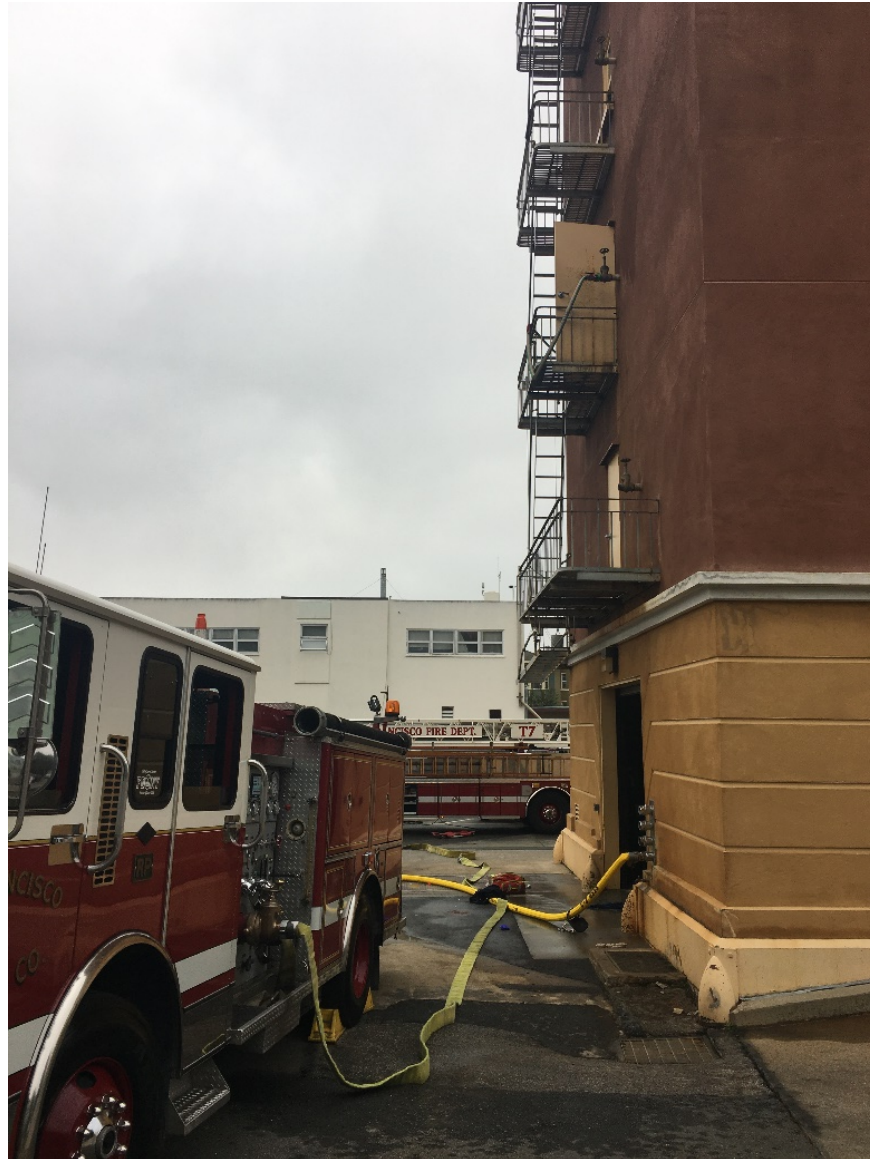
View looking East of Engine 3 and fire escape with standpipe connections

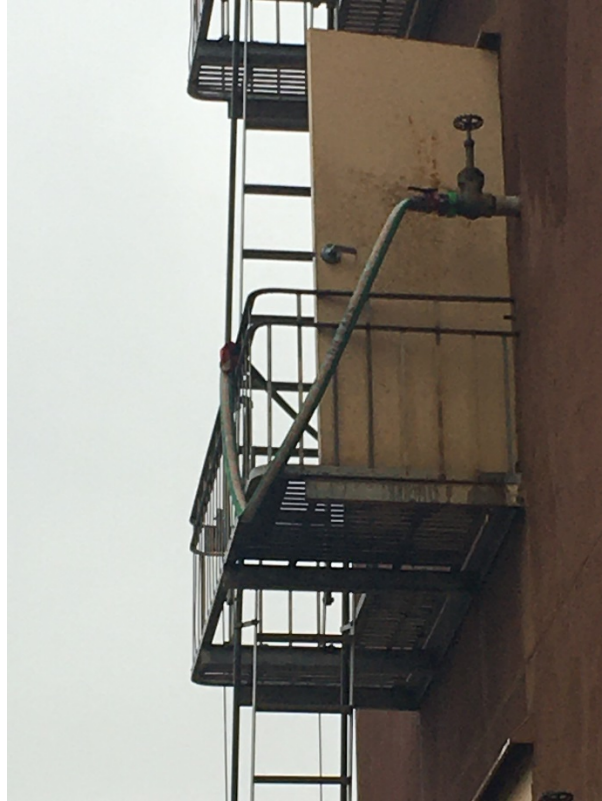
The LT looked up from his position at the pump panel to see the FF/PM standing on the third-floor fire escape. It is not known why he was standing on the fire escape at this time as the drill was not completed. The LT observed the FF/PM opening the gate of the wye without the hose line attached. The stream coming from the open outlet on the wye struck the FF/PM in the chest causing him to lose his balance, fall backwards into and over the railing of the fire escape to the ground below.

Close up view of the third floor fire escape and standpipe outlet

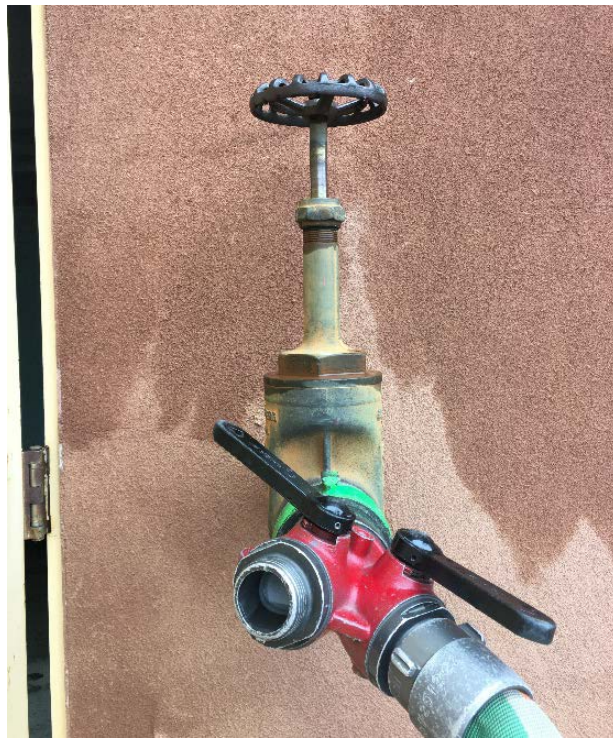
Standpipe outlet on third floor fire escape
