August 27, 2012

**RE: OBSERVATION REPORT FOR ALLEN HIGH SCHOOL STADIUM CONCOURSE SLAB**

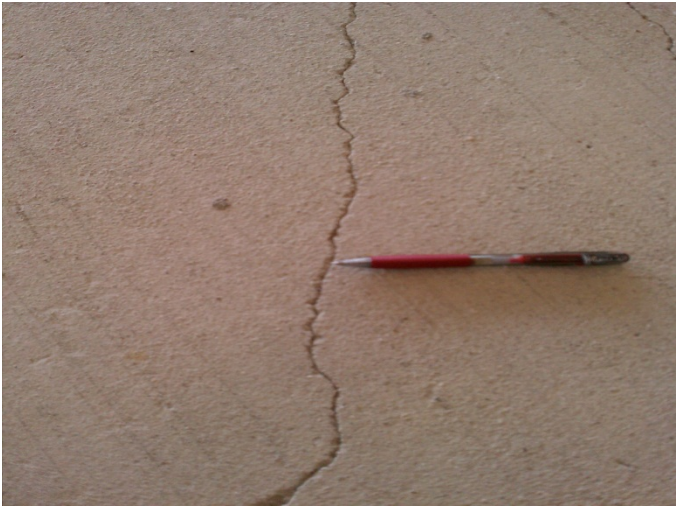
**Photo #1**

Upon my arrival to Allen High School Stadium, I met with Rick Wirley of Pogue Construction who directed me to the areas with the most severe surface cracking. I was informed that although minor cracking has occurred throughout the project, the majority of the surface cracks occur within areas 'D', 'E', and 'F'. I began my inspection by first walking the concourse level to get a general idea how widespread the cracking was throughout the project, and to identify areas for closer inspection. As stated above, small surface cracks have developed sporadically throughout the concourse structural slab. I observed minor cracking to some degree in virtually every plan area. In general, the cracks were on the order of hairline to approximately 1/32" in width. The largest cracks observed were approximately 1/16" in width (see Photo 1) and continued completely through the slab. Although I did observe some areas where the hairline cracks "spider webbed" in a random pattern, the vast majority of the cracks ran parallel to the concrete pan joist.

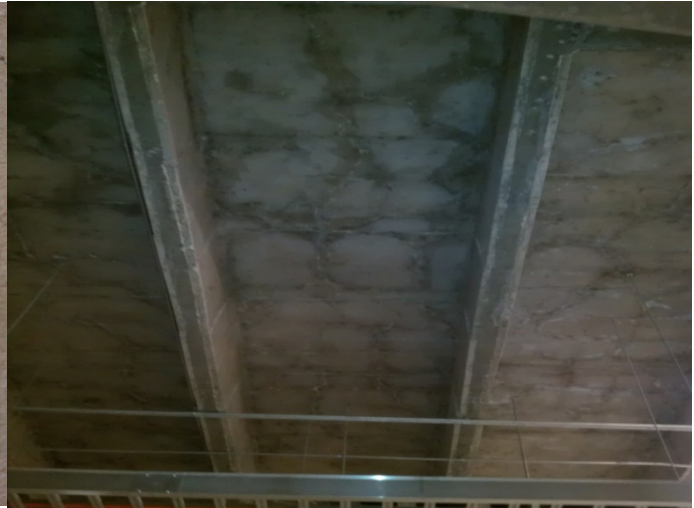
**Photo #2**

Area 'D' has the highest concentration of cracking. This area exhibits extensive random hairline cracking as well as regular linear cracking parallel to the pan joists (see Photo 2 and 3). I did not have access to the concrete testing reports to verify the in place concrete strength and water content. I was informed by Rick Wirley that Area D was the first pour of the pan joist system and that it was a "hot and

windy day". I asked if proper curing procedures of "Hot Weather Concreting" were followed as described in ACI 305, to prevent the concrete from drying out prematurely. It was unclear as to the exact procedure that was used, but I was informed that the concrete was not covered or kept damp throughout the curing process. It was also stated that most of the cracks appeared within a few days of pouring the concrete.

Recommendations for slab repair: It is recommended that the larger slab cracks (1/32" and larger) be thoroughly cleaned and repaired with a low-viscosity epoxy or polyurethane crack filler. These products have the ability to penetrate deep into the crack. The color of the cured product varies with the manufacture, and some products may be custom pigmented in an attempt to match the existing concrete color. Some products for consideration include: Crack-Pac Injection Epoxy or Crack-Pac Flex-H<sub>2</sub>O Polyurethane Crack Sealer, by Simpson Strong-Tie.

The crack filler won't effectively repair the micro and hairline cracks in the slab. This is best addressed with a self-leveling concrete topping product. A few of the major manufactures of this type of product include ARDEX Engineered Cements, STONHARD seamless polymer floor, wall and lining systems, and Spraylock concrete protection.

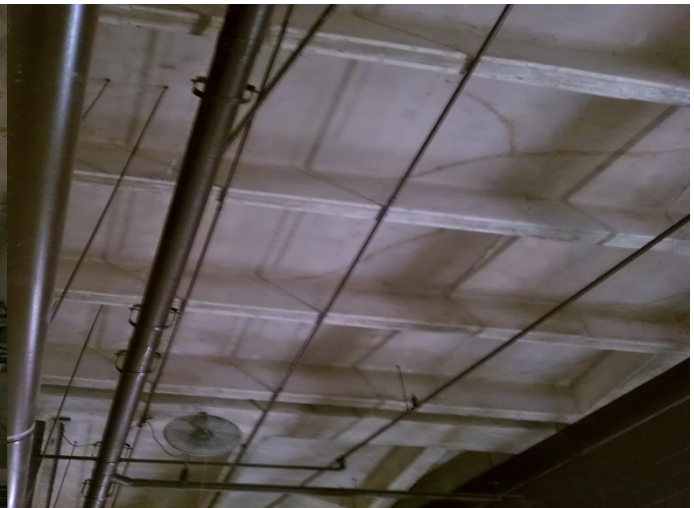
**Photo #4**

Area 'E' also contained random cracking and linear cracks parallel to the joist. This linear cracking typically occurred only in the slab and at approximately halfway in between the adjacent pan joist. Where the cracks did migrate across the joist, the crack was contained within the slab and did not migrate down into the actual concrete joist (Photo 4). I observed cracking to some degree throughout the rest of the concourse, but by far the greatest concentrations of cracks were limited to areas D and E. Upon mapping the linear cracks on the framing plan a pattern developed. In areas D and E the pattern was a series of cracks spaced approximately 10' to 15' followed by a gap of approximately 25' to 30' before the next series of cracks was observed. In some areas individual cracks occurred approximately 25' to 30' from other linear cracks or expansion joints. This regular pattern as well as the quick appearance of the cracks in the green concrete are consistent with concrete shrinkage cracks.
