NATIONAL TRANSPORTATION SAFETY BOARD
Office of Research and Engineering
Washington, D.C. 20594

Video Study

**NTSB Case Number:
HWY20MH002**

Location: Mount Pleasant, Pennsylvania
Date: January 5, 2020
Time: 3:30 AM
Vehicle No.1: 2005 Van Hool motorcoach ('motorcoach')
Vehicle No.2: 2018 Freightliner Cascadia truck-tractor in combination with a semitrailer, operated by FedEx Ground ('truck')

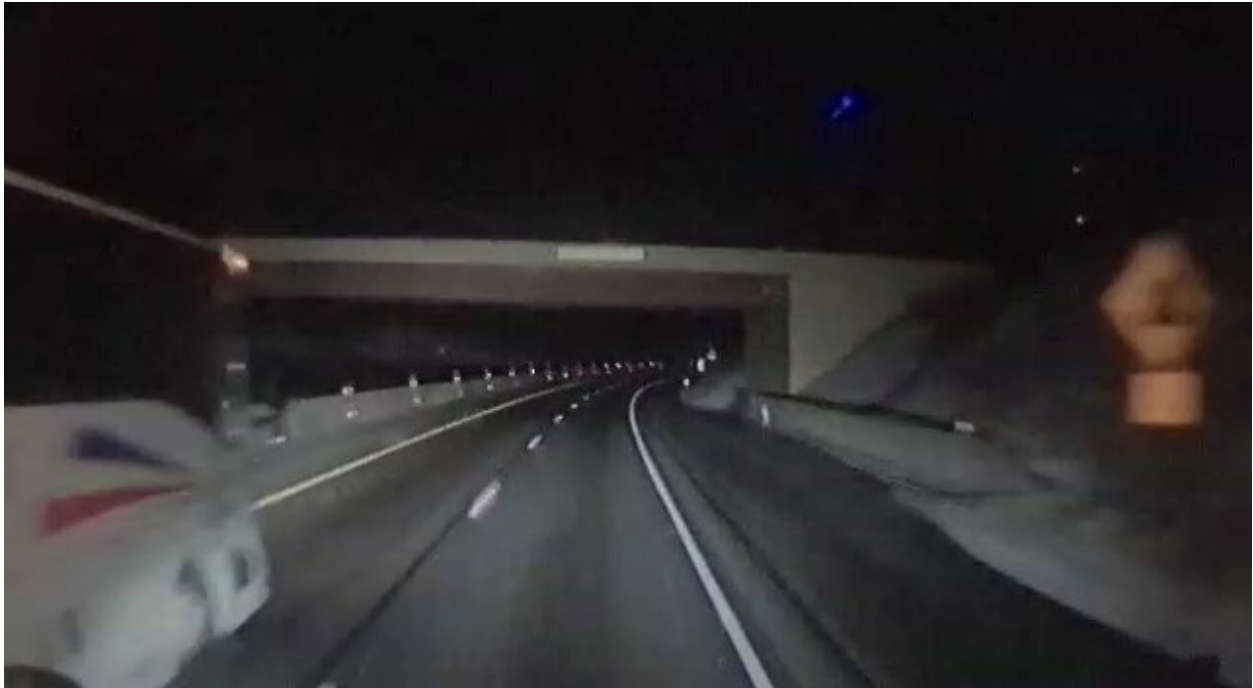
Figure 1 is a frame from the forward-looking camera video that shows the motorcoach when it was passing the truck. The motorcoach was 45 feet long and it took 13 video frames for the length of the motorcoach to pass the same location in the video frame from the forward-looking camera. Considering the 10 fps frame rate, the motorcoach was moving faster than the truck by $45/(13/10)=34.6$ ft/s or 23.6 mph. Therefore, the nominal estimated speed of the motorcoach was $46+23.6=69.6$ mph. Adding the inaccuracy of estimating the relative speed of the two vehicles, the motorcoach speed was 69 ± 2 mph when it passed the truck.

Figure 1. Video Frame Showing the Motorcoach Passing the Truck

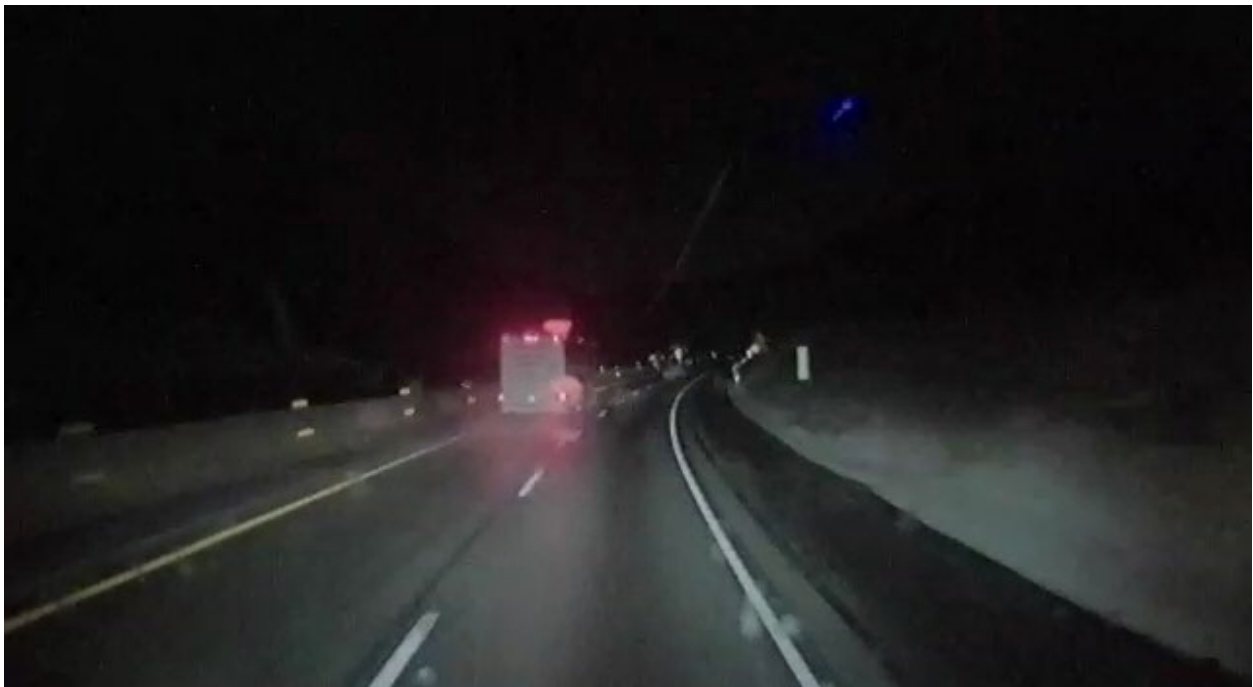
There was a concern that the speed of the motorcoach when it was passing the truck could have been changed by its driver because he was starting the process of passing the truck. Therefore, it was desirable to estimate the speed of the motorcoach after it passed the truck. After the motorcoach passed the truck, its distance from the truck was measured in terms of the increasing number of the 40-foot white line plus gap segments visible in the video. Figure 4 shows the motorcoach when three segments were visible. It was possible to estimate the location of the motorcoach when 1, 2, 3 and 4 segments were visible. The estimated speed of the motorcoach relative to the truck using this method was 21.5 ± 2.5 mph.

Figure 2. Video Frame Showing the Motorcoach after It Passed the Truck

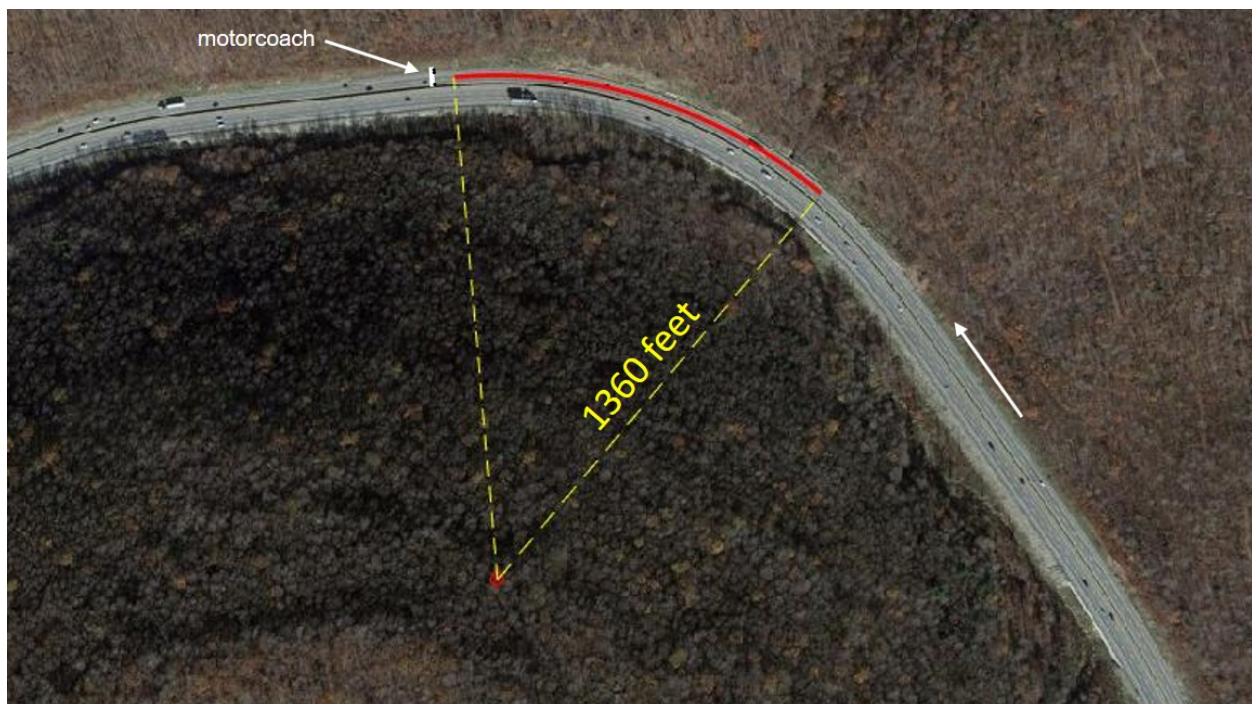
The radius of the curve on which the motorcoach crashed was estimated by fitting circular arcs to the curve seen in a Google Earth aerial image. Figure 3 shows the geometry of the estimation process. The estimated radius was 1360 feet. The blueprints used to construct the road, dated April 2005, specify the radius as 395 meters or 1296 feet and the superelevation as 8%.

The lateral acceleration on the curve, assuming speed of 69 mph and curve radius of 1360 feet, is $V^2/R=(69 \times 1.467)^2/1360=7.53$ ft/s² or 0.23 g. The minimum coefficient of friction required to provide the centripetal force required for negotiating the curve is $\mu=0.23-0.08=0.15$. This estimate takes into account the 8% superelevation. Note that this lateral acceleration estimate is for a vehicle that successfully negotiates the curve while moving at the assumed 69 mph speed of the motorcoach.

Figure 3. Estimation of Accident Curve Radius

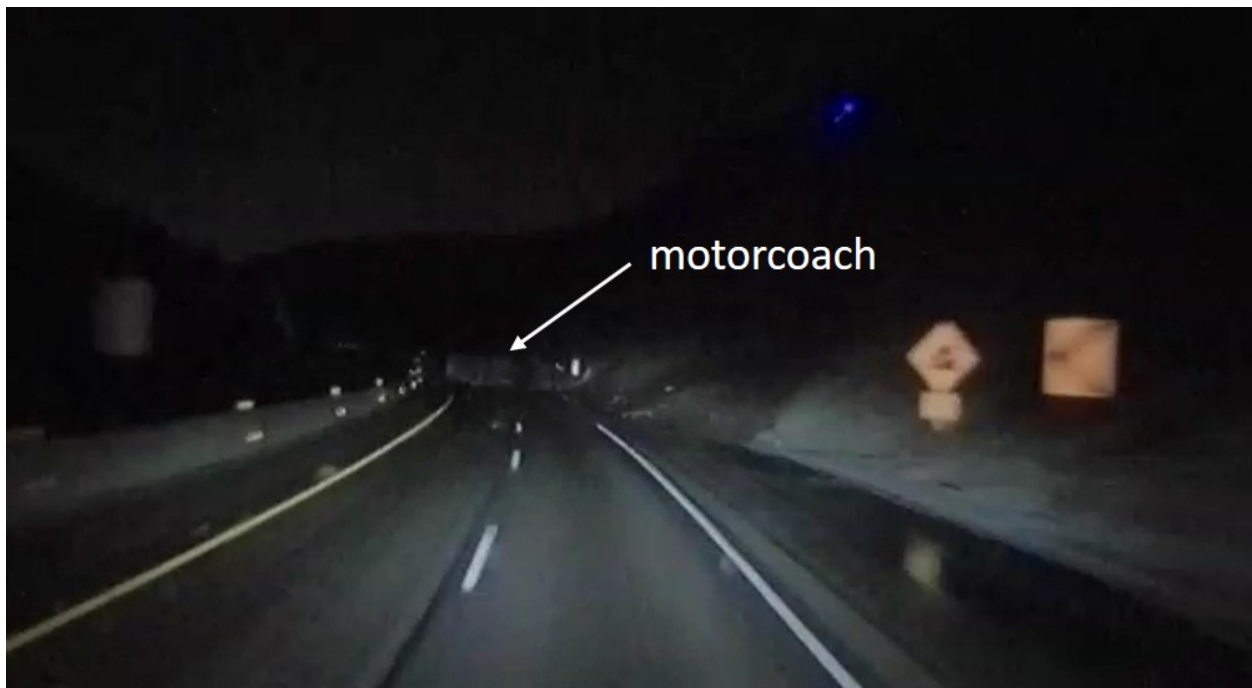
Figure 4 shows the frame from the forward-facing camera video that corresponds to the time when the inward-facing video shows the driver starting to change his posture and focusing on something on the road ahead. This frame was recorded 5.3 seconds before impact. Until 5.4 seconds before impact, the video shows the driver leaning forward and looking straight ahead. At the time of detection, the video shows that the driver started moving to an upright sitting position while continuing to look straight ahead.

Figure 4. Video Frame Recorded when the Truck Driver Detected Obstacle ahead (5.3 seconds before impact with the motorcoach)

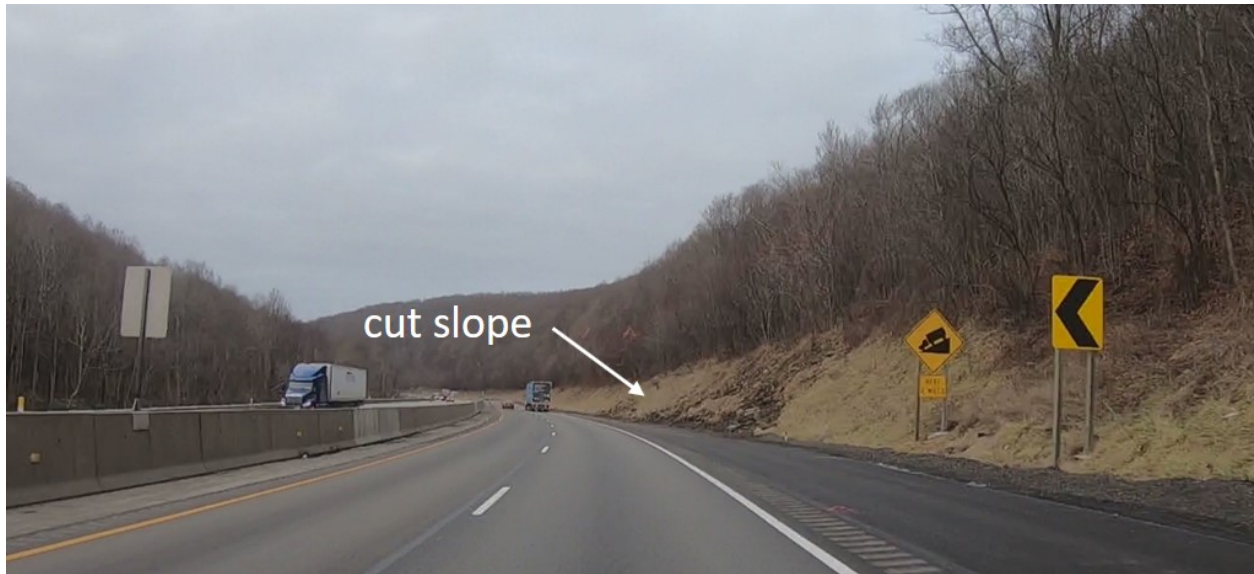
The accident happened on a curve where the road surface elevation was significantly lower than the elevation of the terrain beyond the right shoulder. This limited the visibility of what was ahead of the truck in its right lane. The presence of the overturned motorcoach had to be detected against the background of the cut slope (also called back slope) and the trees that were to the right of the right shoulder. Detection of the motorcoach required realizing that there was an object closer to the truck than the cut slope and the trees.

Figure 5 is a frame from an NTSB daytime drive-through video. It illustrates the visibility problem caused by the cut slope and the trees. The inside-view camera video recorded the driver and made it possible to estimate the time when he detected the overturned motorcoach and started dealing with the new situation, as detailed below.

Figure 5. Frame from NTSB Daytime Drive-through Video Showing the Cut Slope

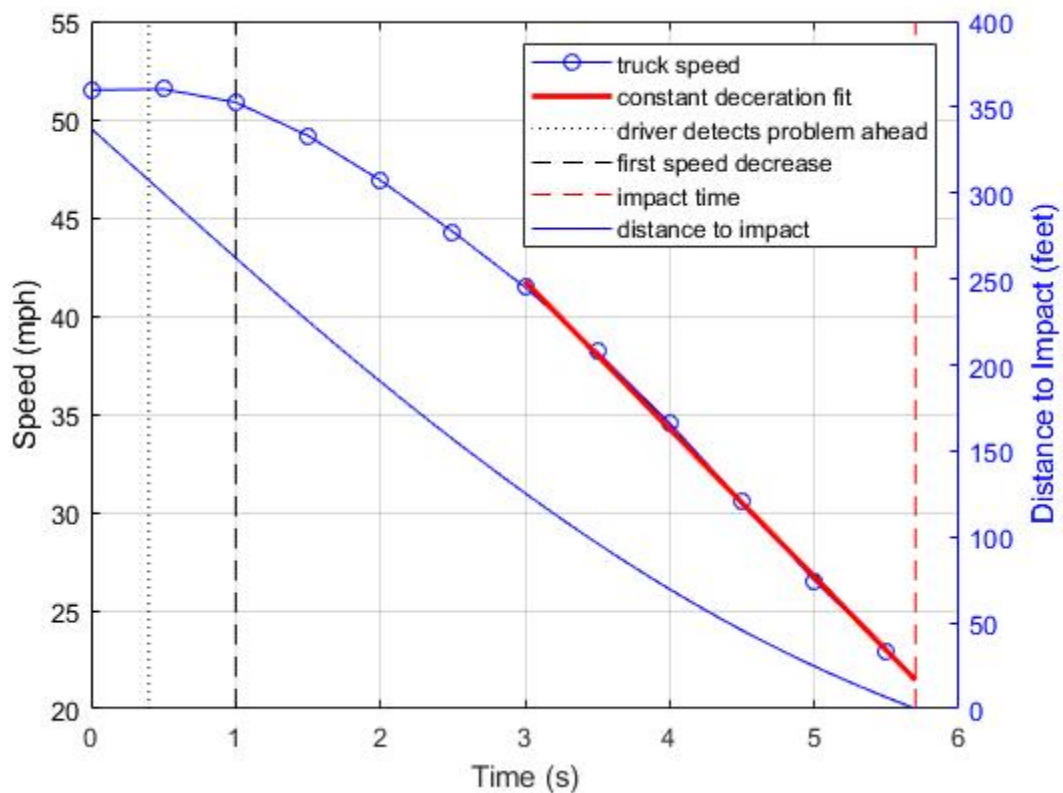
speed vs. time in a 6-second-wide time window. The window was set to start shortly before the driver detected the motorcoach and to end shortly after impact. The figure shows that the driver started braking shortly after detecting the overturned motorcoach.

Figure 6. Estimated Speed of the Truck as It Approached the Motorcoach

The truck impacted the motorcoach with the speed of about 22 mph at time 5.7 seconds in the 6-seconds-wide time window in Figure 6. The figure also shows the distance to the impact location. It was computed by integrating the truck speed back in time starting at the time of impact. The figure shows that the driver noticed the overturned motorcoach when he was about 310 feet from it (5.3 seconds to impact). First speed decrease was observed when the distance to the motorcoach was about 265 feet (4.7 seconds to impact). When the distance was down to about 125 feet (2.7 seconds to impact), the truck reached its maximum achievable deceleration of 0.34 g.
