Job # 1112

Report Date: Sept. 29, 2011

ASSIGNMENT

Farmers Insurance assigned Smitho Engineering and DY Calison to perform an inspection of the Llopis residence in Citrus Heights, California. The purpose of this inspection was to evaluate the property for its structural stability / soundness on the date of the observation; in particular, to determine the cause of the driveway failure.

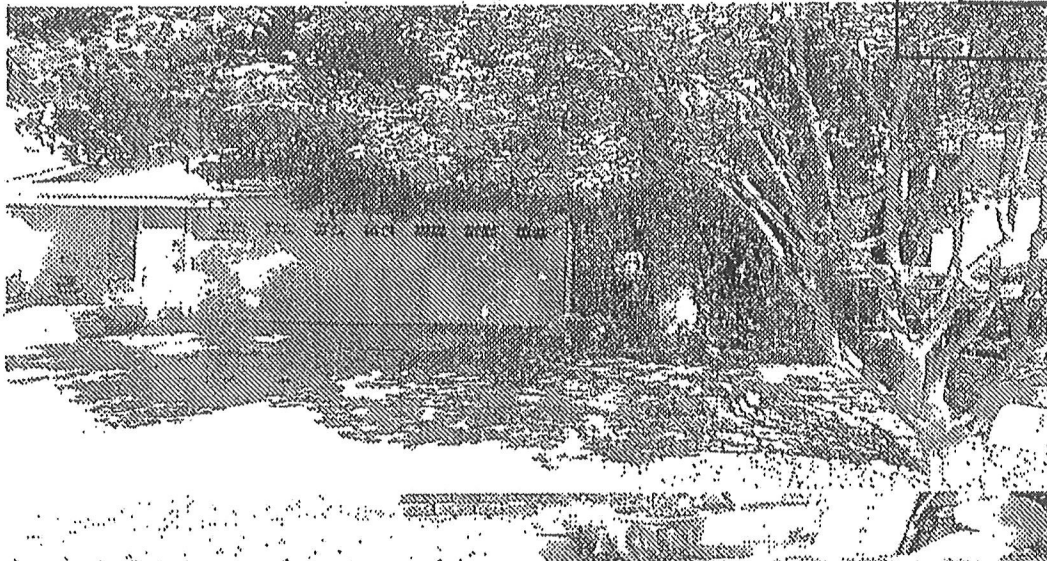
PHOTO #4

The driveway at the residence is approximately 29 ft long and 16ft wide; The thickness is approximately 4". The driveway is severely cracked, lifted up, and sunk. The driveway is lifted up on the left side where it meets the garage. There is a liquid amber tree on the right side of the driveway (see photo #4). There is a drain line under the driveway approximately 8' from the garage door (see photo #5). This area is severely sunk. The drain in the driveway collects water from the right side of the home and from the driveway, and drains out on the left side of the home approximately 60 ft from the collection point in the driveway to the street. Tree roots from the liquid amber tree are visible on the right side of the driveway. The concrete is lifted in several locations. The owner stated that there was a leak in the water line on the city side of the meter and the meter box was full of water as was the drain line in the driveway. A pressure test was done on the water lines and they did not hold pressure. The leak was found to be in the hall bathroom toilet. There were no other leaks found in the water lines.

1. It is of my opinion that the severe lifting of the concrete is due to the roots of the liquid amber tree. The cracking in the driveway has become progressively worse over time due to the tree roots. The sinking of the concrete especially in the drainage line area is due to the water leak that had occurred in the water main.
