August 2014

Dealer Service Instructions for:

Safety Recall P36 / NHTSA 14V-391

Sun Visor Wiring

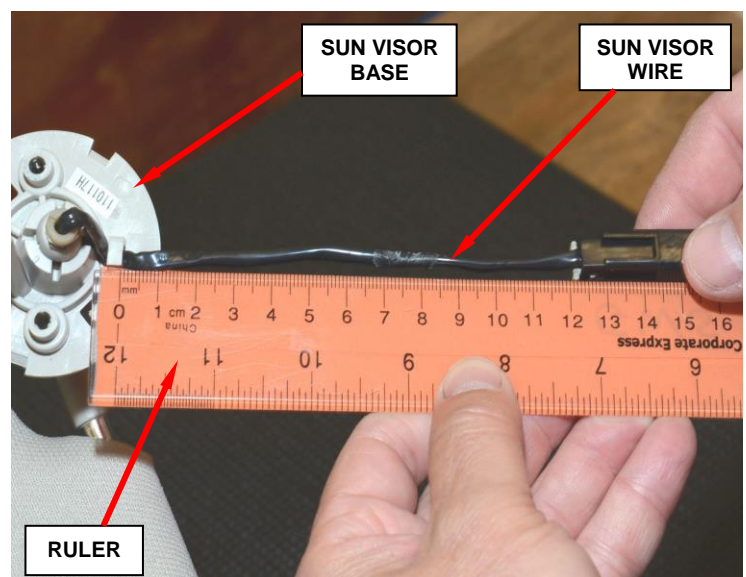
Figure 11 – Measure Wire Length

NOTE: The majority of the vehicles built before September 01, 2012 will have a 4 ¾ inch (120 mm) long sun visor wire. The majority of the vehicles built after September 01, 2012 will have a 2 ¾ inch (70 mm) long sun visor wire.

28. Measure the length of the sun visor wire to determine the correct wire routing (Figure 11).
