Safety Recall P36 / NHTSA 14V-391

Sun Visor Wiring

2011 – 2014 (WD) Dodge Durango

(WK) Jeep® Grand Cherokee

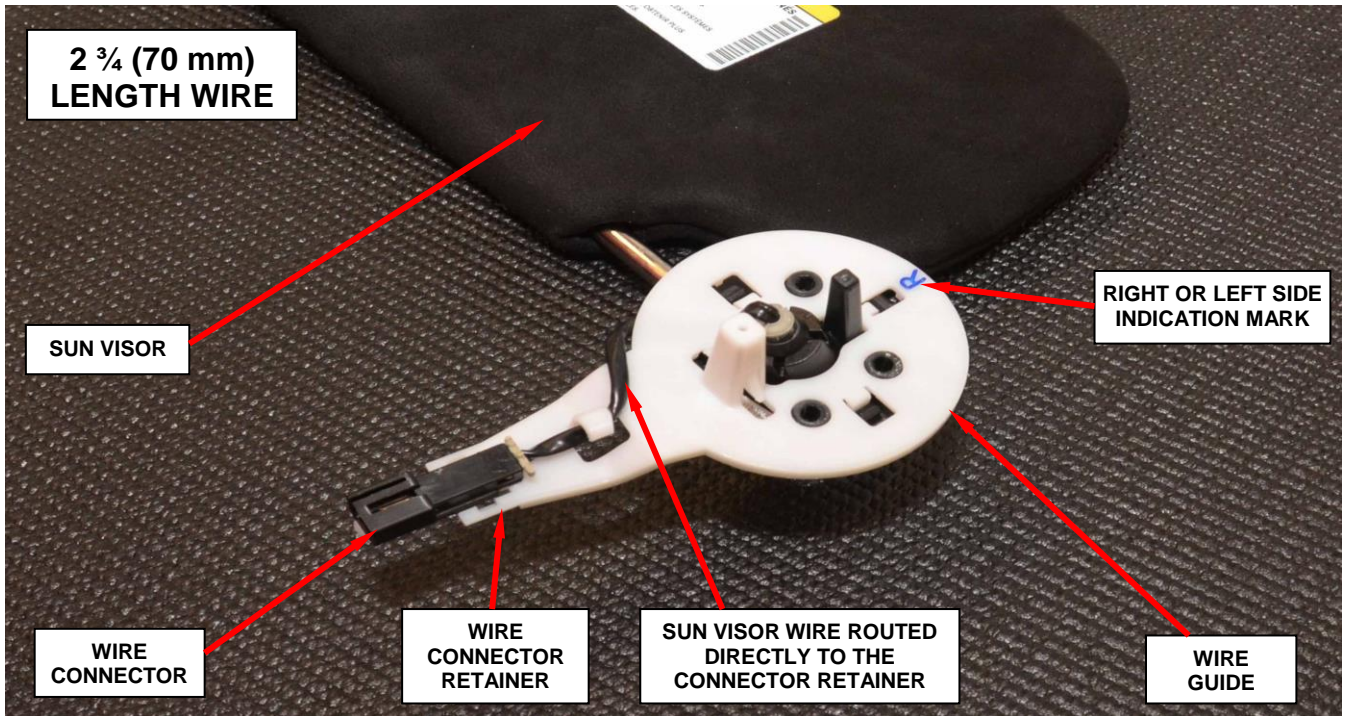
Figure 13 - Sun Visor Wire Routing (2 3/4 Inch / 70 mm Length Wire)
(Parts removed from vehicle for photographic purposes only)

NOTE: The plastic wire guides are marked “R” for the right side and “L” for the left side (Figure 13).

31. Route the wire as shown in Figure 13 or 14 depending on the length of the sun visor wire. Then connect the sun visor wire harness electrical connector to the wire guide connector retainer.
