# National Transportation Safety Board Aviation Accident Preliminary Report

<b>Location:</b>	Wilton, CA	<b>Accident Number:</b>	WPR22LA015
<b>Date &amp; Time:</b>	October 14, 2021, 16:00 Local	<b>Registration:</b>	N857PF
<b>Aircraft:</b>	WSK-MIELEC AN-2TD	<b>Injuries:</b>	2 Serious, 2 Minor
<b>Flight Conducted Under:</b>	Part 91: General aviation - Personal

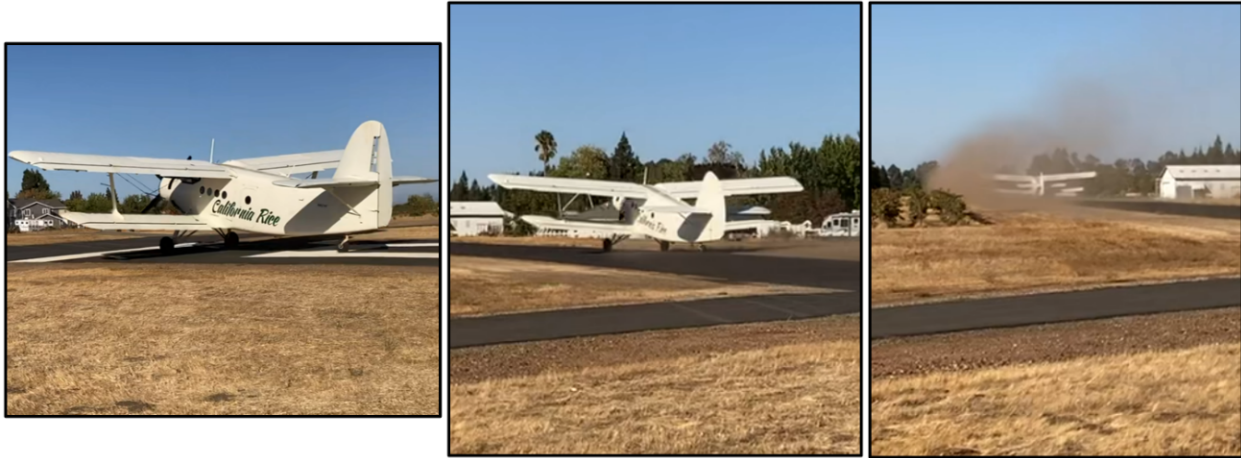
There were two witnesses located at the airport that took videos of the airplane departing. One video showed the airplane just prior to the takeoff roll. The tailwheel is positioned backward and as the airplane starts the roll, the tailwheel swivel and the airplane moves to the right of the runway (see Figure 1 below).

*Figure 1: The Airplane Starting the Takeoff Roll*

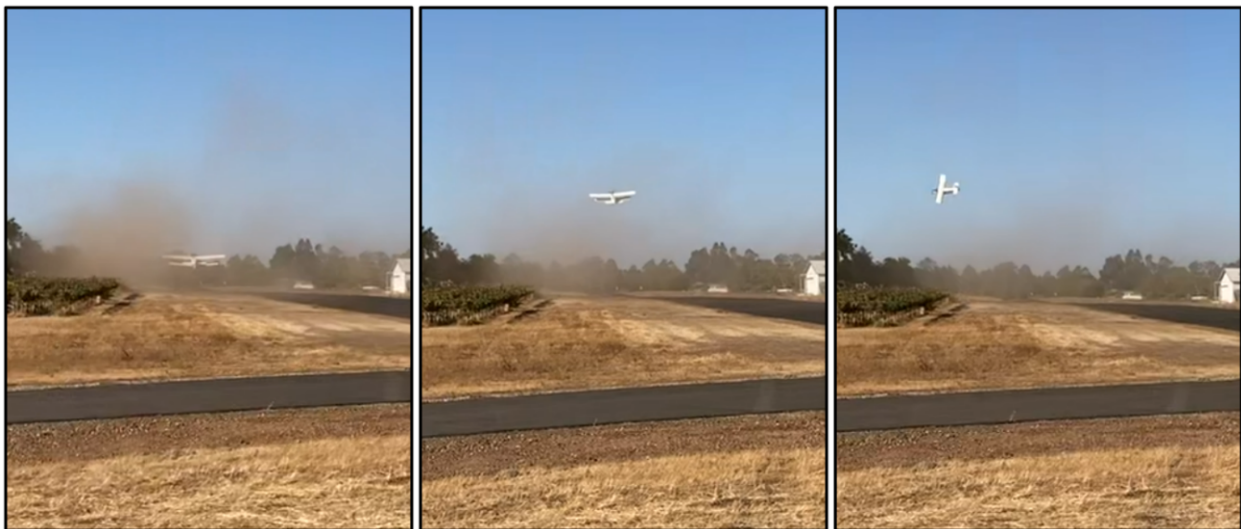
The airplane then veered to the left of the runway and became airborne shortly thereafter. In the approximate 10 seconds that followed, the airplane pitched up at an increasingly higher and higher angle-of-attack. The airplane then made a sharp left turn and goes behind the trees as it descends (see Figure 2 below).

*Figure 2: The Airplane Airborne*
