Ms. Aundria Blatch
Miami-Dade County
Internal Services Department
111 NW 1st Street, 24th Floor
Miami, Florida 33128

July 6, 2021 (*updated*)
Via Email: ablatch@miamidade.gov

**RE: Miami-Dade County Courthouse
June 2021 Condition Report**

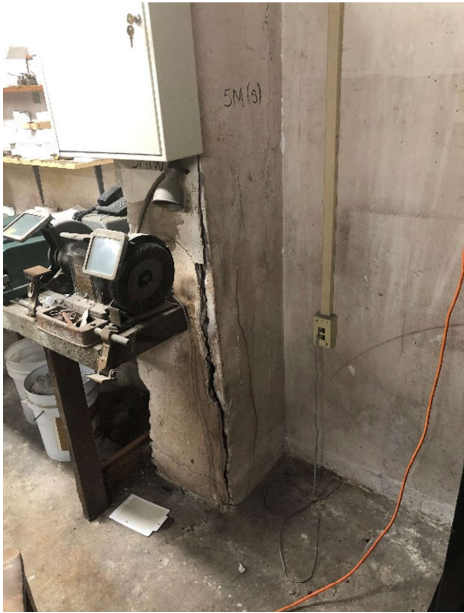
- a) Though signs of moisture were apparent in several areas, we did not observe any standing water at the time of our visit.
 - b) As previously reported and documented, the majority of the concrete column encasements have varying degrees of concrete spalling and cracks, ranging from minor to severe. The concrete encasement acts as fireproofing for the structural steel members below. The spalled concrete compromises the fire protection and allows moisture penetration which corrodes the steel members below.

1. BASEMENT – COLUMN ENCASEMENT SPALL

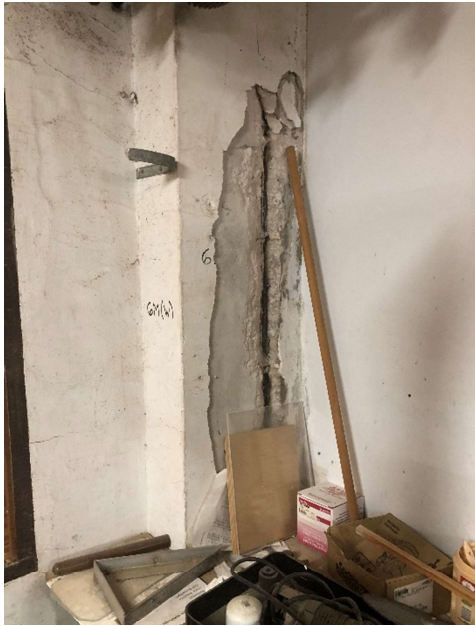
2. BASEMENT – COLUMN ENCASEMENT SPALL

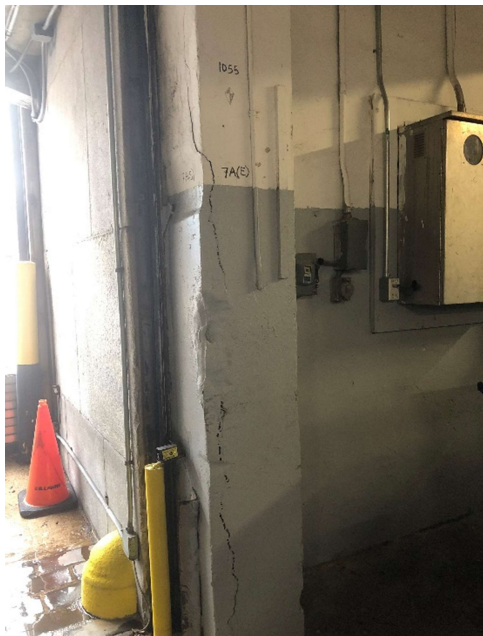
3. BASEMENT – COLUMN ENCASEMENT SPALL

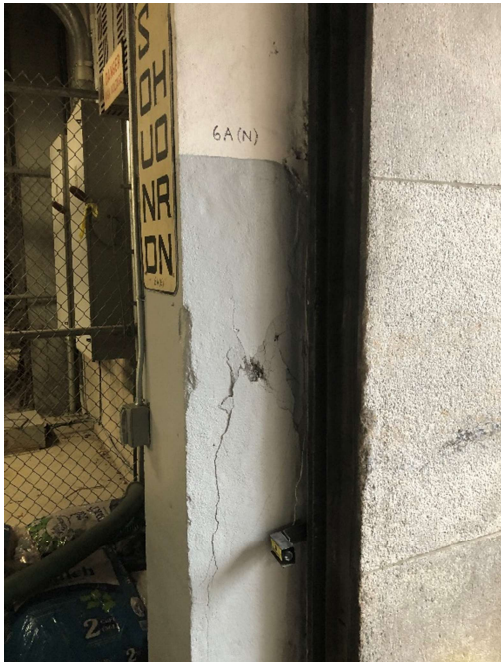
4. BASEMENT – COLUMN ENCASEMENT SPALL

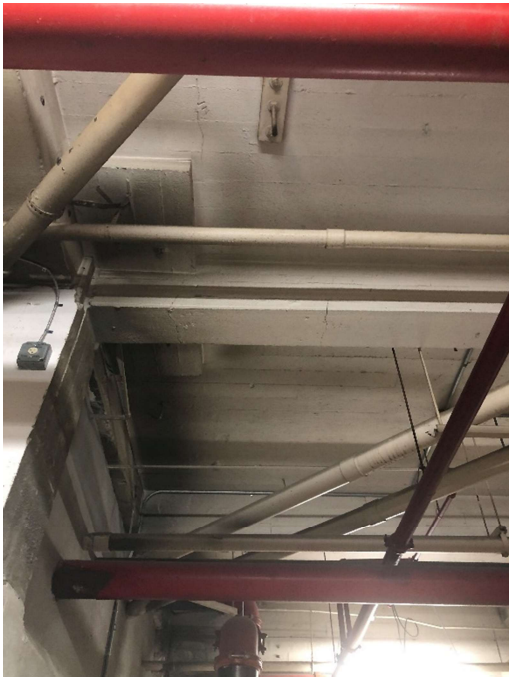
- c) As previously reported and documented, numerous embedded steel column members have varying signs of corrosion.
 - d) As previously reported and documented, concrete spalling and cracks are present in some of the overhead beams and slabs.

5. BASEMENT – BEAM CRACKS

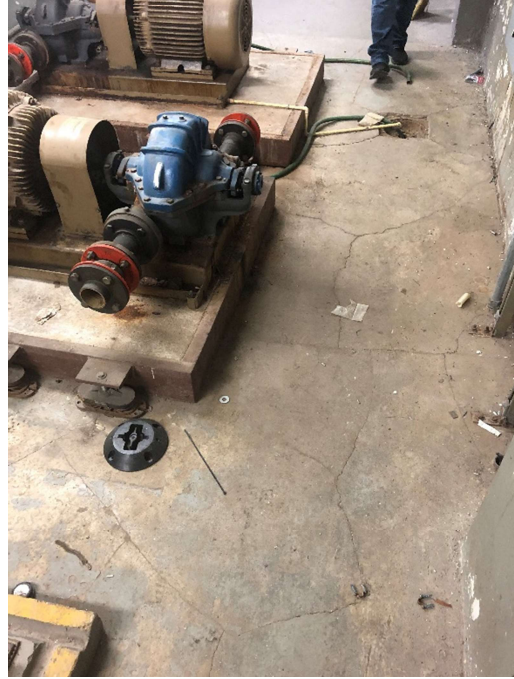
6. BASEMENT – SLAB CRACKS OVER CRAWL SPACE

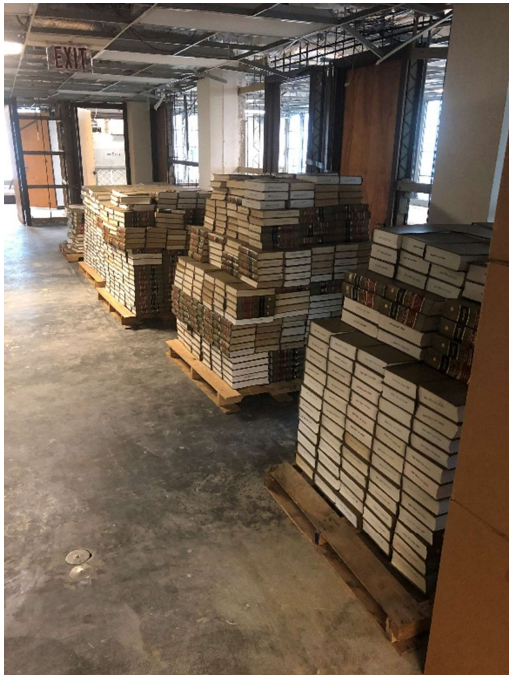
- b) Until such time as the preceding analysis can be performed, we recommend that floors 16 and above not be occupied and all live loads removed.
 - c) Floor 16 – we observed 5 pallets of stored books. This load must be removed immediately (see photo #7).

7. FLOOR 16 (REMOVE LOAD FROM BOOKS)

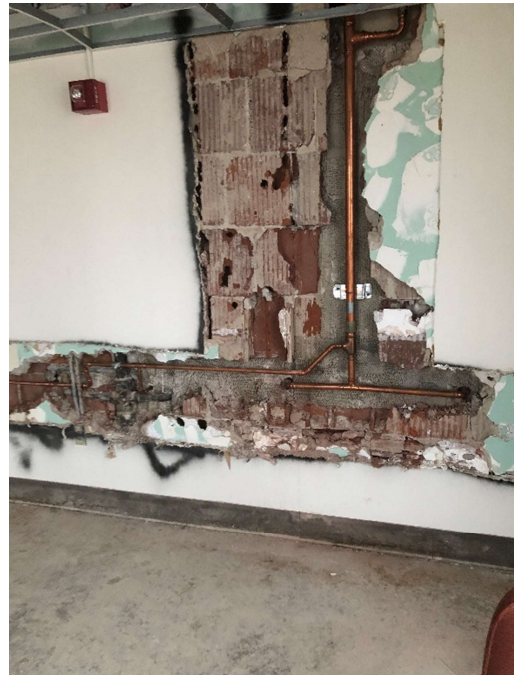
8. FLOOR 16 (PARTITION WALL DAMAGED BY PLUMBING WORK)

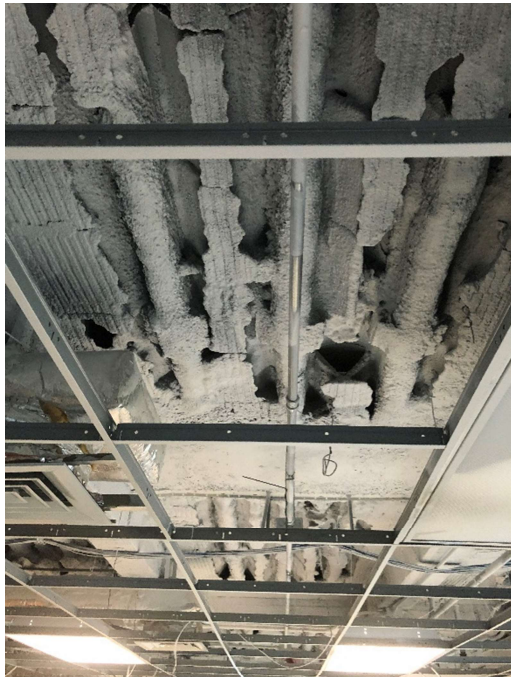
4. Access was provided to floors 3, 15, 16, 17, 20, 21, 22, 24, 25, 26 and 27th floors. In general, the following was noted:
 - a) Terracotta-joist floor system was exposed at floors 16, 21, 24 and 25. At floors 15, 17, 20 and 21 we randomly removed some drop-ceiling panels to expose the floor framing above. Many of the visible members noted were repaired at some point in time using *gunite*. This method of repair is not precise and results in a joist member with an inconsistent profile. In addition, the terracotta, which provides lateral bracing for the joists was knocked-off and removed at numerous locations, and not replaced. We recommend that a search of City records be

9. FLOOR 16 (17TH FLOOR JOIST AND TERRACOTTA FRAMING ABOVE / GUNIT REPAIR)

- performed to confirm if the preceding repairs were documented with a permit. If not, we recommend an analysis of the remaining joist profile to confirm its structural adequacy.

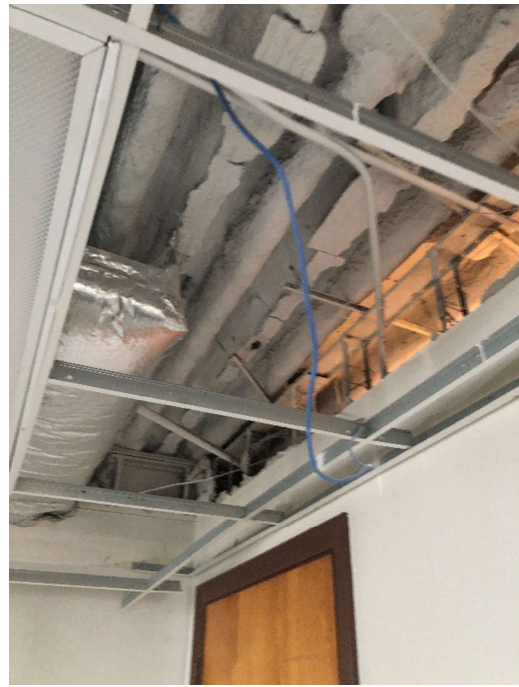
10. FLOOR 16 (17TH FLOOR JOIST AND TERRACOTTA FRAMING ABOVE / GUNIT REPAIR)

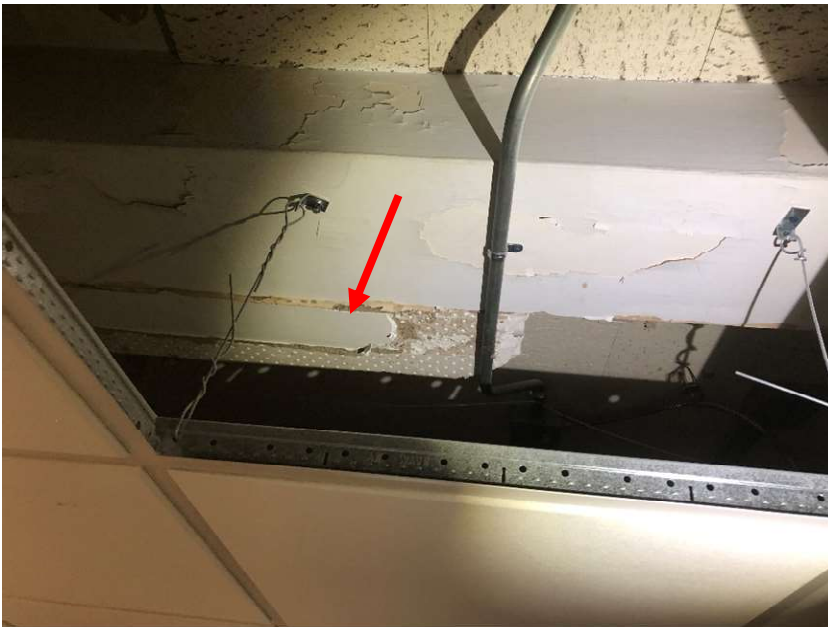
11. FLOOR 15 (COURTROOM 15-1 REMOVE UNSUPPORTED GYPSUM MEMBER WITHIN CEILING SPACE)

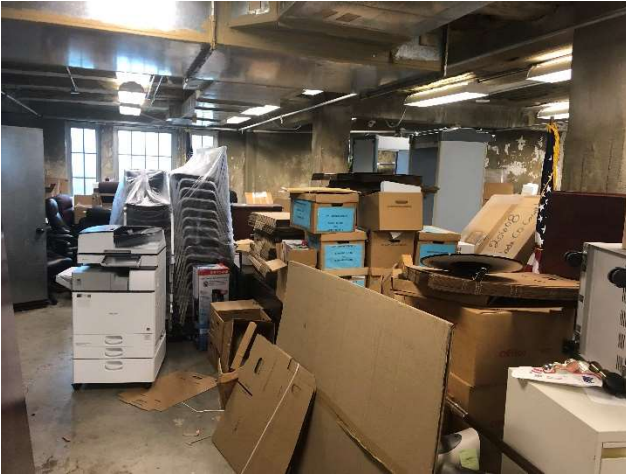
- d) Floor 21 – we observed excessive storage, which also presents a fire hazard. All excessive loads and storage must be removed as soon as possible.

12. FLOOR 21 (REMOVE LOADS / STORAGE)

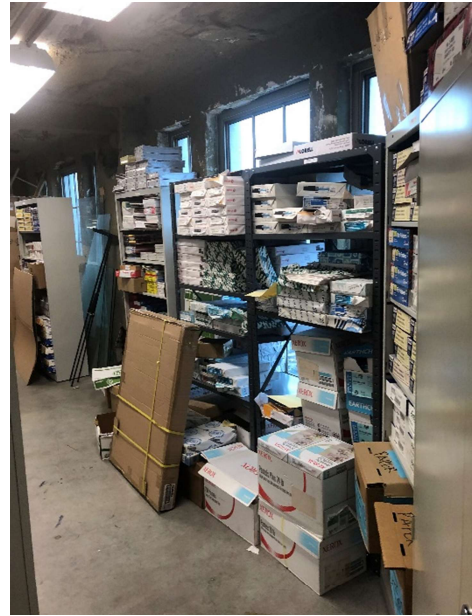
13. FLOOR 21 (REMOVE LOADS / STORAGE)

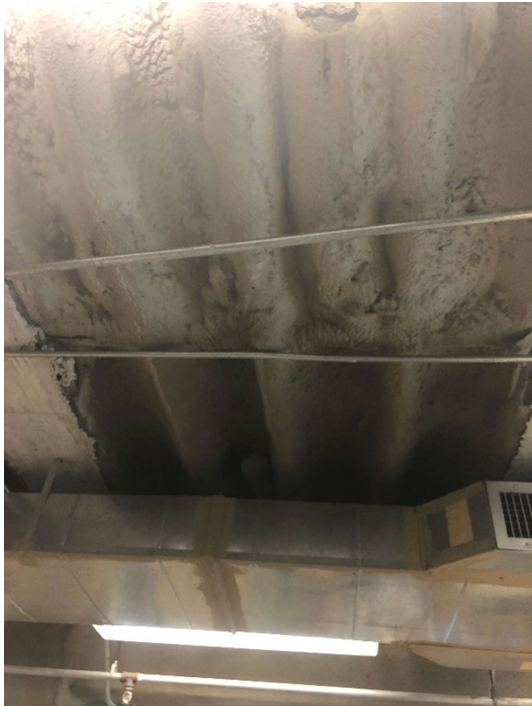
14. FLOOR 21 (22ND FLOOR JOIST AND TERRACOTTA FRAMING ABOVE / GUNITE REPAIR)

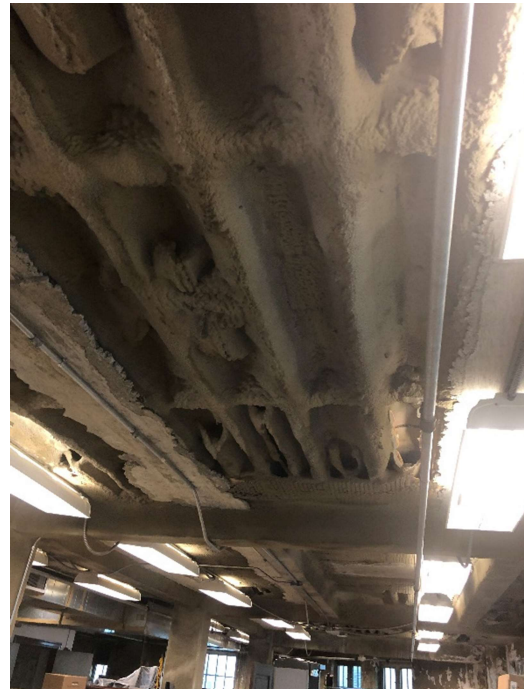
15. FLOOR 21 (22ND FLOOR JOIST AND TERRACOTTA FRAMING ABOVE / GUNITE REPAIR)

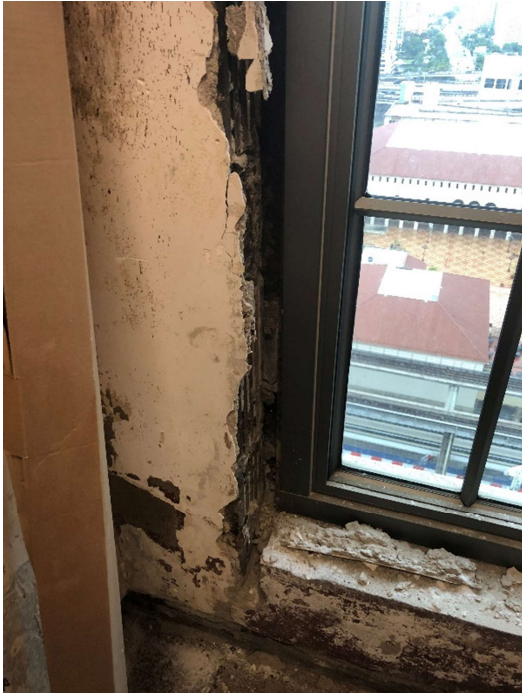
16. FLOOR 21 (DETERIORATION AT JAMBS)

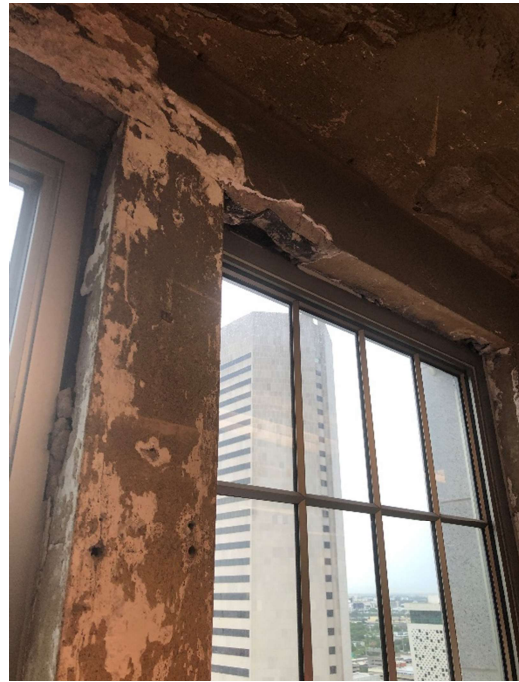
17. FLOOR 21 (DETERIORATION AT LINTEL)

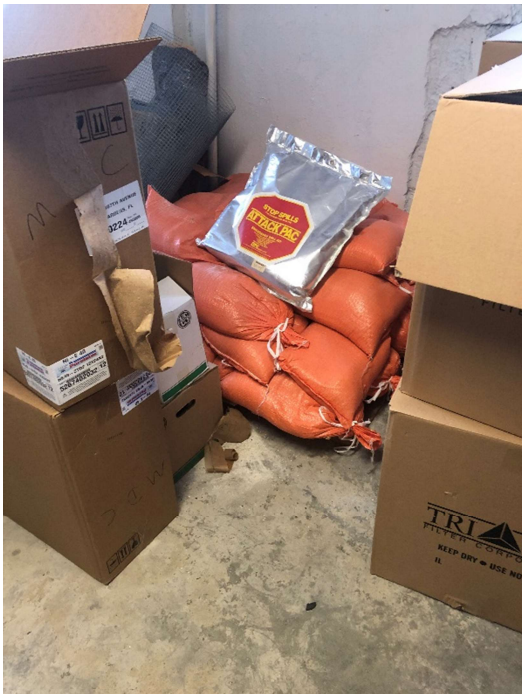
- e) Floor 24 – we observed a pallet of sandbags that must be removed, or the bags spread out to distribute the load (see photo #18).
 - f) Floor 25 – this floor is not currently occupied. We observed spalling at columns, beams, lintels, slab and joist system, and corrosion at steel column members. Given the degree of deterioration observed this floor shall not be occupied until repairs can be performed.

18. FLOOR 24 (REMOVE SAND BAG LOADING)

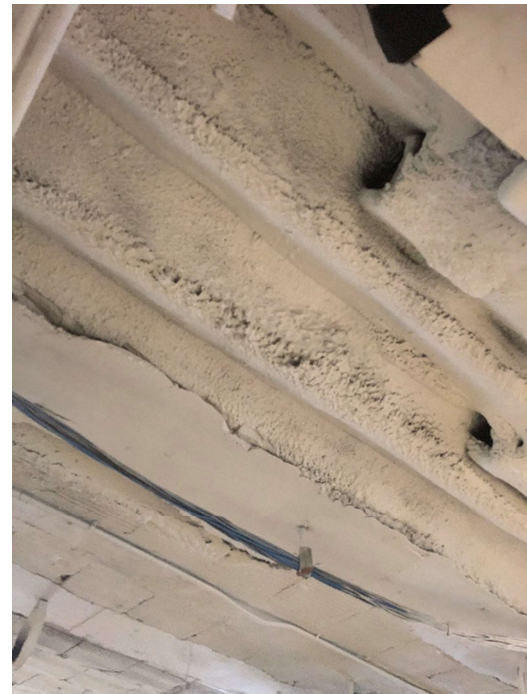
19. FLOOR 24 (25TH FLOOR JOIST AND TERRACOTTA FRAMING ABOVE / GUNITRE REPAIR)

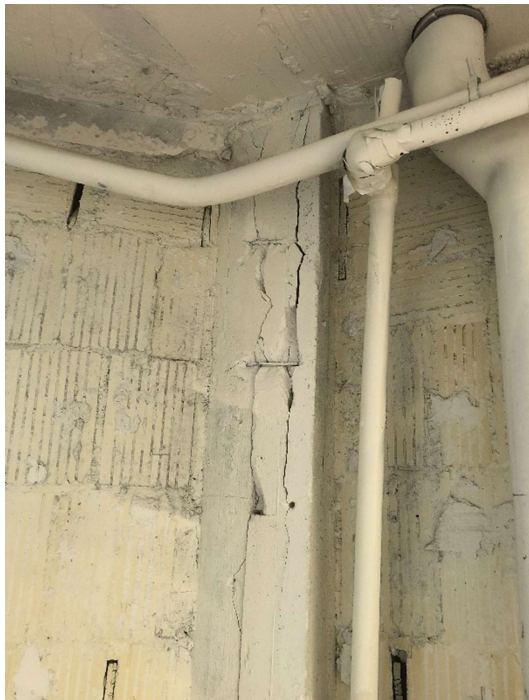
20. FLOOR 24 - COLUMN ENCASEMENT SPALL

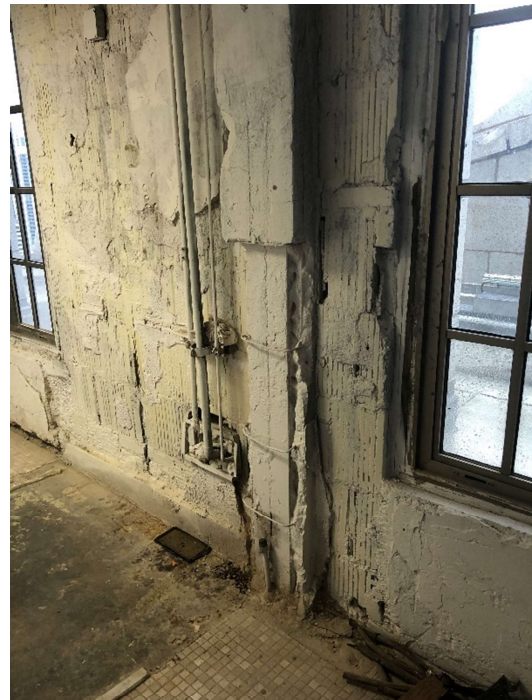
21. FLOOR 24 (EXPOSED STEEL COLUMN / CONC. ENCASEMENT HAS BEEN REMOVED)

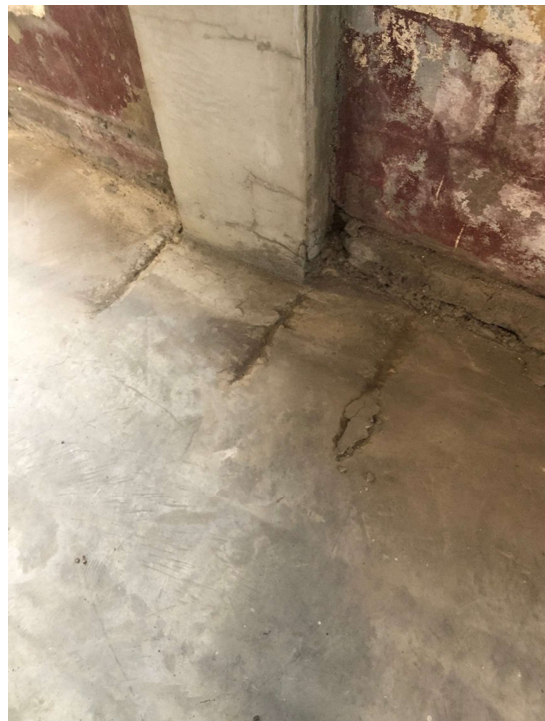
22. FLOOR 25 (SLAB SPALL AND EXPOSED REBAR)

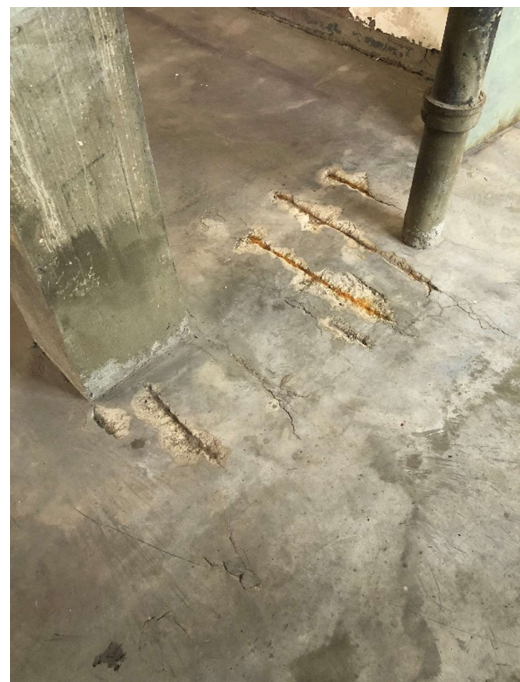
23. FLOOR 25 (SLAB SPALL AND EXPOSED REBAR)

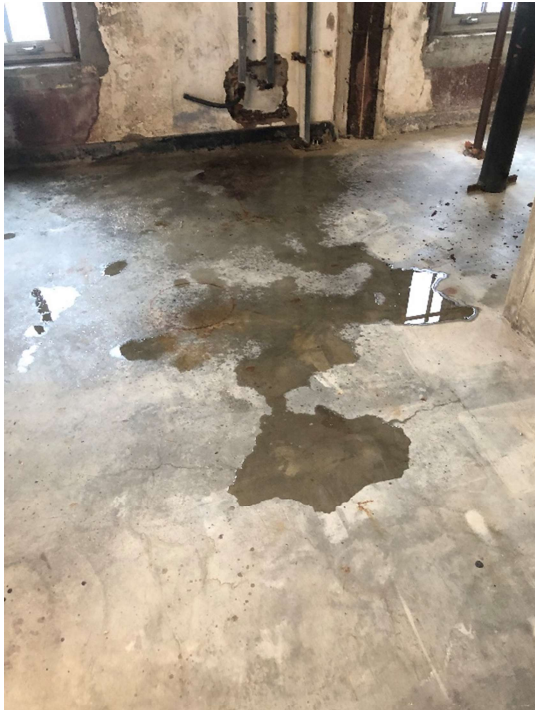
24. FLOOR 25 (LEAK FROM A/C UNIT ABOVE AT FLOOR 26)

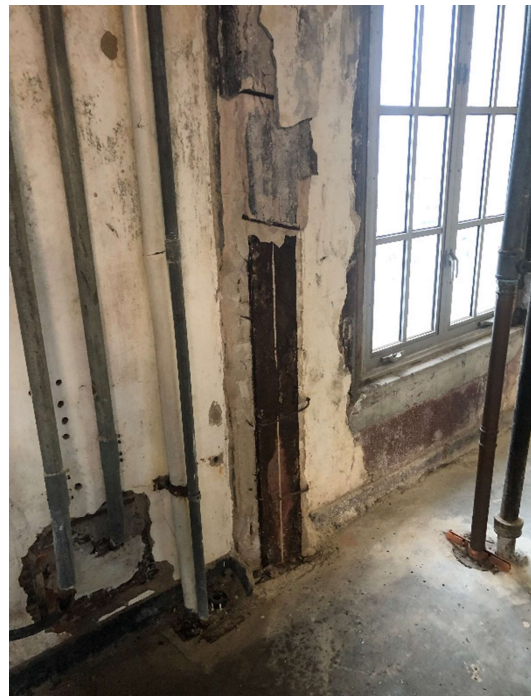
- g) Floor 25 – there is an existing column at the south end that has lost its concrete encasement and the steel member below is excessively corroded. **We recommend that this column be shored within 30 days of this letter** until such time as permanent repairs can be performed (see photo #25).

25. FLOOR 25 (EXPOSED STEEL COLUMN / CONC. ENCASEMENT HAS BEEN REMOVED AND STEEL IN POOR CONDITION)
SHORING IS RECOMMENDED

Of immediate attention, we recommend that the existing column noted in item (g) above at Floor 25 be shored within 30 days of this letter. We further recommend that all live loads (personnel, equipment,

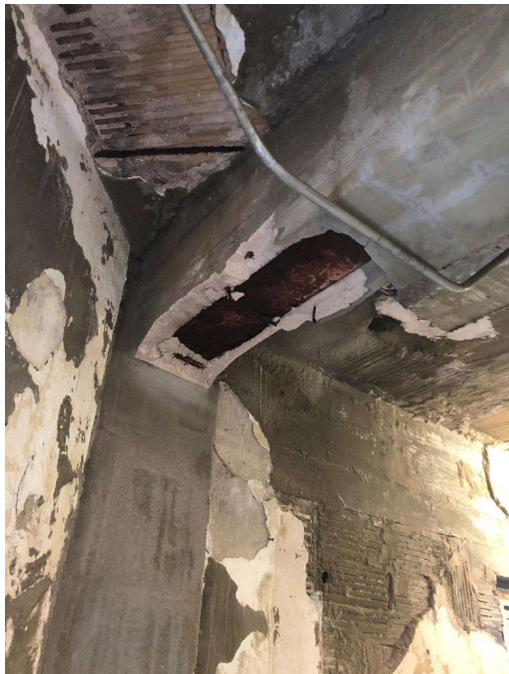
26. FLOOR 25 (CONCRETE ENCASEMENT HAS DISLODGED / EXPOSED STL BEAM)

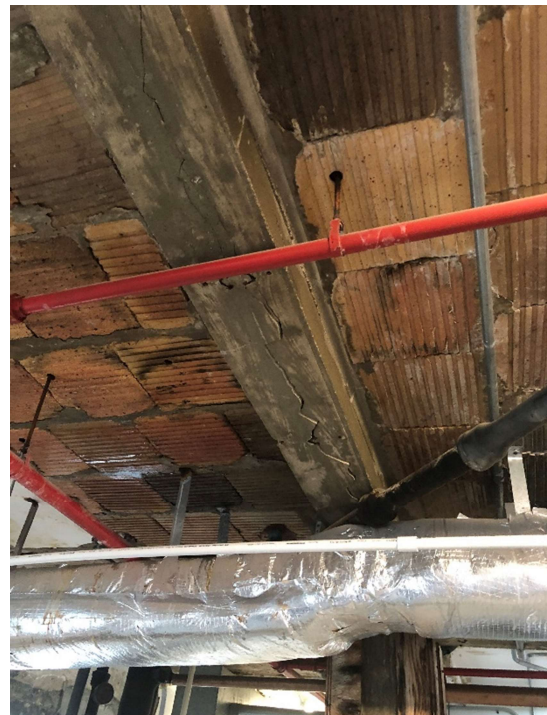
27. FLOOR 25 (SPALLING AT CONCRETE BEAM ENCASEMENT)

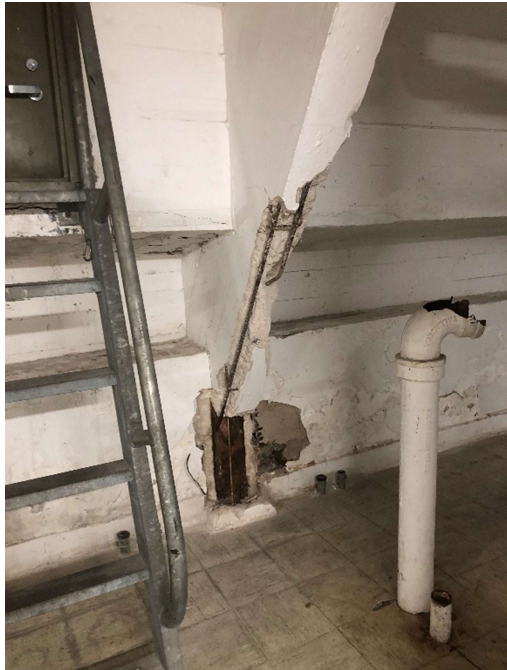
28. FLOOR 26 (CONCRETE BEAM SPALL AND EXPOSED STL COLUMN)

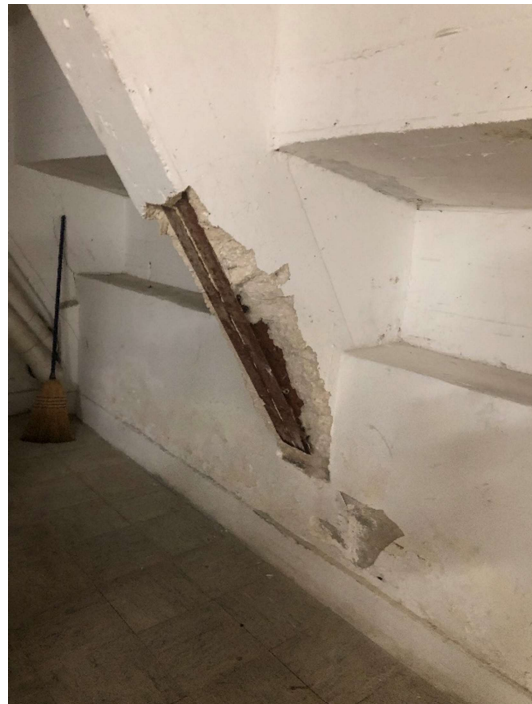
29. FLOOR 26 (EXPOSED STEEL BEAM MEMBER)

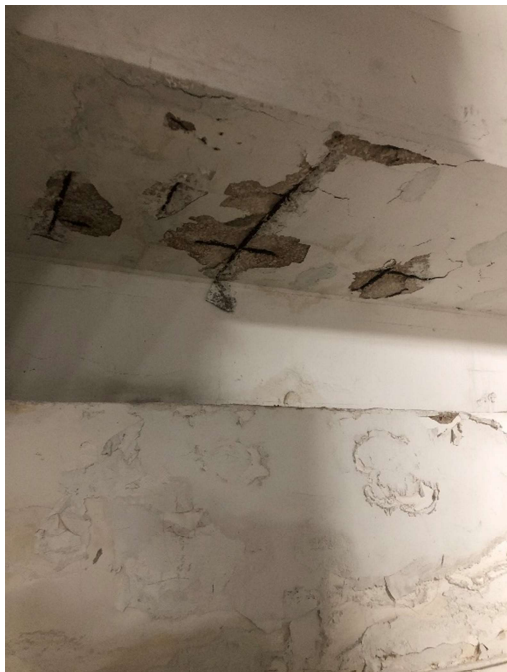
30. FLOOR 26 (OVERHEAD SPALL)

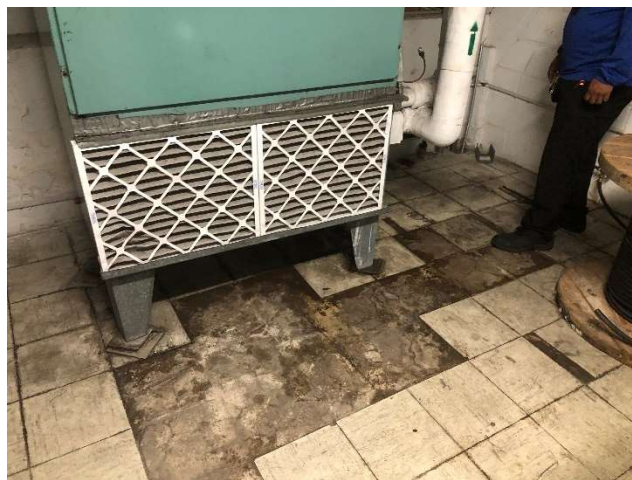
31. FLOOR 26 (LEAKING A/C UNIT)

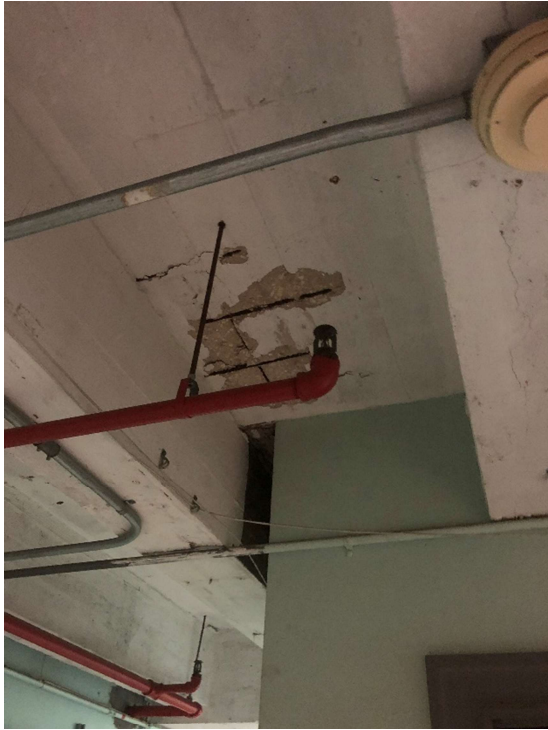
32. FLOOR 27 (OVERHEAD SPALLS)

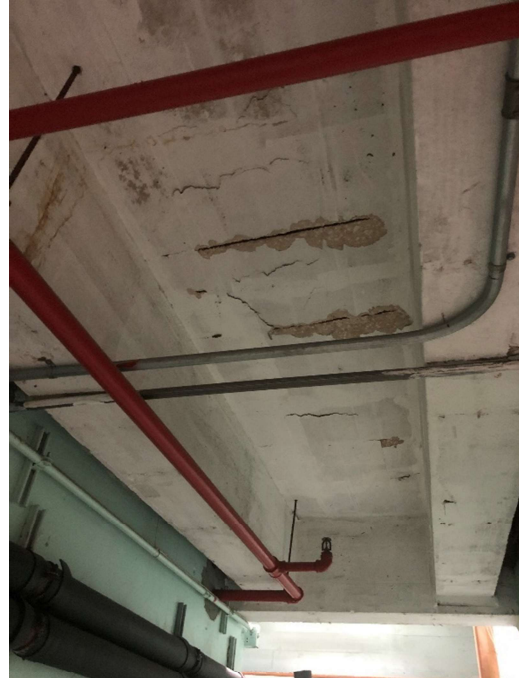
33. FLOOR 27 (OVERHEAD SPALLS)
