**Firefighter Line of Duty Death**

**06/28/2015 Incident 15-0061817**

**06/28/2015 Incident 15-0061833**

**PIA June 28, 2015  
Incident 15-0061817**

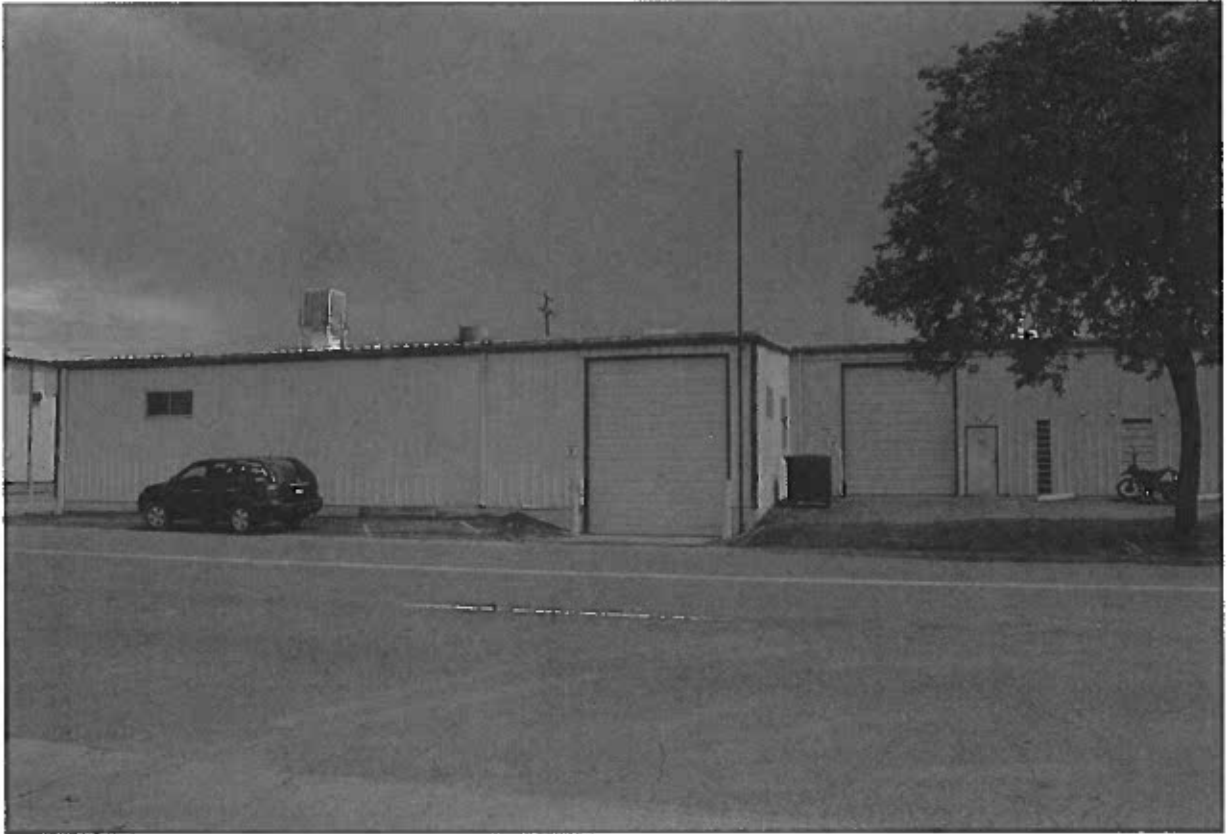
The building located at 3860 Blake Street is an L-shaped, vacant warehouse occupancy approximately 60ft X 300ft in size. This location is a high density commercial area that borders Districts 2 and 6. With the recent expansion of Light Rail and the DIA Heavy Rail system running through this area it is currently experiencing a large amount of urban renewal. The building was formerly Car-Go Battery until 2012. In April of 2013 an inspection was performed while the building was vacant. In approximately March of 2014 it was found that a marijuana start-up business was illegally operating in the building. After multiple court summons were issued due to a prohibited change of occupancy (proper permits for new construction and marijuana business conversion were not pulled) it was then closed for business. As part of the sentence, the property was ordered to pull the appropriate building permits to ensure the building was put back to its original use. On October 1<sup>st</sup> of 2014, a follow up inspection was performed and the building was returned to its original state. During an inspection in March of 2015 the Fire Prevention Division confirmed that it was still in its current vacant state as a warehouse.

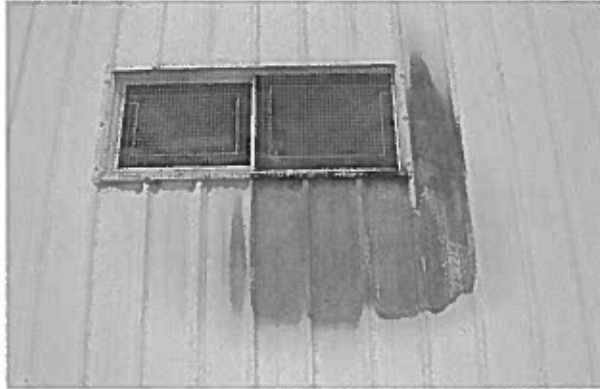
Command was established. TR9 dismounted the apparatus and immediately pulled the dumpster away from the building using a New York Hook. It was noticed that the warehouse next to the dumpster had charring on the paint where the dumpster was

against the wall. It was further observed that the window directly above the location of the dumpster was still intact.

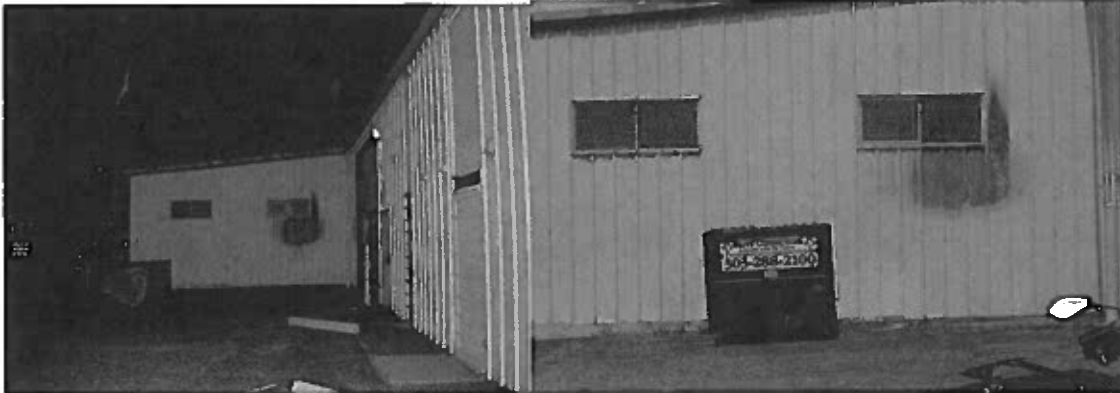
**TR9:** *Command from Truck 9, this looked like it just scorched the outside of the building. I don't see a Knox box or anything. We might have to force a door if we want to get in?*

TR9's crew noticed the paint on the outside of the structure where the dumpster was located had scorch marks and was directly below a window. Sizing up the structure, TR9 had the option of a glass man door or an overhead garage door. TR9 crew members chose the large roll-up door to cause the least amount of property damage and because of its proximity to the exposure. TR9 was able to forcibly pry under the roll-up door using a halligan to raise the door approximately 7'.

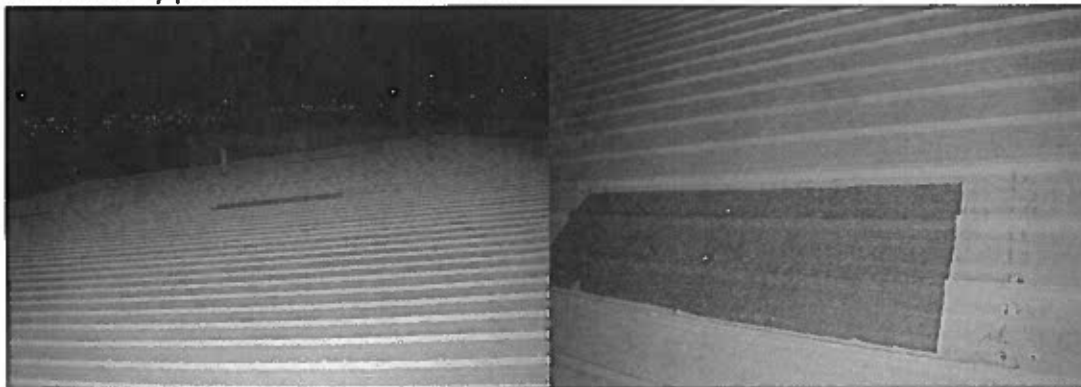
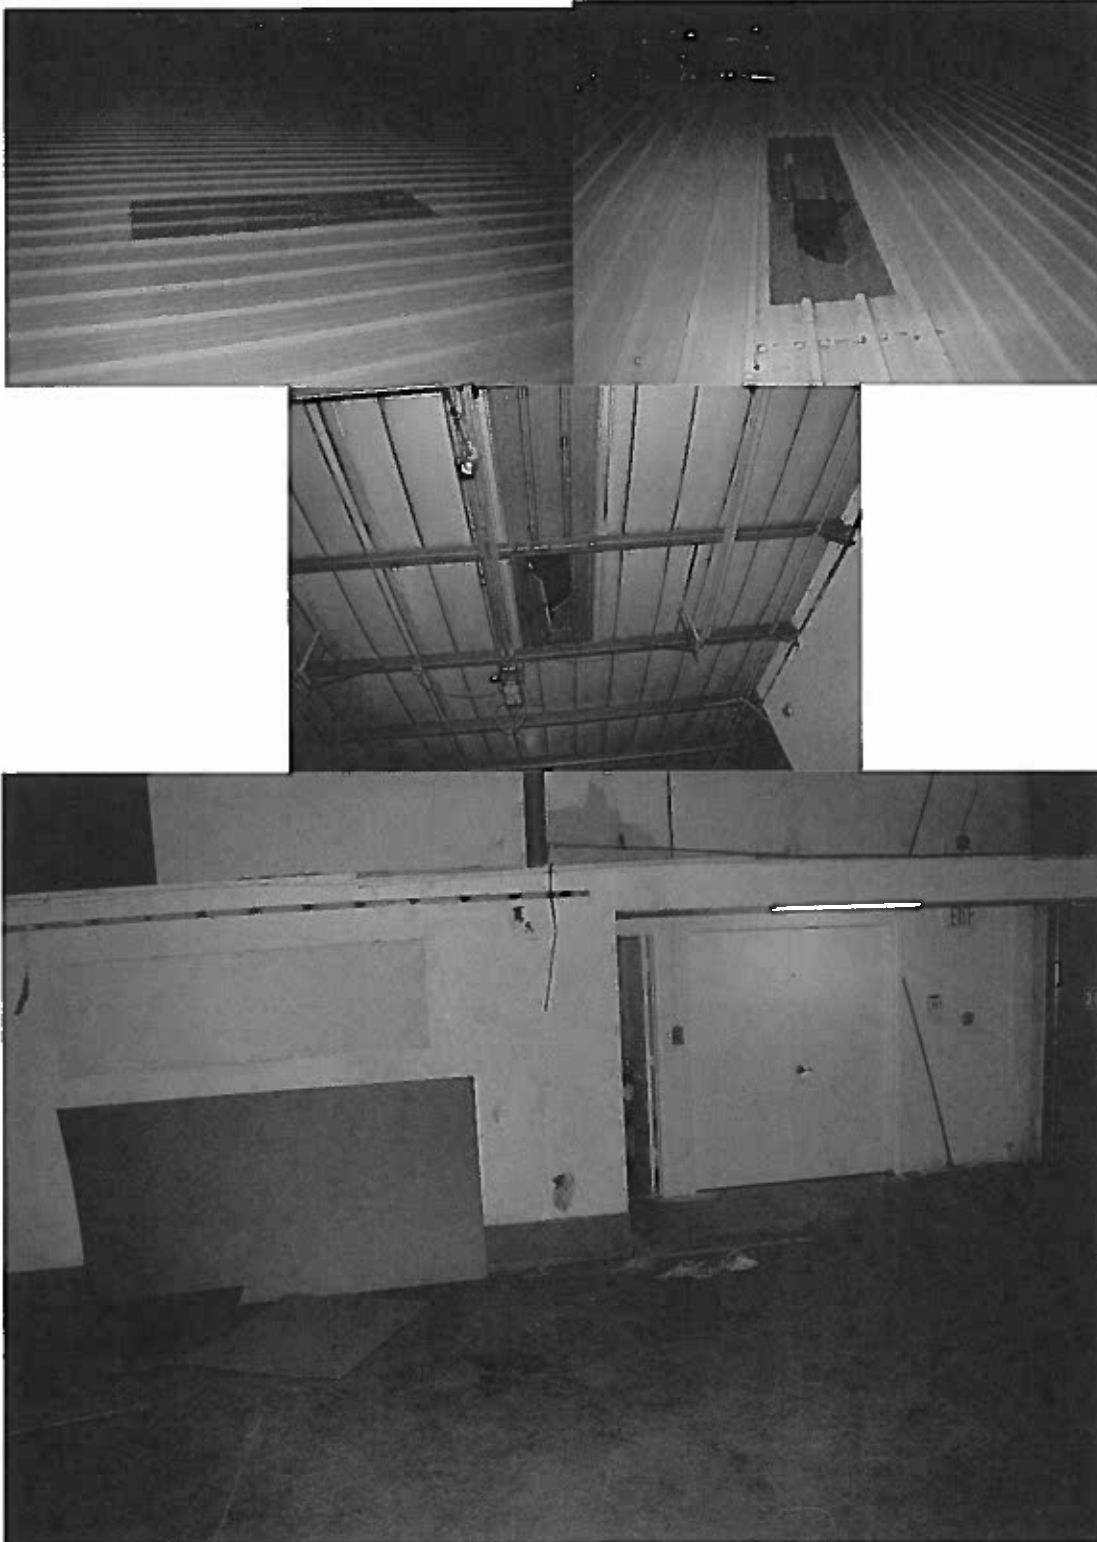
At this time T8 Alpha heard a large thud and turned to look and saw that Truck 8 Bravo was no longer on the roof

T8 members went to the hole in the roof and tried to see if they could assist their Engineer. It was observed that T8 B had fallen to the concrete floor below. They then immediately proceeded to exit the roof.

- Conditions did not warrant SCBA usage on the interior
- Crews sent to the roof to confirm size of building and check for vertical extension
- Firefighter went through a skylight on the roof while completing roof assignment
