Fire at 936 Childs Point Road

**Bureau of Alcohol, Tobacco, Firearms and Explosives
Anne Arundel County Fire Department**

Executive Summary
ATF Investigation # 761010-15-0026 / AAFD Investigation # 15-017
Fire at 936 Childs Point Road, Annapolis, MD

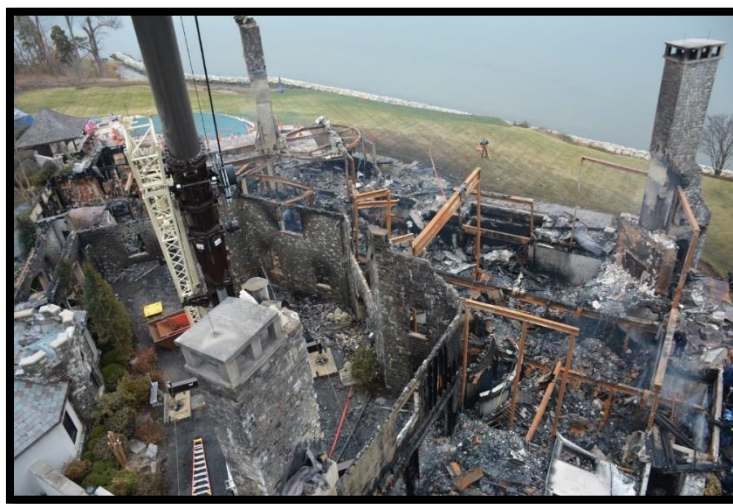
Figure 8 – Aerial view of main residence

Investigators were unable to assign any meaningful significance to macro fire patterns due to the extensive damage observed to all major structural members throughout the building. Therefore, investigators subsequently attempted to use micro, or local, fire damage comparisons in an effort to identify potential directional fire patterns.

An aerial view highlighted the vast devastation to the structure as depicted below in Figure 8.

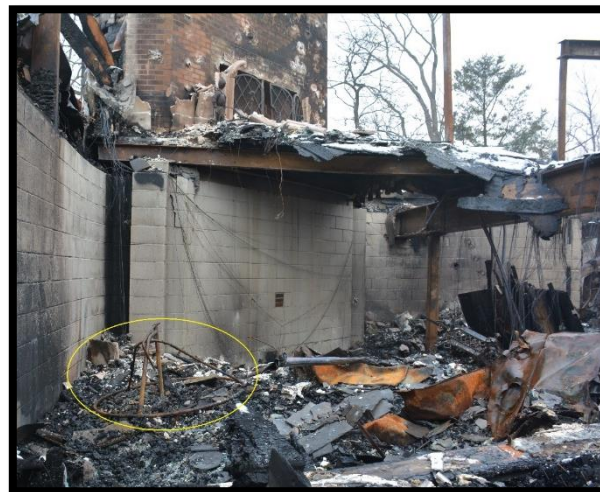
Figure 9 – Location of Christmas tree stand

During initial damage assessment, investigators also discovered remnants of a metal Christmas tree stand in the Great Room debris field. The stand was near the top of the debris with a burned stump still in the bottom screw of the stand. The Christmas tree stand stood approximately 2 feet high and the diameter of its base spanned approximately 4 feet. The charred tree stump remnants were approximately 6" wide and 10" high. The metal stand was located just off the south wall, east of the Great Room fireplace, as depicted below in Figure 9.

Investigators noted that the Christmas tree area was a potential fire origin, so that area was taped off for later excavation.

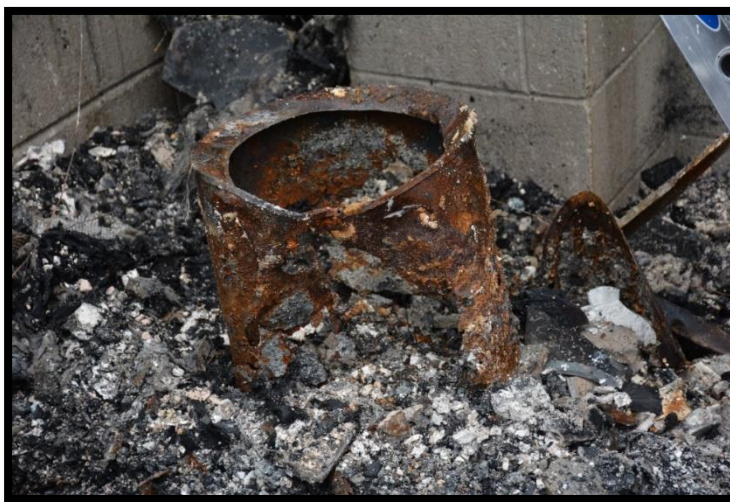
Figure 10 – Damaged ceiling light can

As investigators excavated immediately east of the fireplace and adjacent to the south basement wall, they located a ceiling can light that exhibited more oxidation and mass loss than any other can light located in the Great Room debris, as depicted below in Figure 10. Additional excavation within this general vicinity also revealed a metal door frame for the south exterior patio doors.

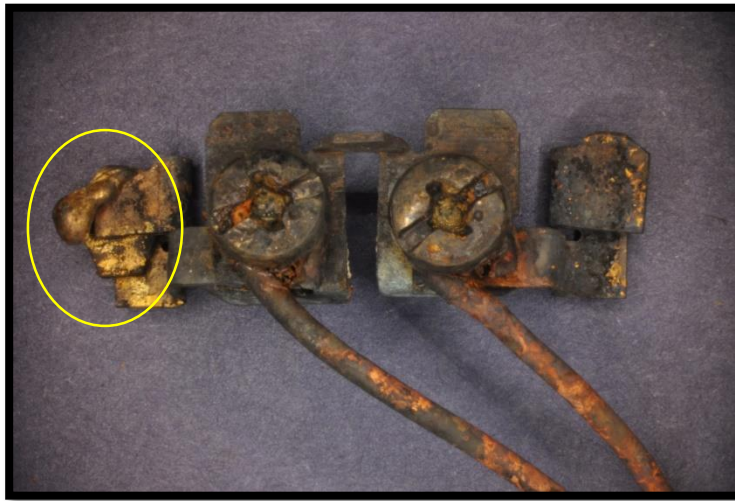
Figure 11 – Plug blade with localized melting

Further analysis was conducted on the floor duplex receptacle. The receptacle was mounted in a metal outlet box with a brass cover plate with hinged covers over the receptacles. The outlet box, cover plate and receptacle mounting yoke were intact with no evidence of electrical activity observed. The receptacle power rails were present within the outlet box, attached to two sets of conductors. The four receptacle screw terminals were observed to be intact. Three of the blade receptors were intact. The fourth blade receptor was observed to be melted. The remnants of an attachment plug blade were present in the receptor; it was observed to be melted. A second attachment plug blade was present within the outlet box. A rounded globule of melted material was present at the top of the plug blade, as depicted below in Figure 11.

The damage to the receptacle power rail and attachment plug blades was highly localized. Other brass components in the vicinity with less mass, such as the ground pin contacts, were observed to be intact. The possibility of failure of the connection between the blade receptor and attachment plug blade or failure of an internal connection within the plug assembly resulting in the production of heat due to a resistive connection cannot be precluded.

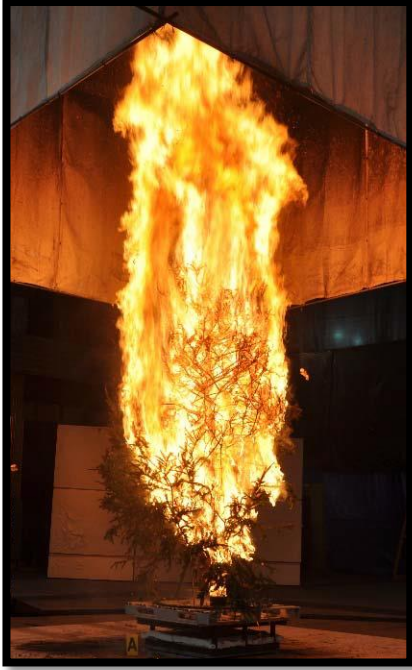
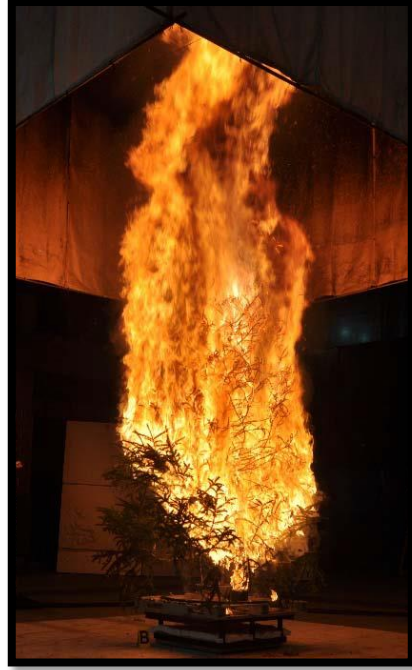
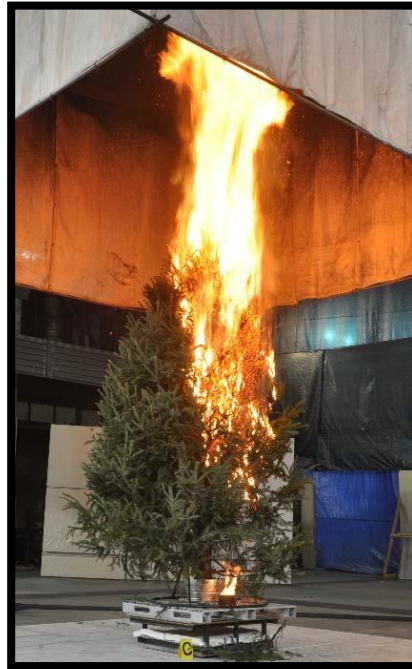
Figure 14, Figure 15 and Figure 16 depict the fire development around the time of peak burning for each of the three trees. The Heat Release Rate from each tree was assessed over the duration of the test.

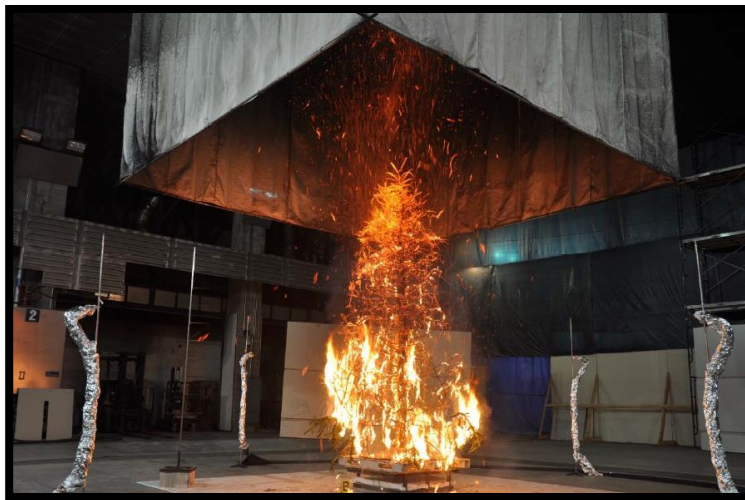
Figure 18 – Burning embers floating down late in test

From the tests, the shape of the fire was approximated as a cylinder, with an estimated flame height of approximately double the height of the tree. Burning embers were also observed to float down from each tree and were particularly prevalent as they began to burn out, as depicted in Figure 18.

For Tree A & Tree B, the peak heat flux at a distance of 10 ft. exceeded 10 kW/m². Ordinary combustibles such as upholstered furniture would be expected to be ignited by this exposure with consideration of the burning embers observed to float down from all three trees.
