# Corrosion Testing Laboratories, Inc.

CTL REF #31636

August 18, 2015

## City of Gardner Leaking Copper Coils Failure Investigation

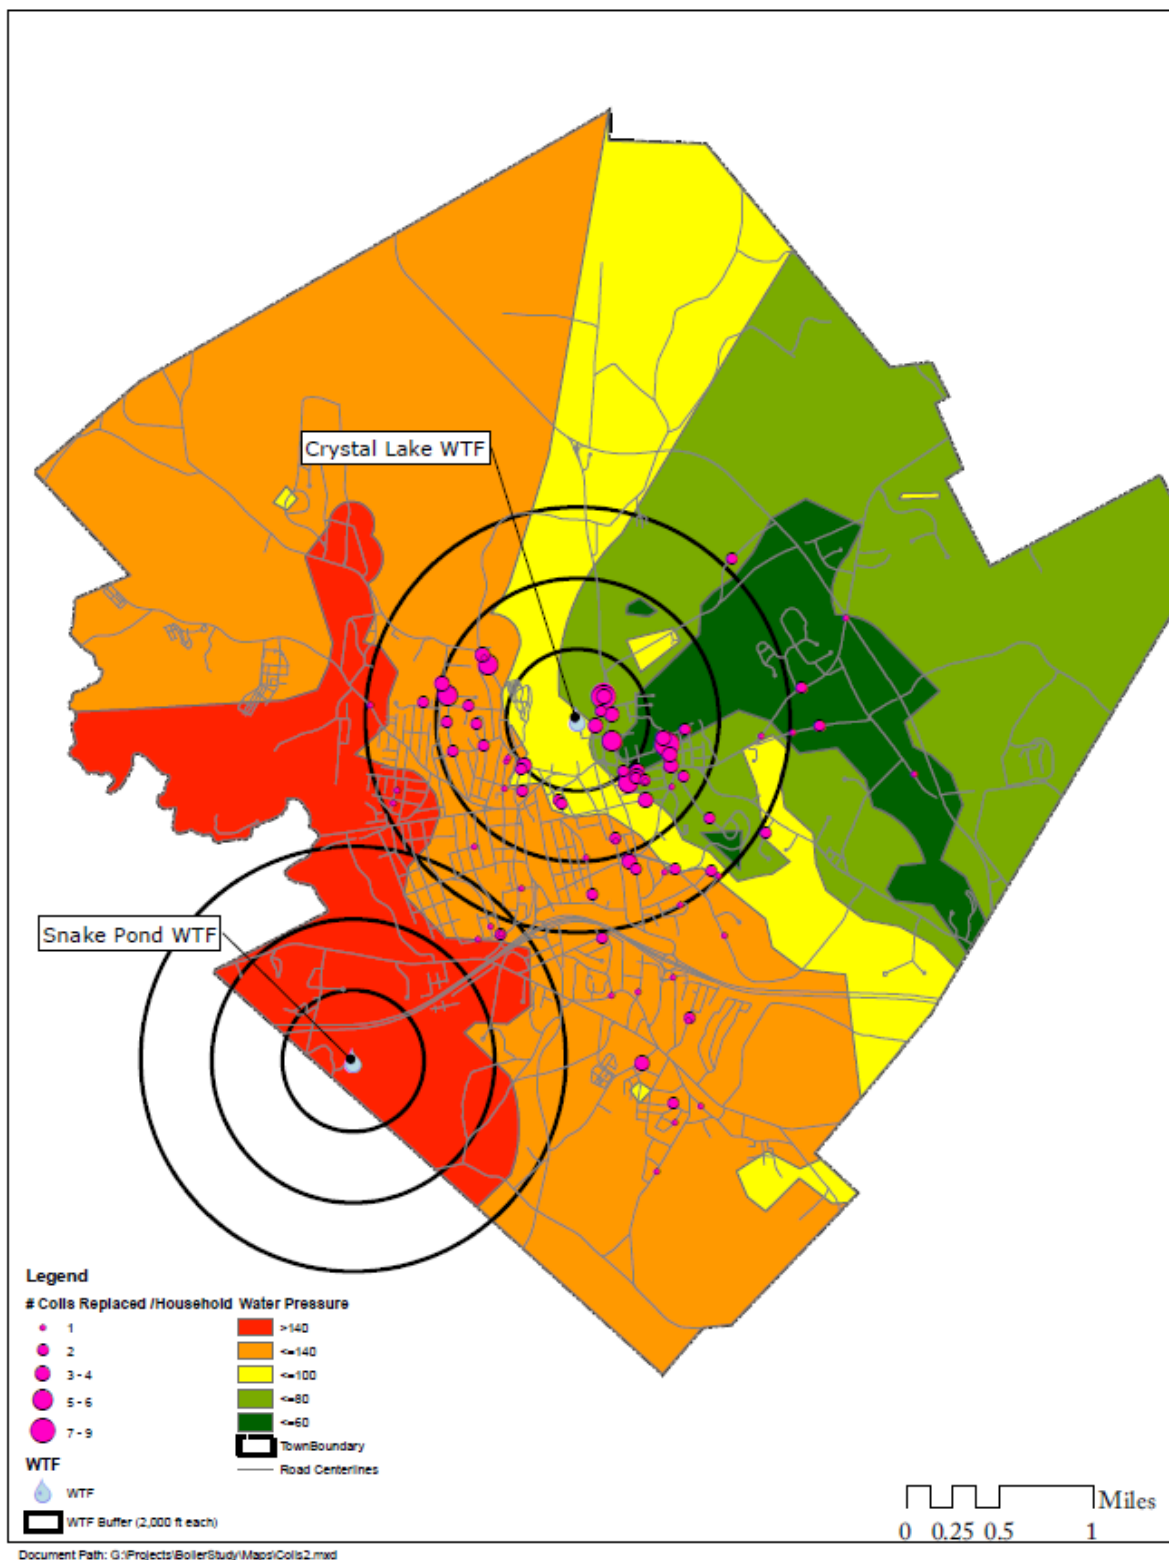
Failures were centralized around the water treatment facility (WTF) that uses surface water as a source (Crystal Lake WTF), with almost no instances around the WTF that sourced well water. A diagram provided of the distribution of the failures is shown in **Figure 1**. A report was provided with results from the analysis of the surface water and well water from the city (summarized in **Table 1**). There are specific parameters of water quality that have been related to the susceptibility of copper to pitting including the following: pH, alkalinity, hardness, total inorganic carbon, sulfate or chloride levels, and levels of aluminum or silica<sup>5,6</sup>. Pitting in copper tubing is often classified as Type I, II, or III. Type I pitting, also called cold water pitting, is typically associated with hard water conditions. Type II pitting is also called hot water pitting. It typically occurs when the water is above 140 °F in soft water. Type III pitting is called soft water pitting. It typically occurs in cold waters with pH above 8, low hardness and alkalinity and with higher levels of chloride and sulfate present. Review of the literature shows that the classifications are not hard and fast and that the mechanisms driving pitting corrosion in copper are not yet fully understood.

**Figure 1.** Map provided by the City of Gardner demonstrating the distribution of coil failures relative to the location of the water treatment facilities. Snake Pond WTF uses well water as their source and Crystal Lake WTF uses surface water.

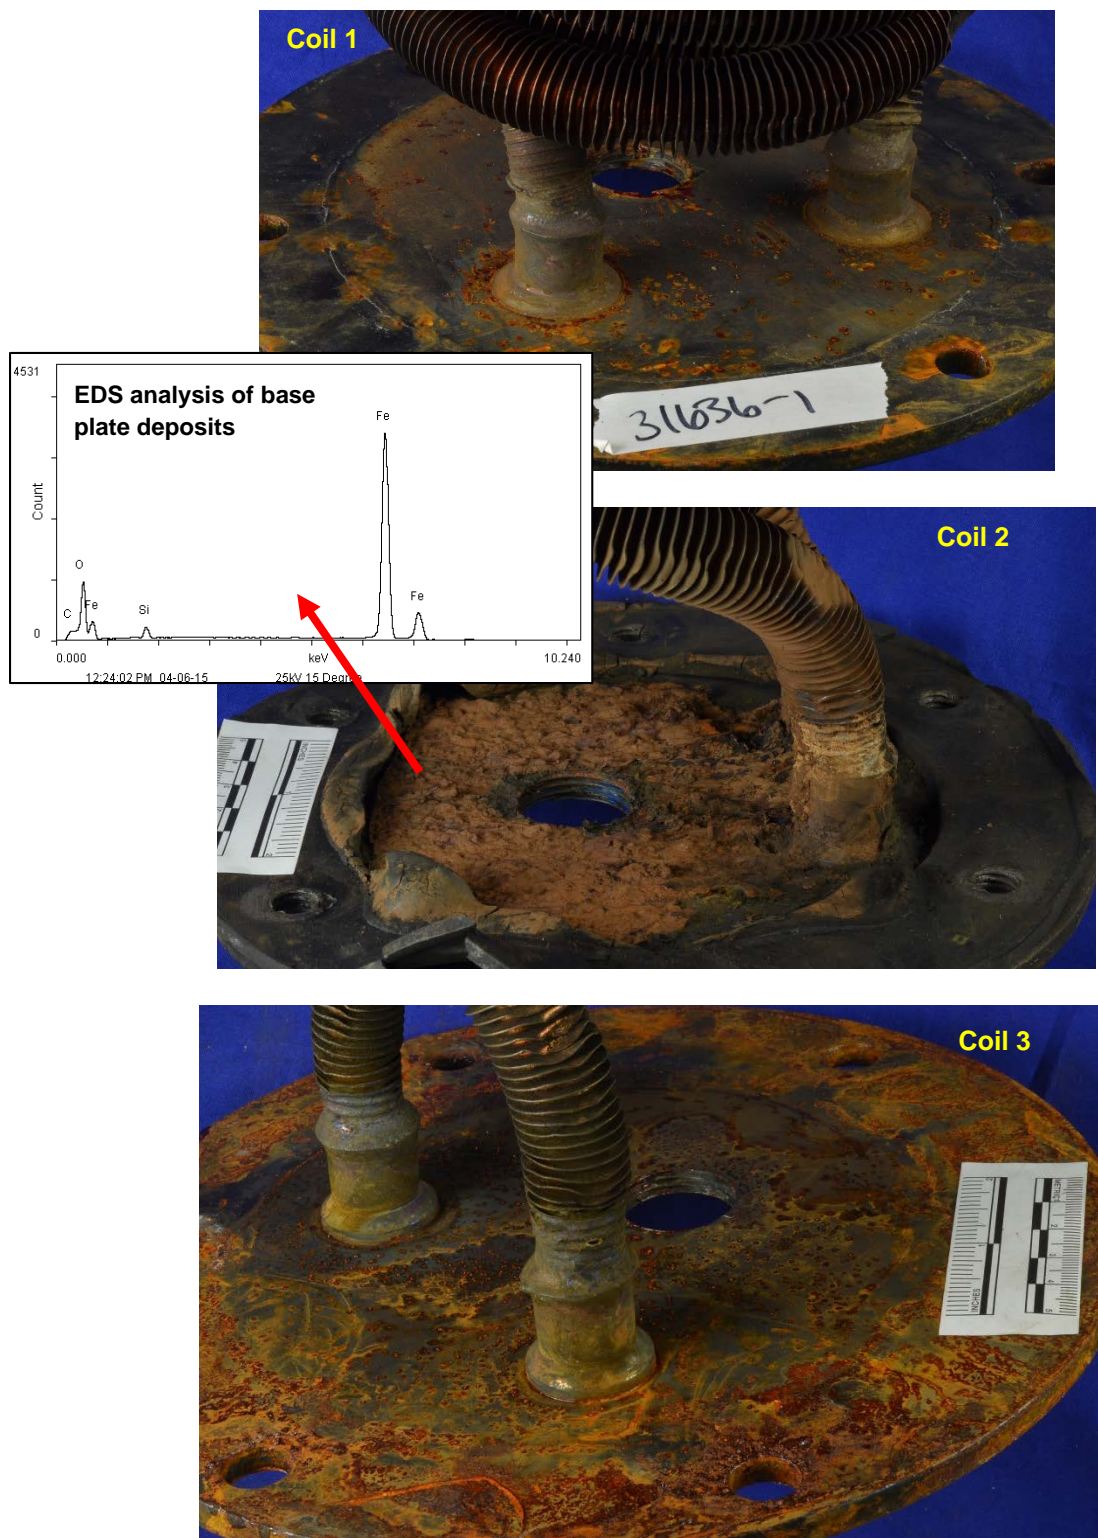
Each coil had two concentric layers of copper piping (an inner and an outer layer, see **Figure 2**) with external fins. The exposed surfaces of the coils were visually examined. The base plates that the copper coils were welded onto appeared corroded, most notably so on Coil 2, **Figure 3**. Deposits from the base plates of Coils 2 and 3 were analyzed for elemental composition by EDS<sup>2</sup>. They were composed primarily of iron and oxygen (i.e., “rust”), with low levels of silicon and, possibly, sulfur.

**Figure 3.** Corrosion on the base plates of the three coil samples. Deposits from Coils 2 and 3 were analyzed by EDS and were determined to be primarily iron and oxygen.

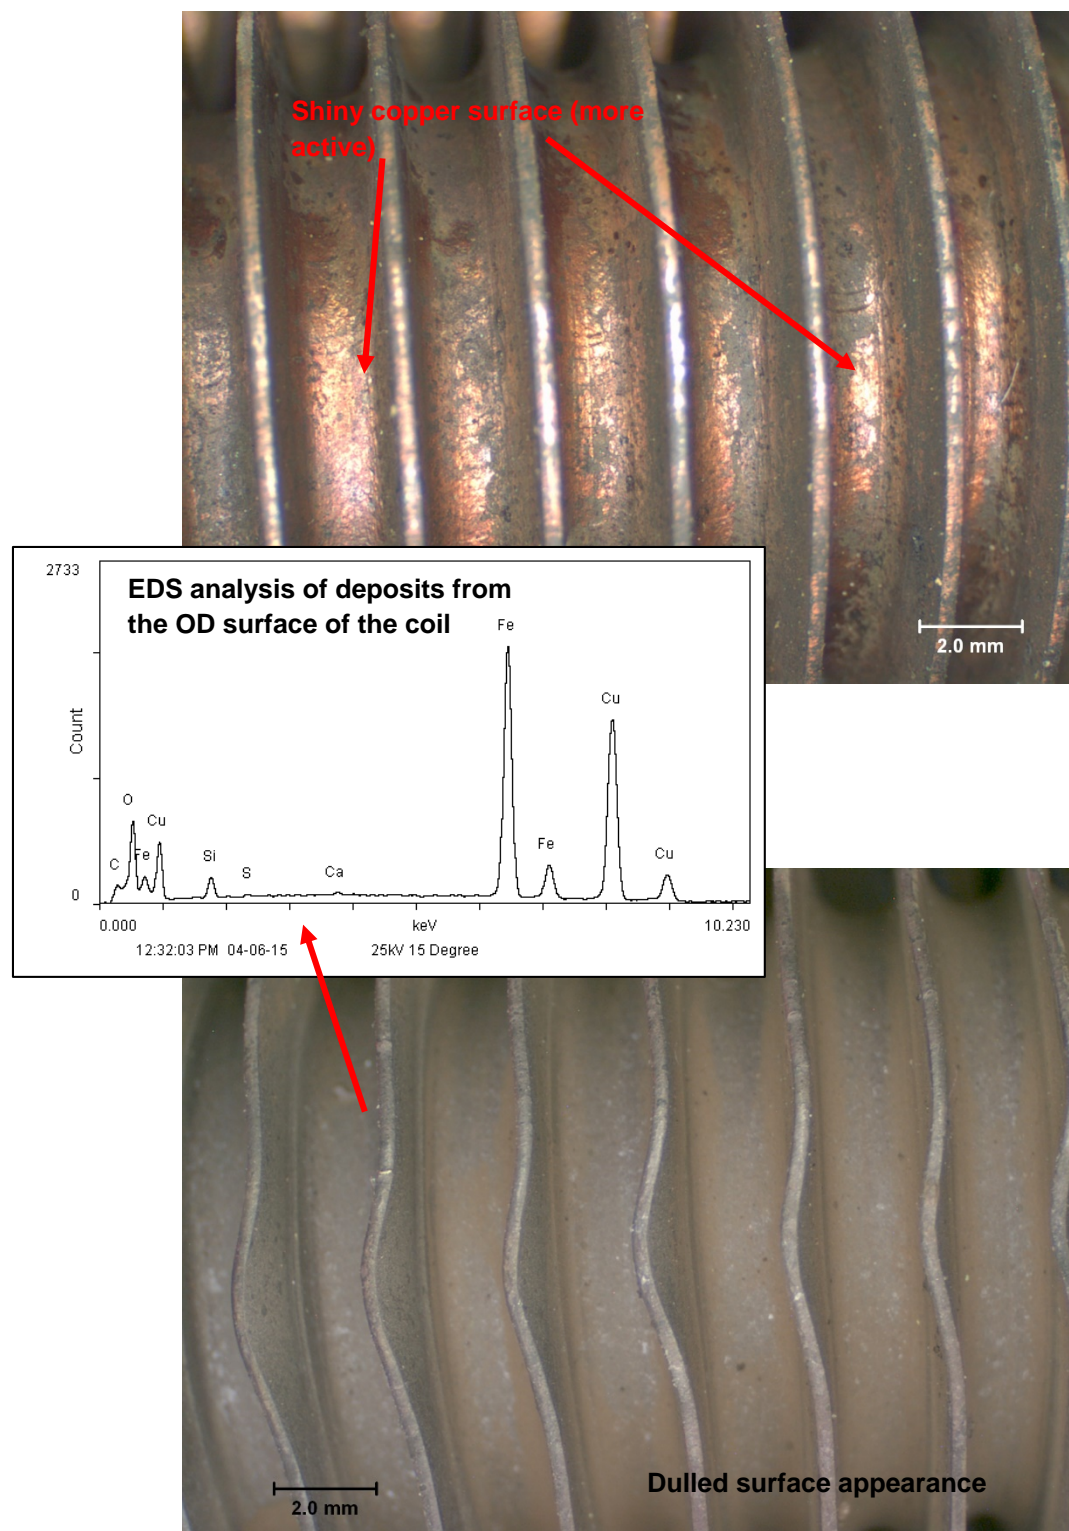
The outer surfaces of the coils were generally coated in a thin layer of dark colored deposits, **Figure 4**. These deposits were determined to be primarily iron, copper, and oxygen, with low levels of silicon, sulfur, and calcium detected. In some locations, the copper appeared shiny, which typically indicates a copper surface that does not have a passive layer. [Note: formation of this layer serves as copper’s inherent corrosion resistance mechanism, resulting in dull-looking material.]

**Figure 4.** Representative images of the exterior surface conditions of the copper coils. In many locations, the surface was dull and covered in deposits, which were analyzed by EDS to determine their elemental composition (bottom image). In some locations, the copper surface was shiny.

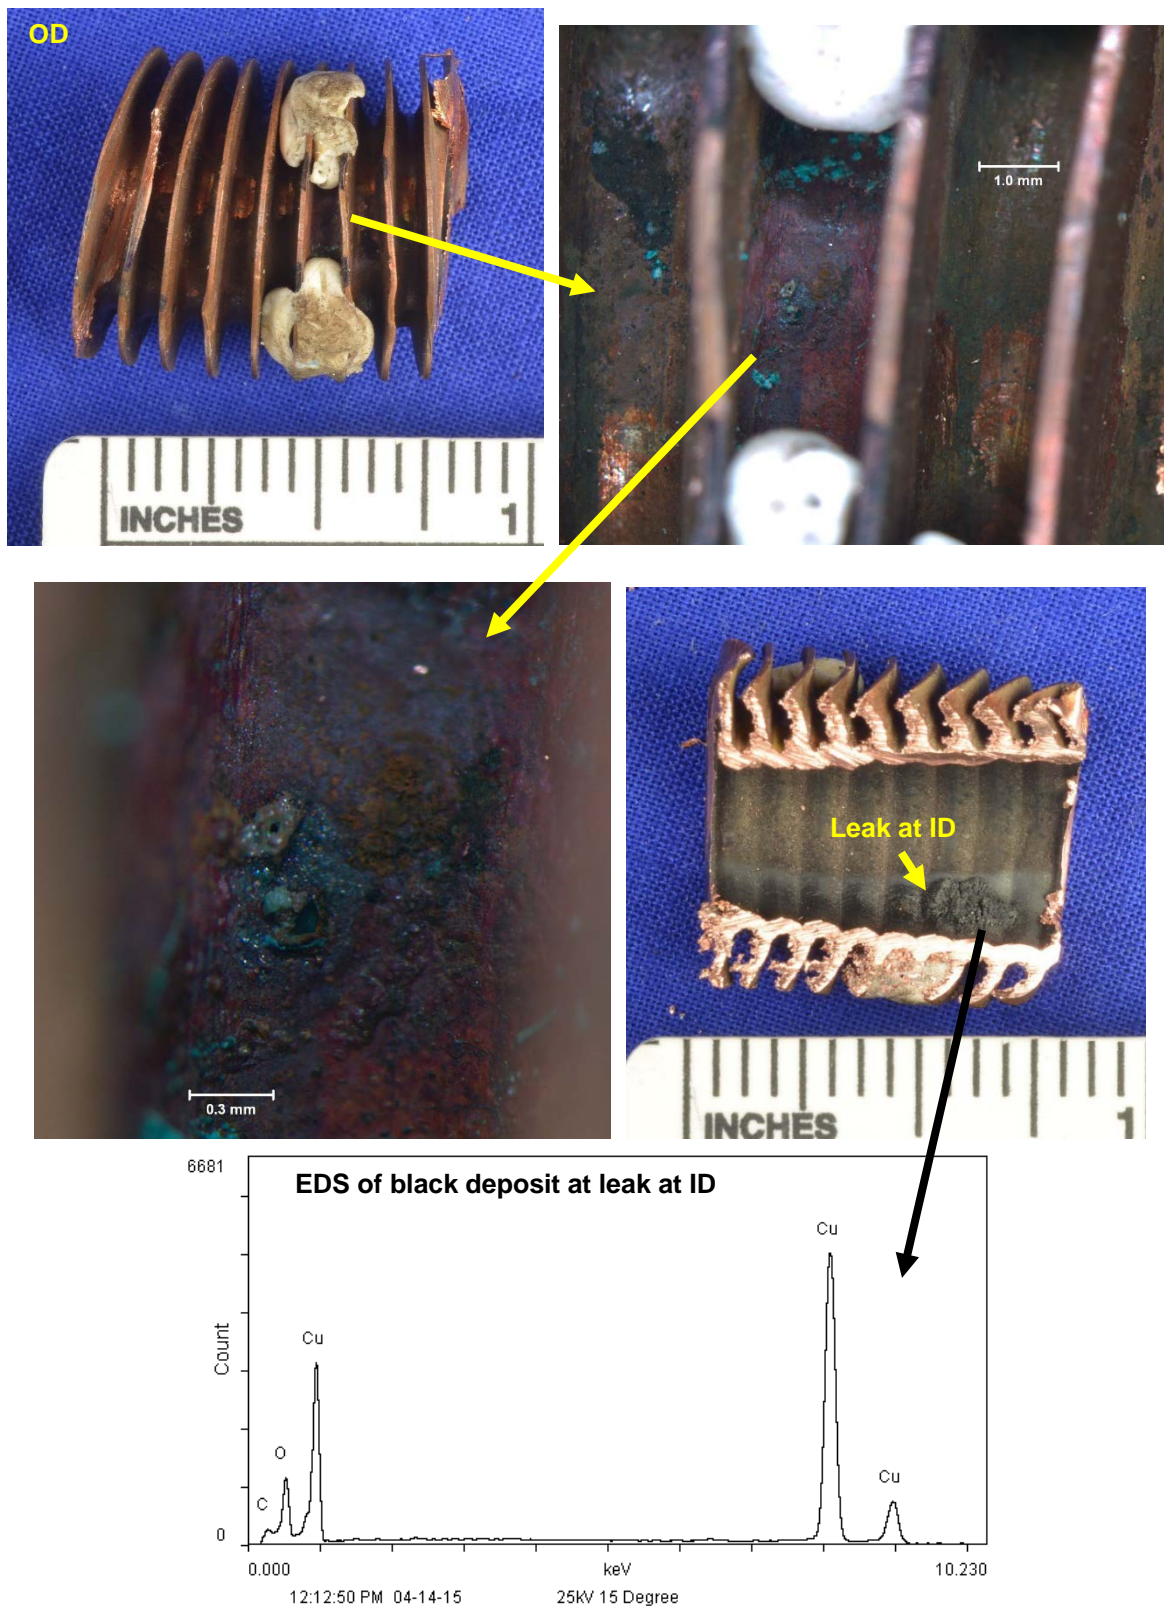
Inside the coils, there were mounds of black deposits at the leaks. The remainder of the inside surfaces were coated in a uniform layer of black deposit. A sample of a black deposit mound from Coil 1 was analyzed by EDS and determined to be primarily copper and oxygen (i.e., copper oxide) with no other detectable contaminants (refer to **Figure 5**).

**Figure 5.** Leak A on Coil 1 identified by pressure testing. At the outside surface, the material at the leak was red in color and there were green-blue deposits. At the inside surface, the leak was covered by a mound of black deposits, which were analyzed by EDS.

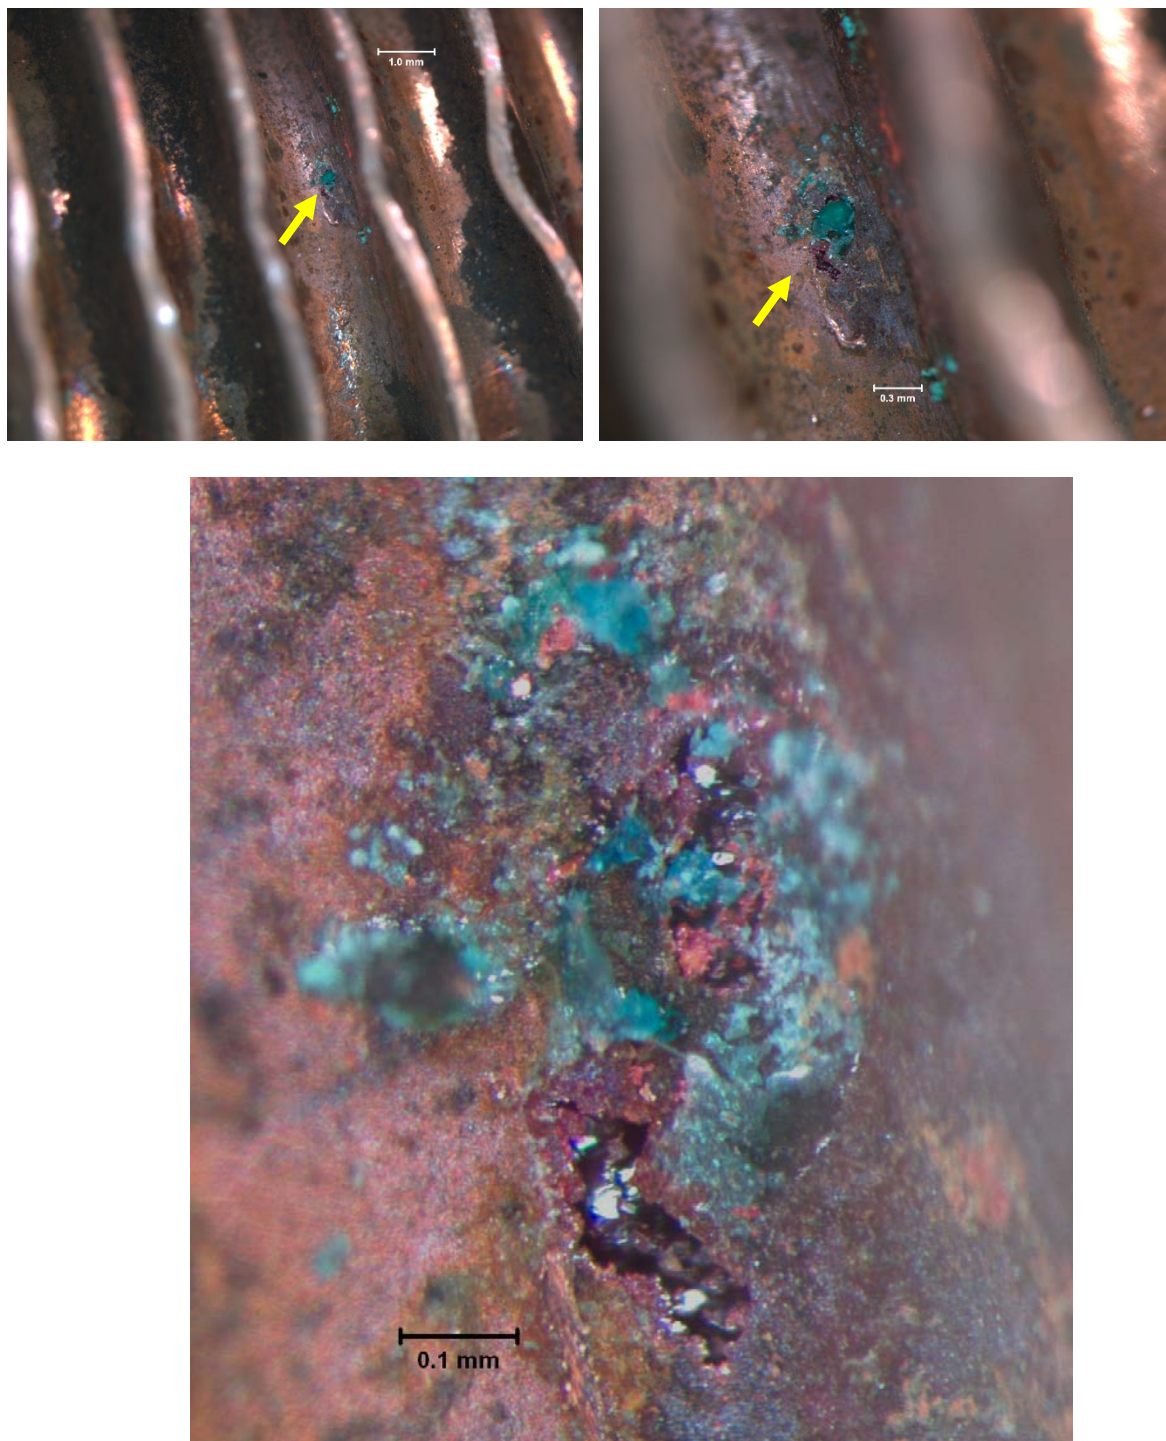
**Figure 6.** Leak B (yellow arrow) on Coil 1 identified by pressure testing. There was a visible hole at the outside surface, inside which there were reddish, crystalline deposits. There was green-blue colored deposits surrounding the attack.

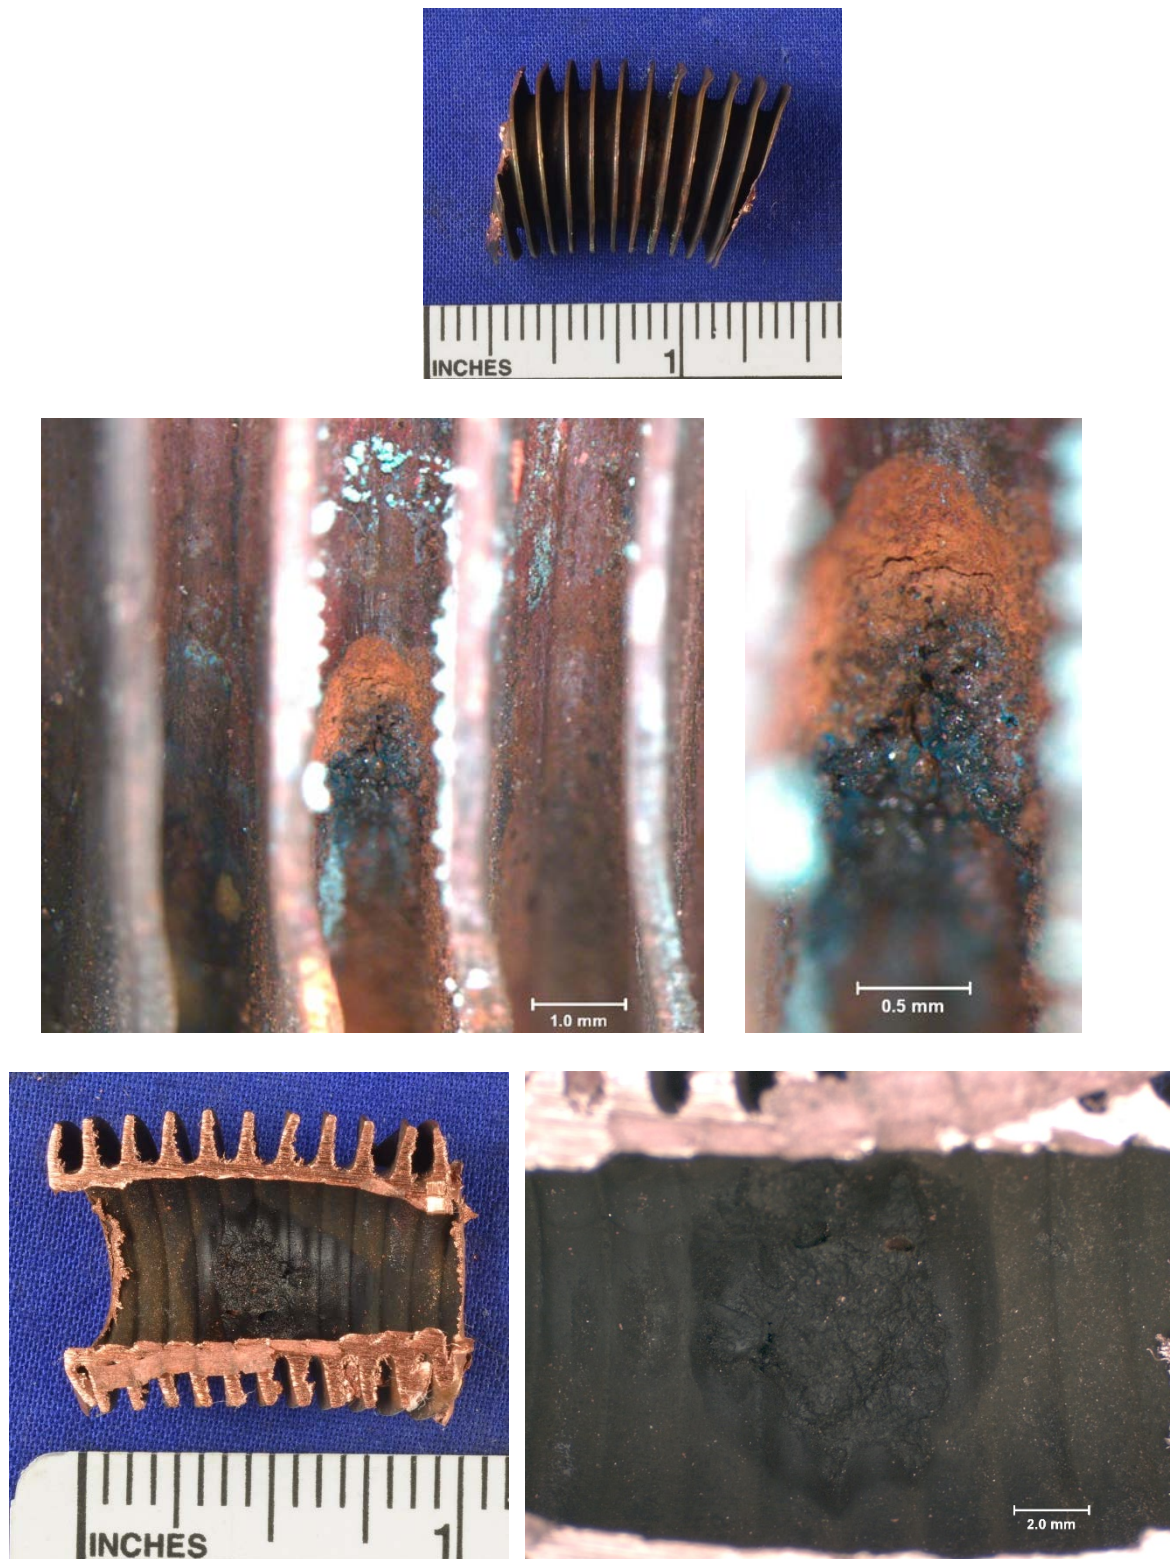
the two leaks in Coil 1 did not have a visible hole. The leak in Coil 3 was covered in orange/brown-colored deposits at the outside and no hole was visible. Some green-blue deposits were also present on the outside surface at the leak.

**Figure 7.** Leak on Coil 3 identified by pressure testing. The leak at the outside surface was covered by orange/brown deposits. There were also green-blue deposits present. At the inside surface, there was a mound of black deposits covering the leak.

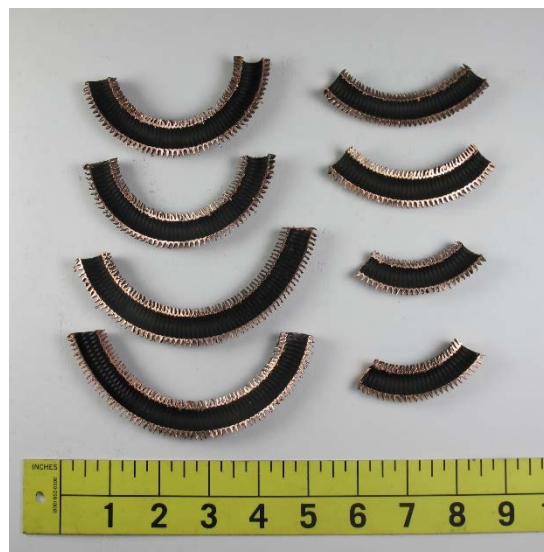
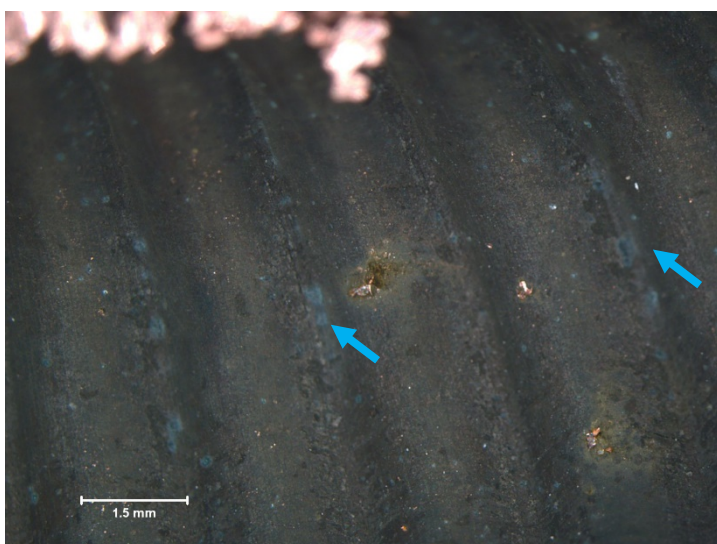
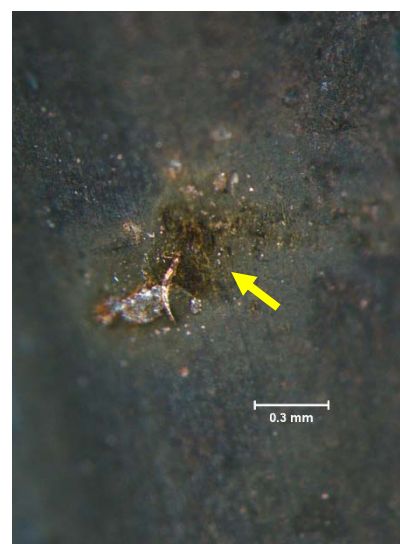
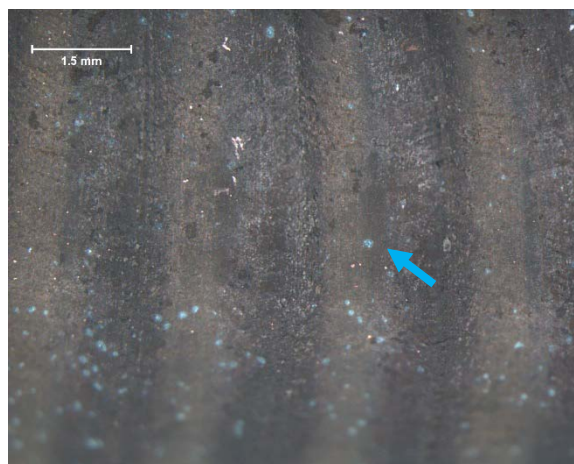
Additional sections from Coil 1 that did not include known leaks (from pressure testing) were split for examination, **Figure 8**. The inside surfaces were covered in a uniform layer of black deposit, similar to the sections that contained the leaks. There were some spots of blue and yellow colored deposits scattered within the black deposit. No pits were identified in these sections, even after scrubbing the inside surface with a soft nylon brush.

**Figure 8.** Sections of coil that were split and inspected that had no known leaks. The surfaces were covered primarily in black deposits, with some blue and yellow colored deposits scattered throughout (see arrows). No pits were identified in any of these sections.

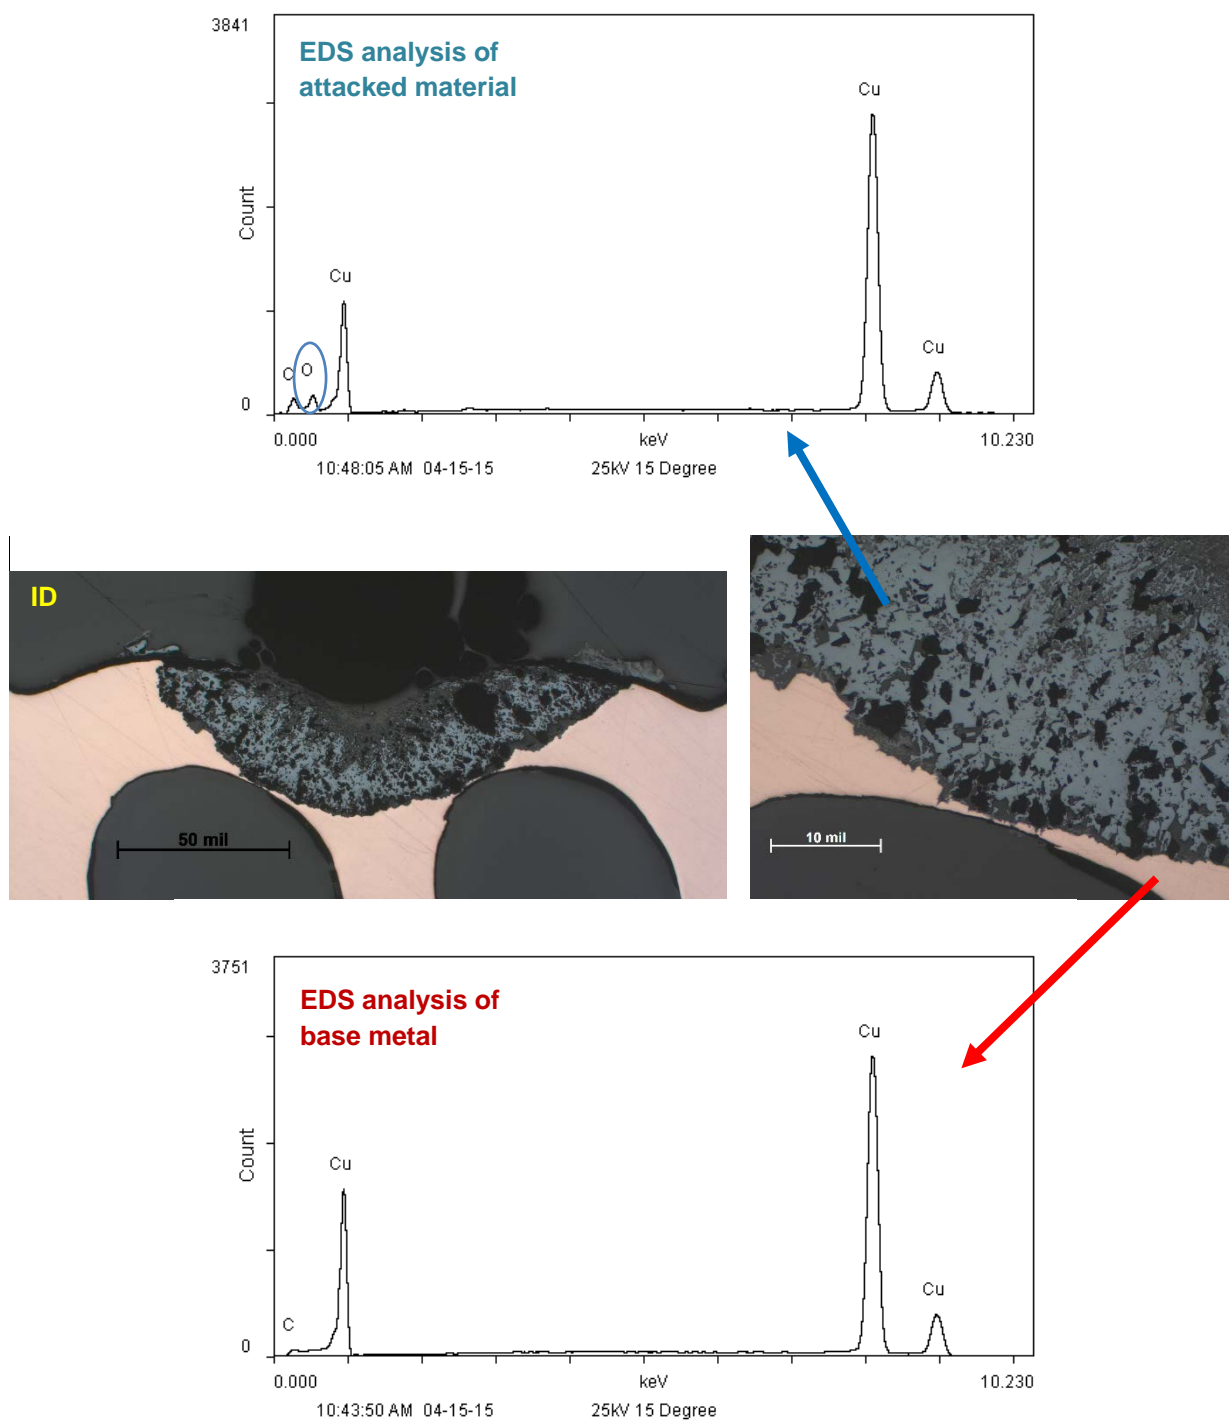
Cross-sections were prepared through two leaks in Coil 1 (10 months to failure) and one leak in Coil 3 (36 months to failure), **Figures 9 through 13**. The attack at the leaks was similar in appearance in all three cross-sections in that it was in the form of a wide pit filled with oxide that originated at the inside surface. The copper in these pits had been converted into cuprous oxide ( $\text{Cu}_2\text{O}$ ), as was indicated by its characteristic red coloration (seen macroscopically at the failure and microscopically when the oxide was viewed using polarized light on the cross-sections). The composition of the oxide was also confirmed through analysis by EDS. There were no other contaminants detected by EDS in the corrosion product at the failure. Away from the leaks shallow, incipient attack at the inside surface was identified, **Figure 11**.

**Figure 9.** Cross-section prepared through Leak A in Coil 1. EDS analysis of the base metal and attacked material inside the pit are shown. 25X and 100X original magnifications. No metallurgical etchant used.

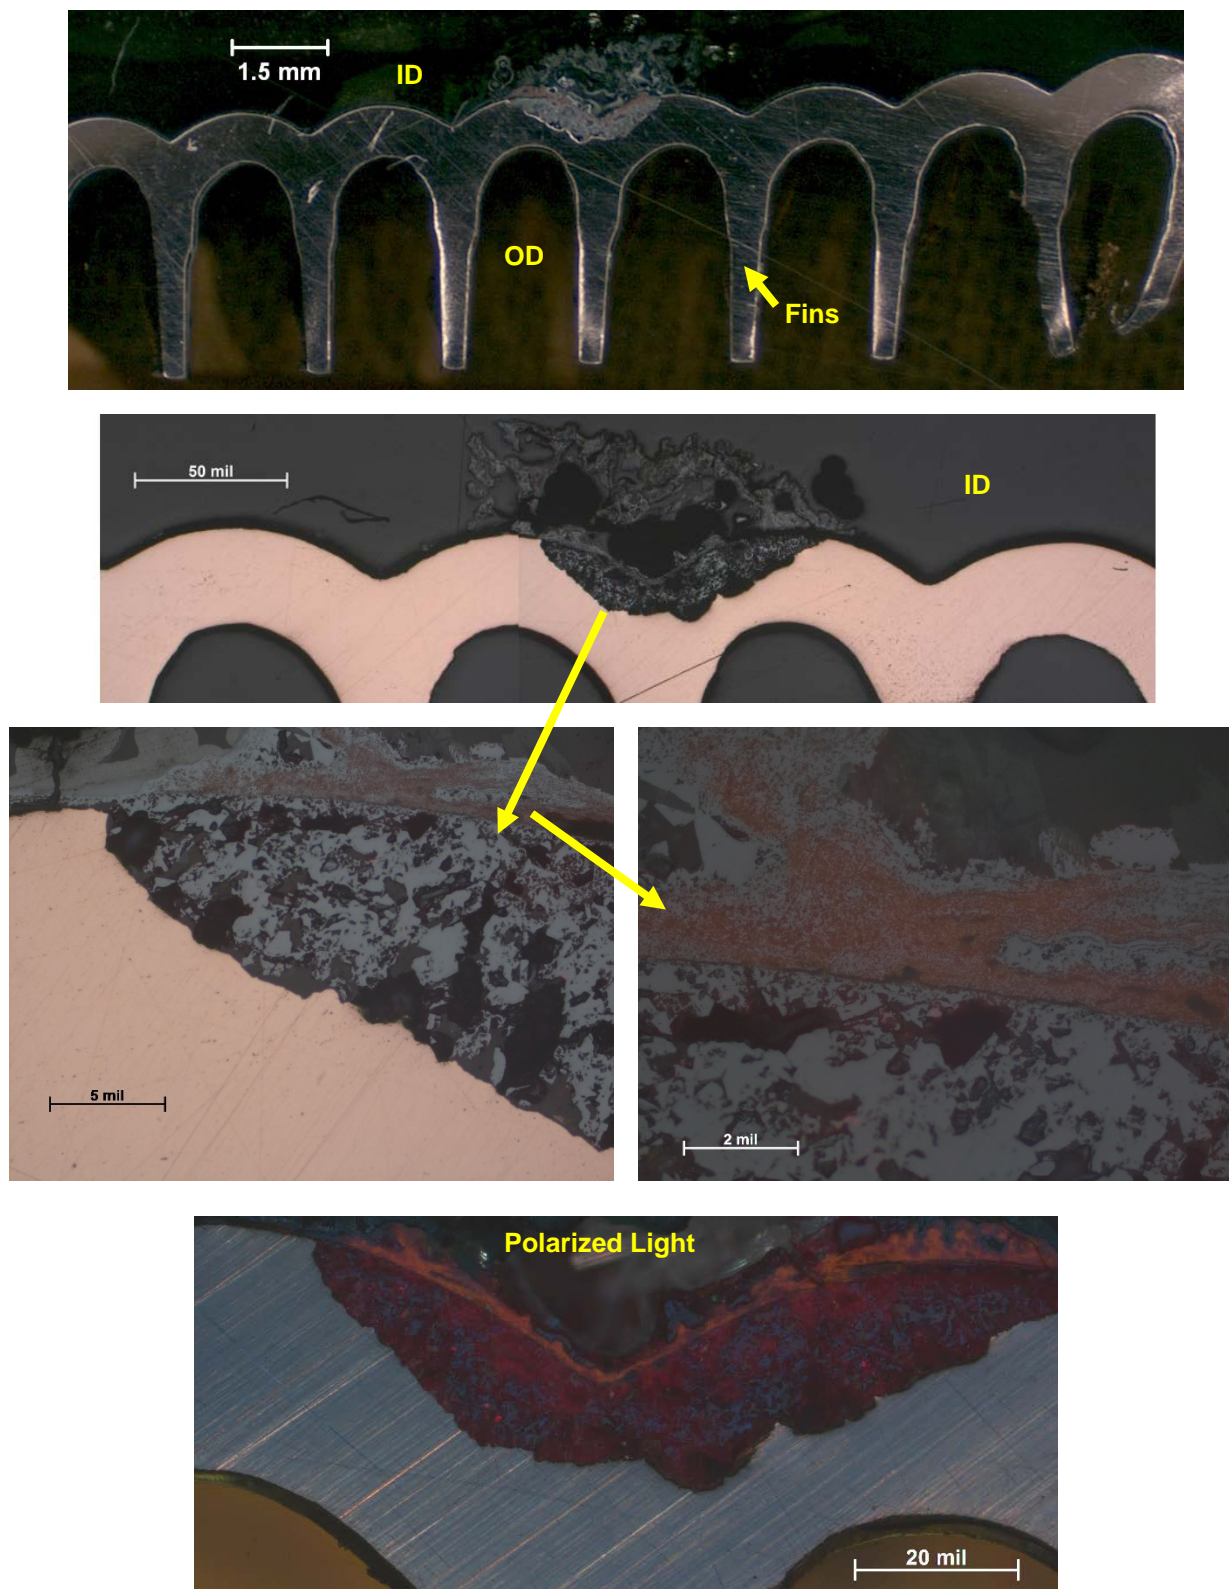
**Figure 10.** Cross-section through Leak B on Coil 1. Bottom image shows attacked area using polarized light. The deposits at the attack appeared red, as is typical of cuprous oxide ( $\text{Cu}_2\text{O}$ ). 25X, 50X, 100X, and 200X original magnifications. No metallurgical etchant used.

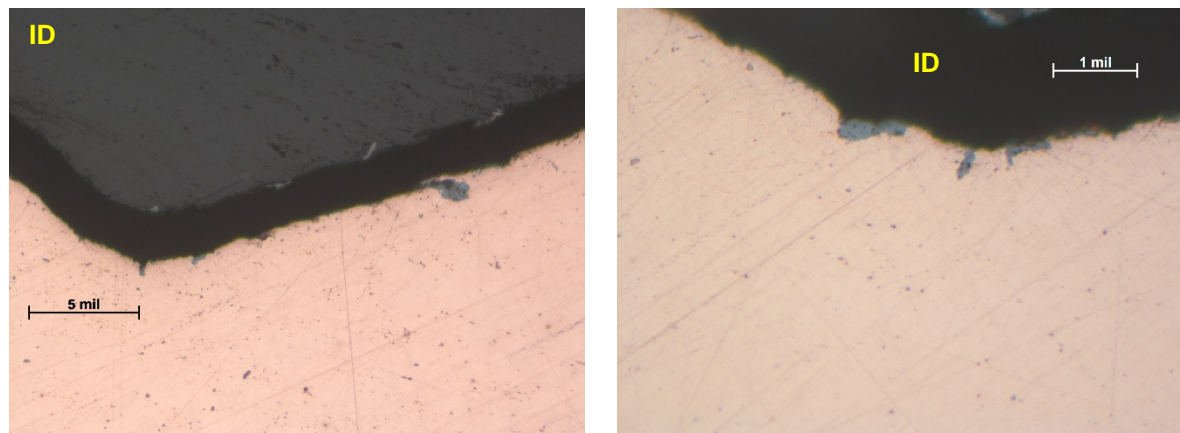
**Figure 11.** Shallow incipient attack at the ID away from the leak in the cross-section prepared at Leak B from Coil 1. 100X and 500X original magnification. No metallurgical etchant used.

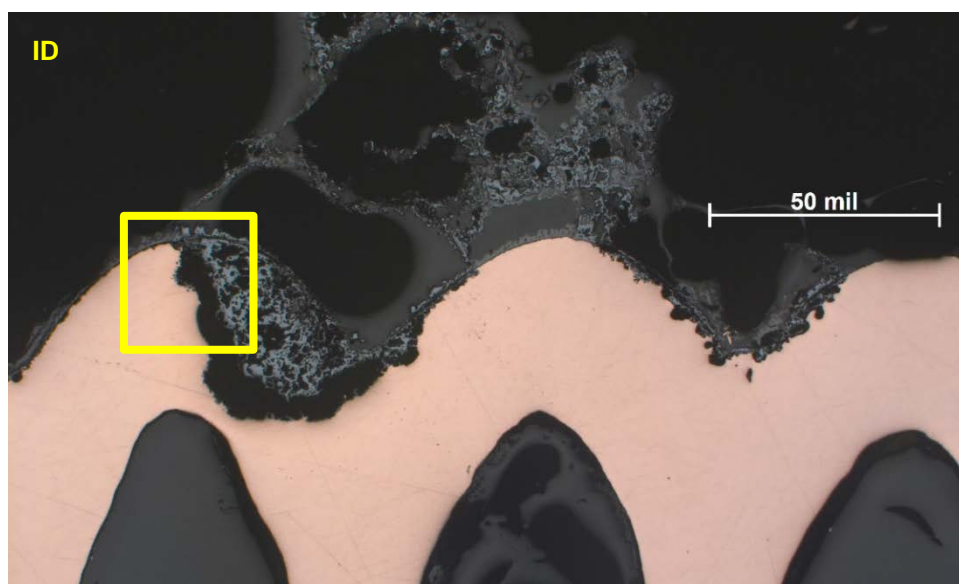
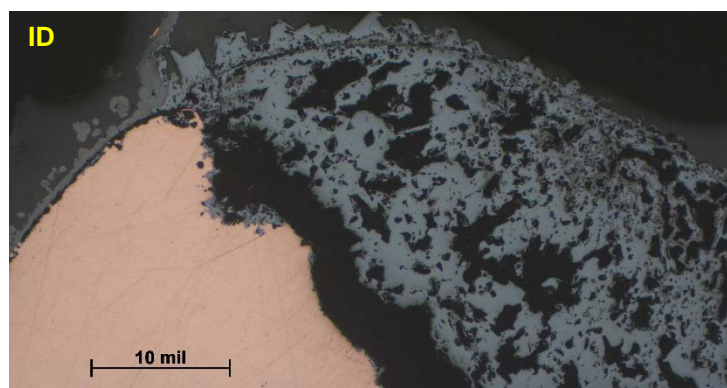
**Figure 12.** Attack on cross-section through Coil 3 leak, which was very similar in appearance to the attack in Coil 1. 25X and 100X original magnifications. No metallurgical etchant used.

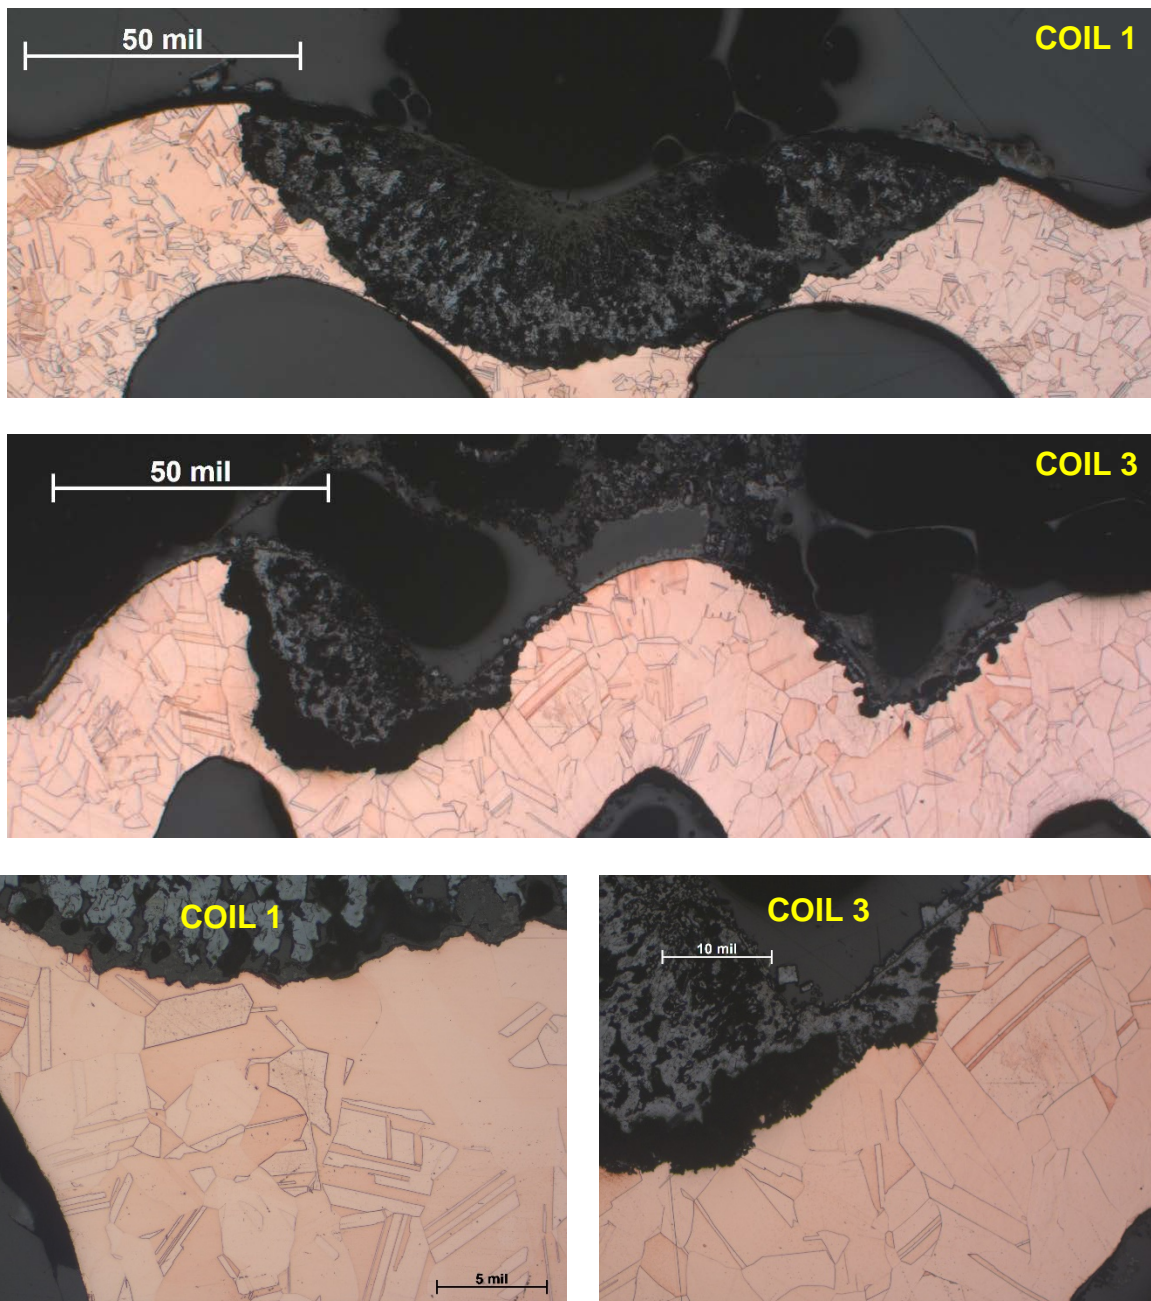
Metallurgical examination of the material revealed no evident differences between the two coils, **Figure 13**. The microstructures of the coils were similar between samples and overall typical of copper, with no obvious inconsistencies or defects.

**Figure 13.** Etched cross-sections showing that the microstructure of the material from Coils 1 and 3 were similar and typical of copper. 25X, 100X, and 200X original magnifications. Potassium dichromate etchant used to reveal microstructure.
