Wabasha Street Rock Slide

Slides prepared by Itasca Consulting Group May 30, 2018

Summarized for presentation by City of Saint Paul Public Works June 1, 2018

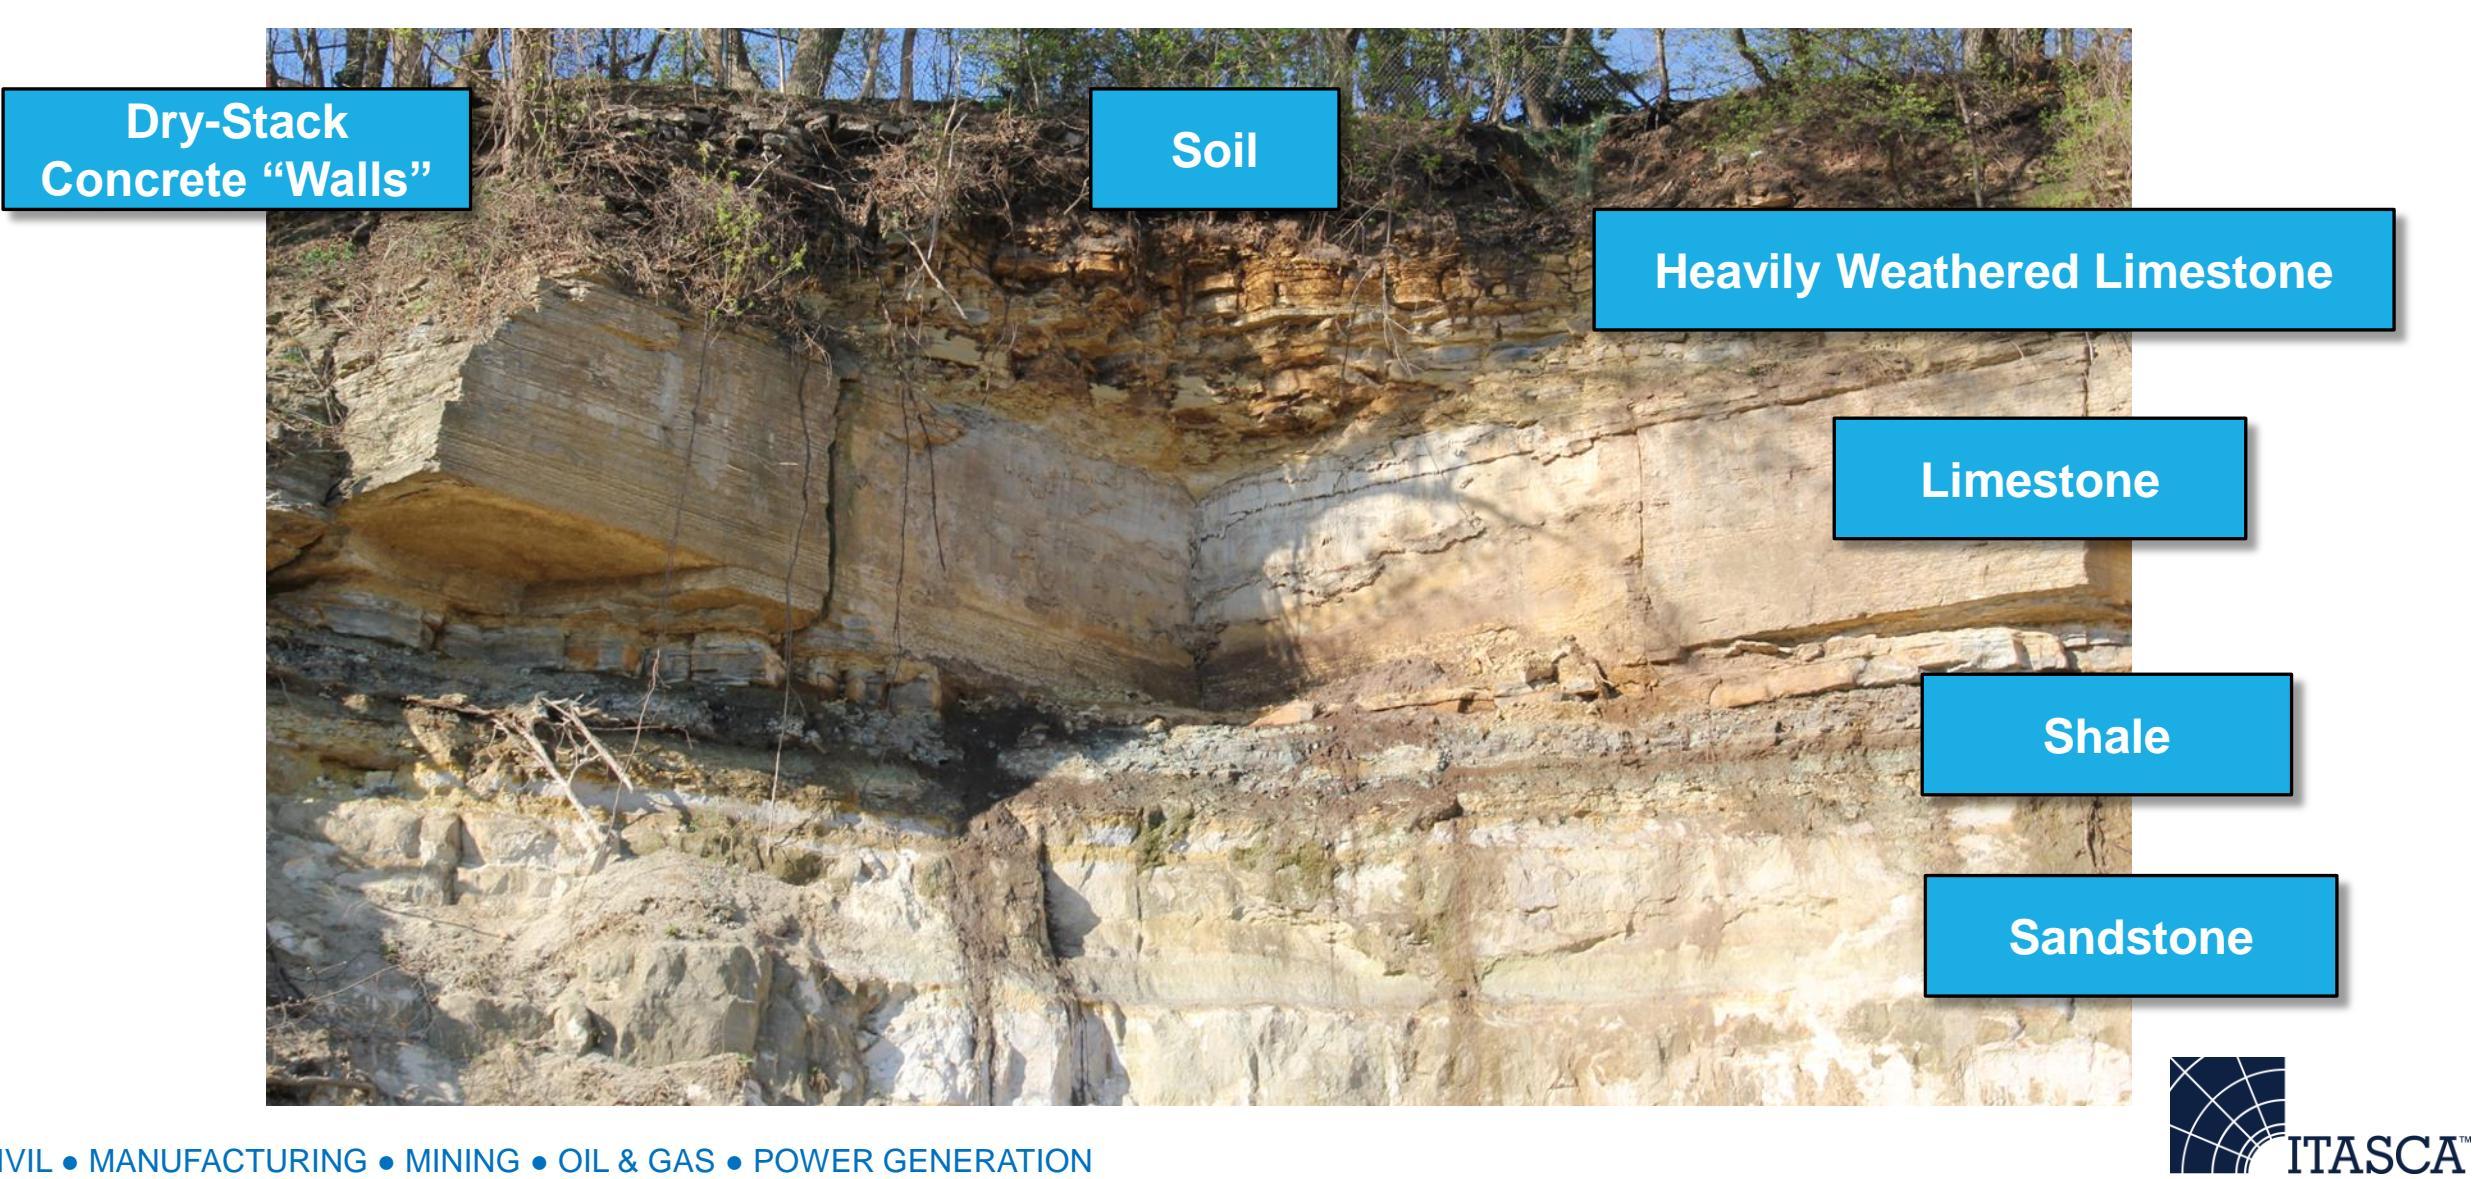
Site Geology

Sandstone and

shale raveling

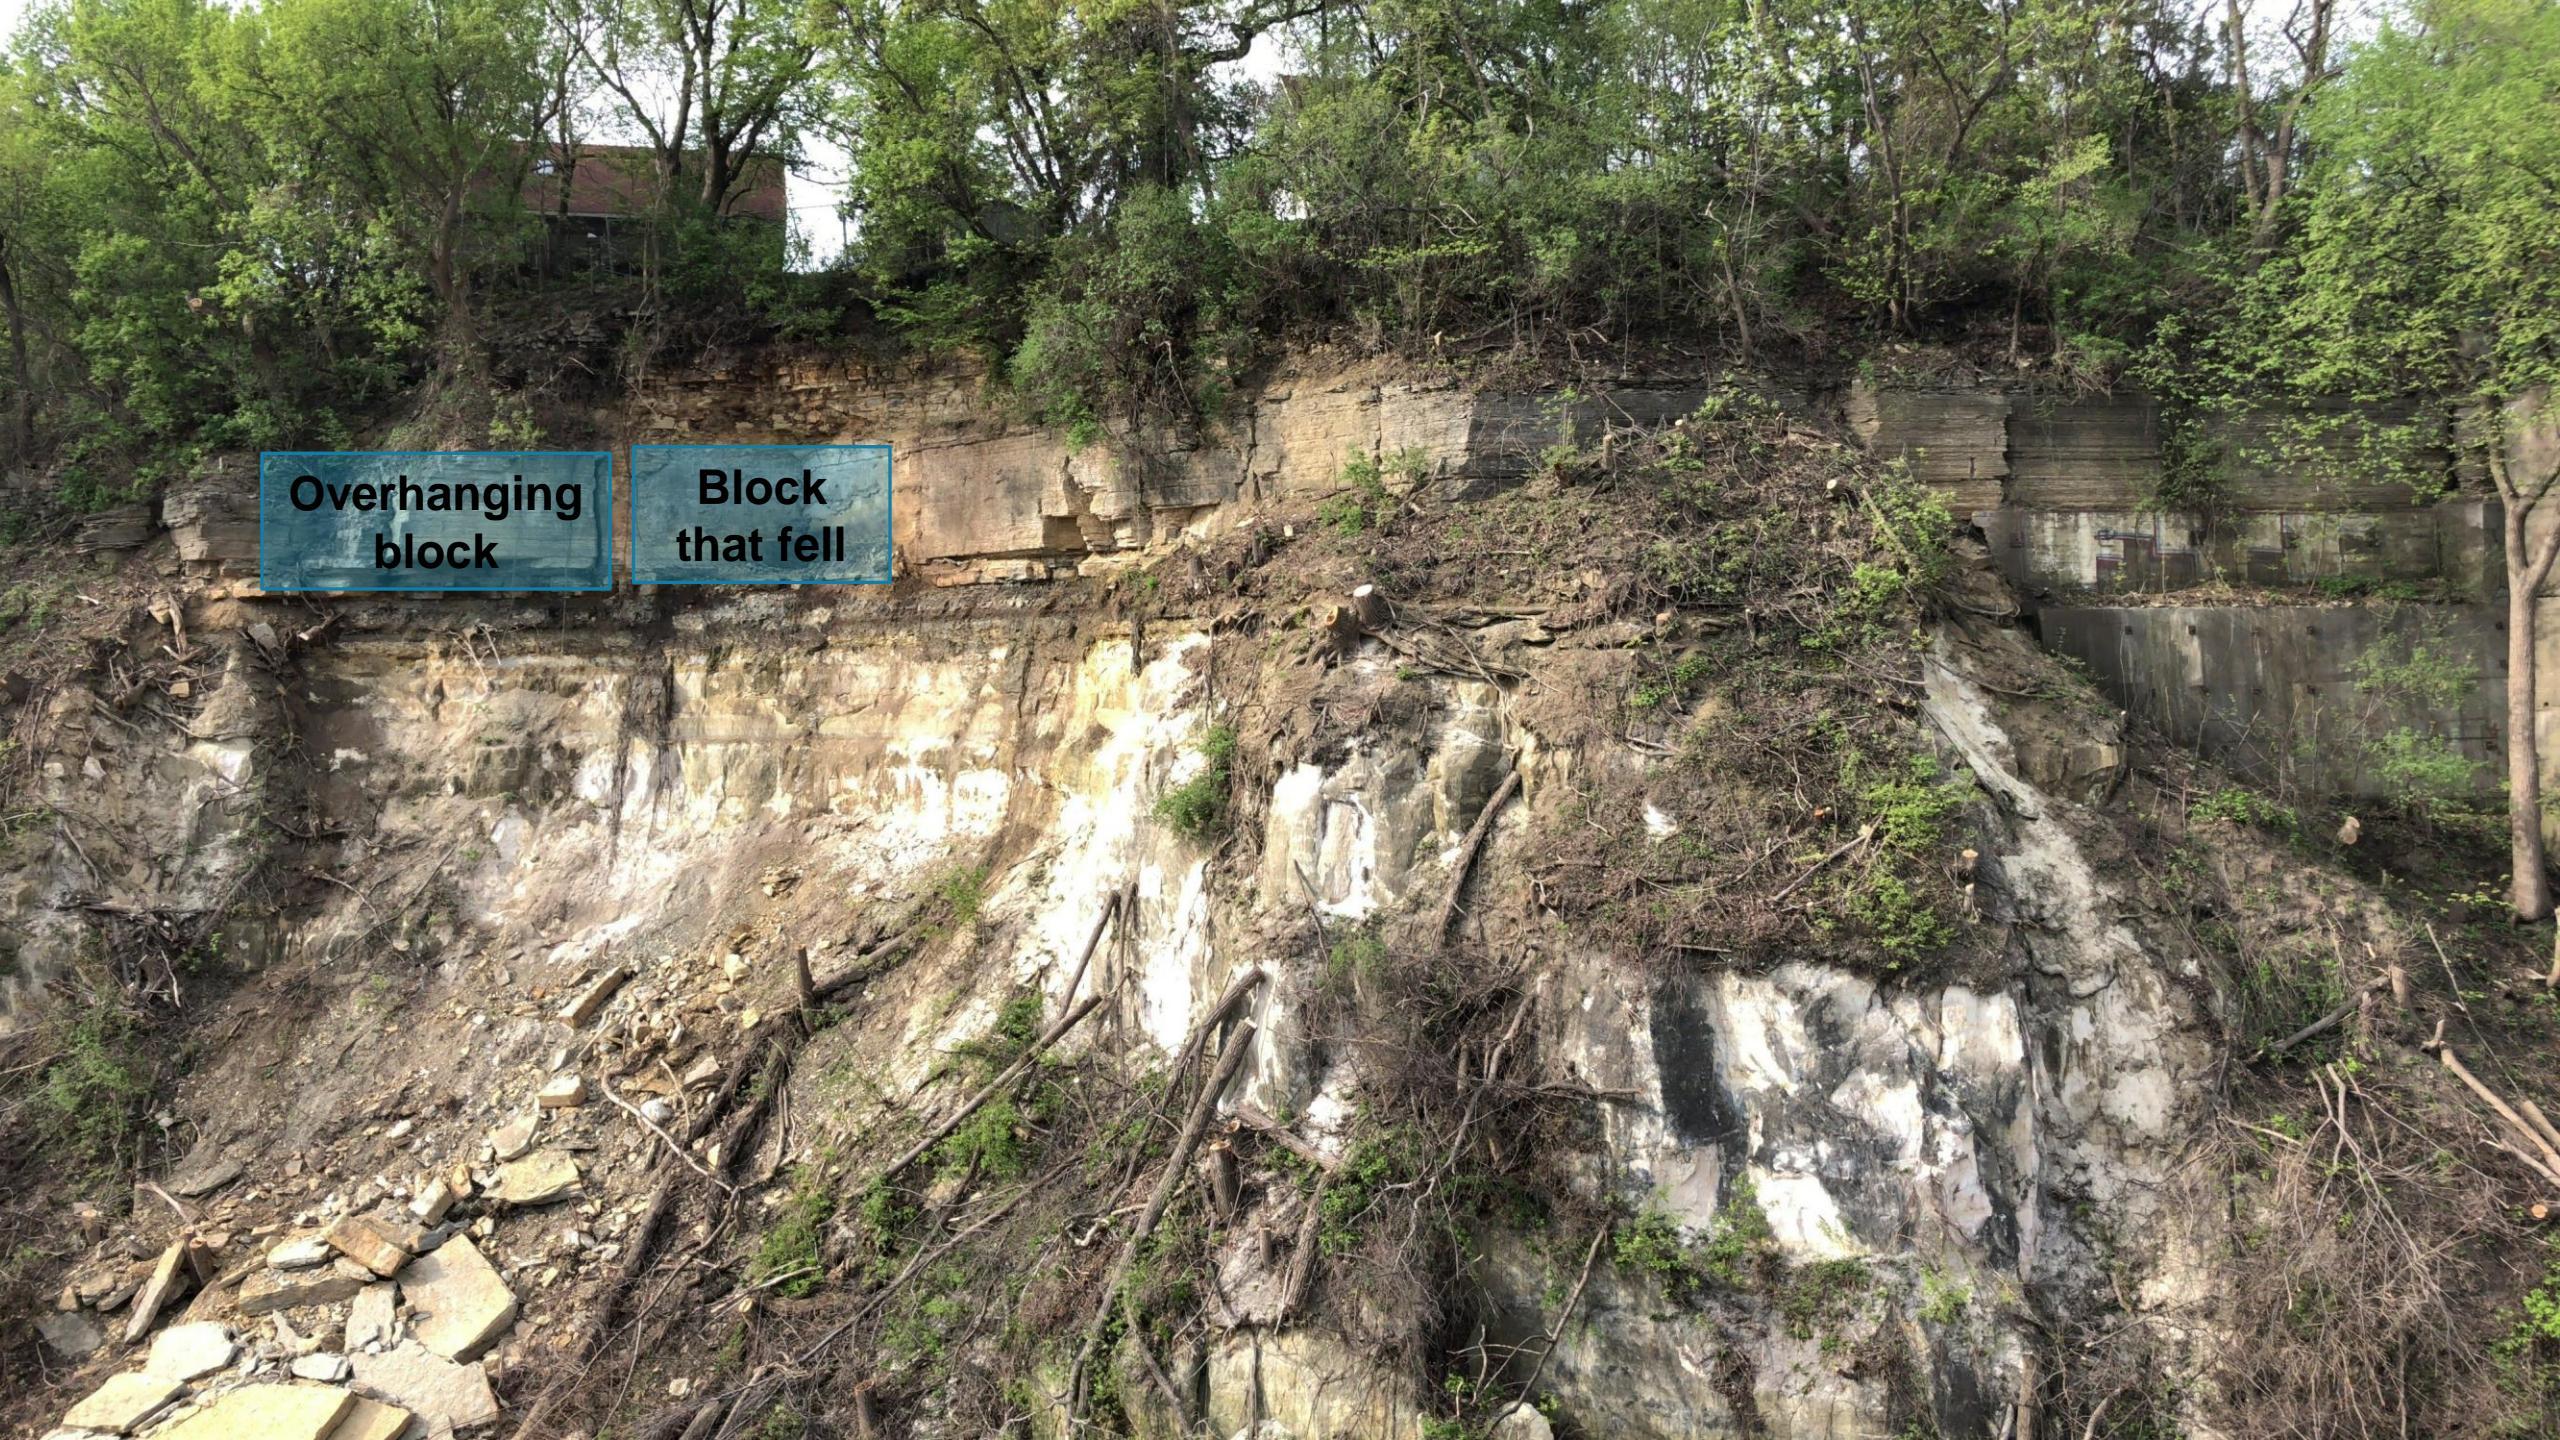
Slide 7

Vertical joints form limestone blocks

Limestone blocks are undercut & topple off

Surface &

groundwater,

freeze-thaw

About 2' limestone has fallen off Shale ITASCA

• Sandstone/shale raveling

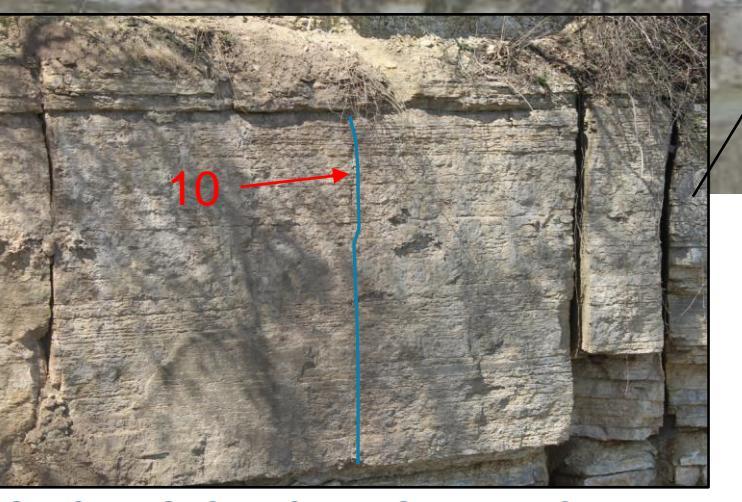
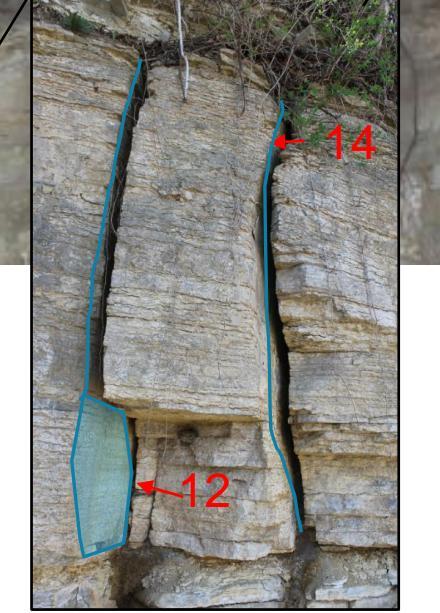
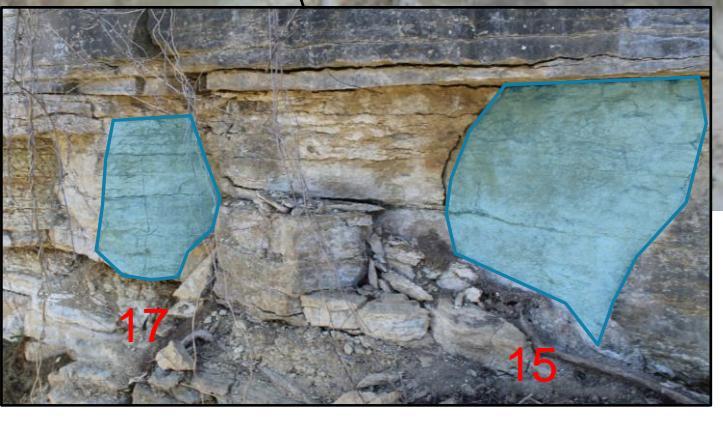
Limestone joints numbered

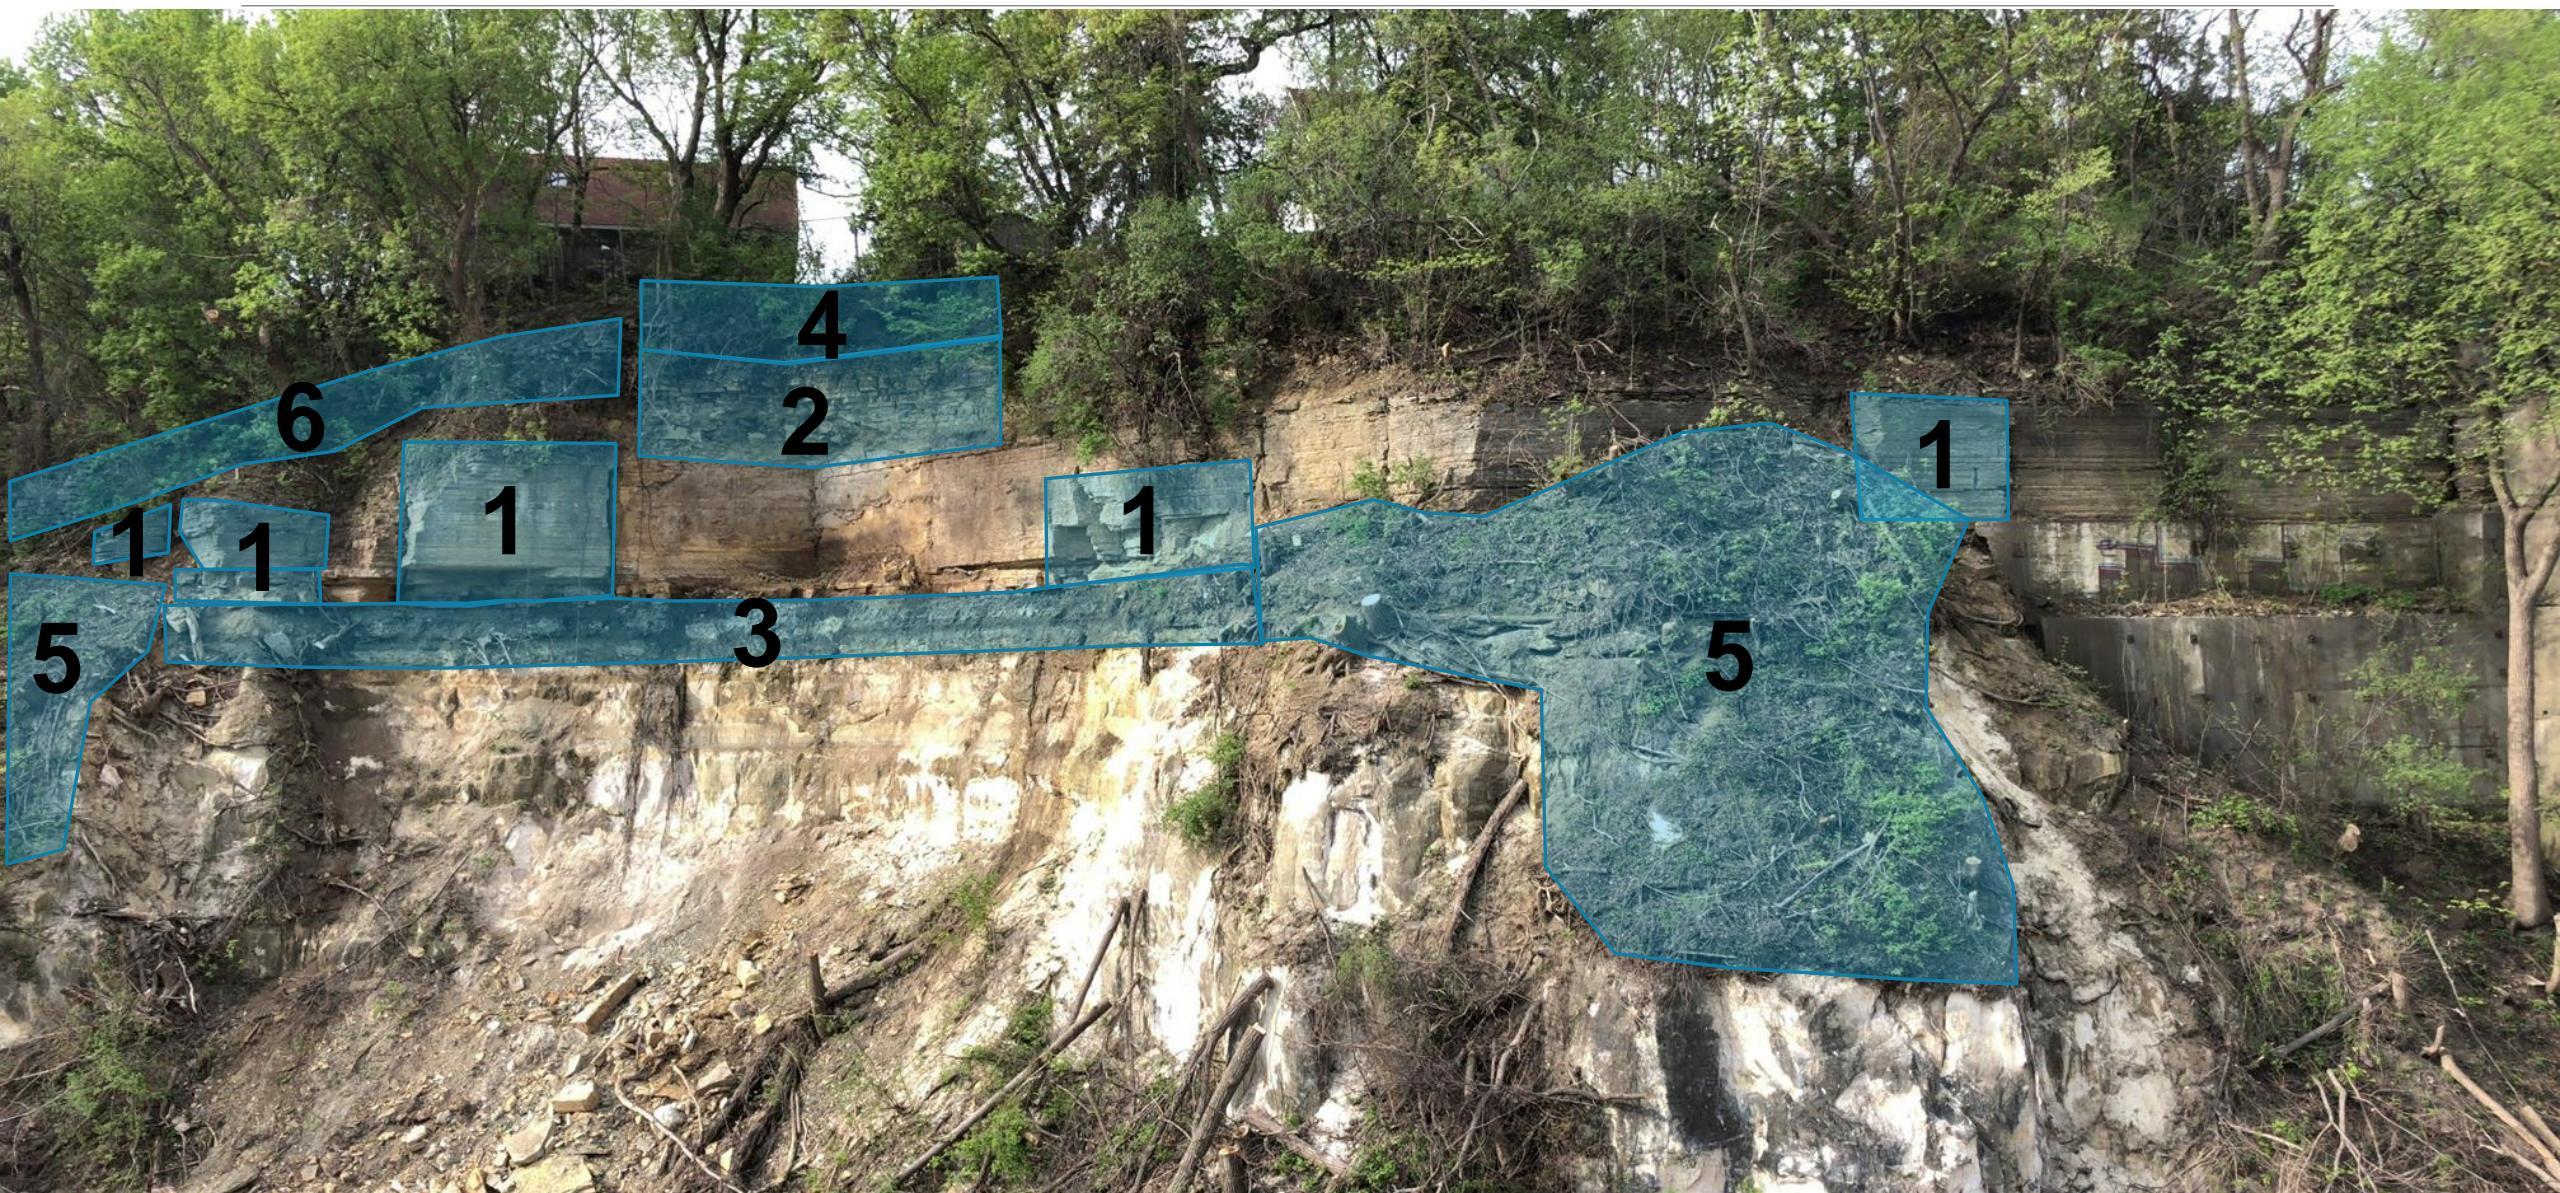
Specific Site Features

- 1. Limestone blocks
- 2. Upper (weathered) limestone
- 3. Limestone-shale-sandstone interface
- 4. Upper Soil
- 5. Lower Soil
- 6. Prior slope stabilization

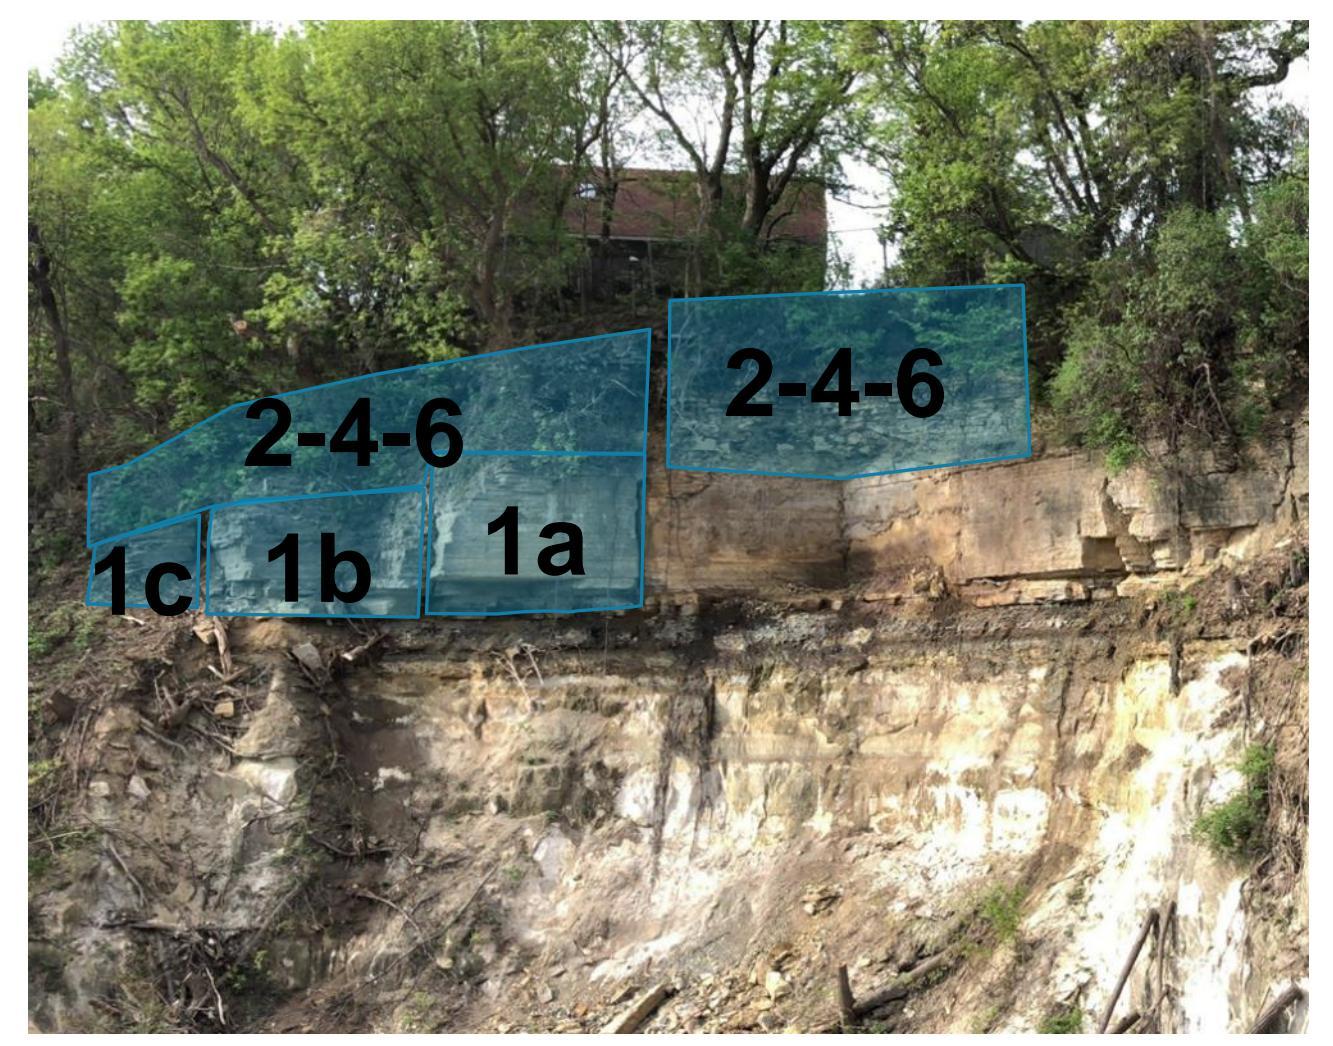
Slide 14

Immediate At-Risk Features (immediate threat)

- Overhanging weathered limestone, dry stack & soil above recent block fall
- Overhanging limestone blocks
 - ✤ 1a—Must be removed
 - 1b, 1c—Likely to be removed (due to removal of 1a or because of instability)
 - Overlying weathered limestone, soil, dry stack, etc. also removed
