Preliminary ADA Assessment at New York Central Park

Gary Talbot

12-14-2013

Major ADA Violations Found at Every Location Assessed

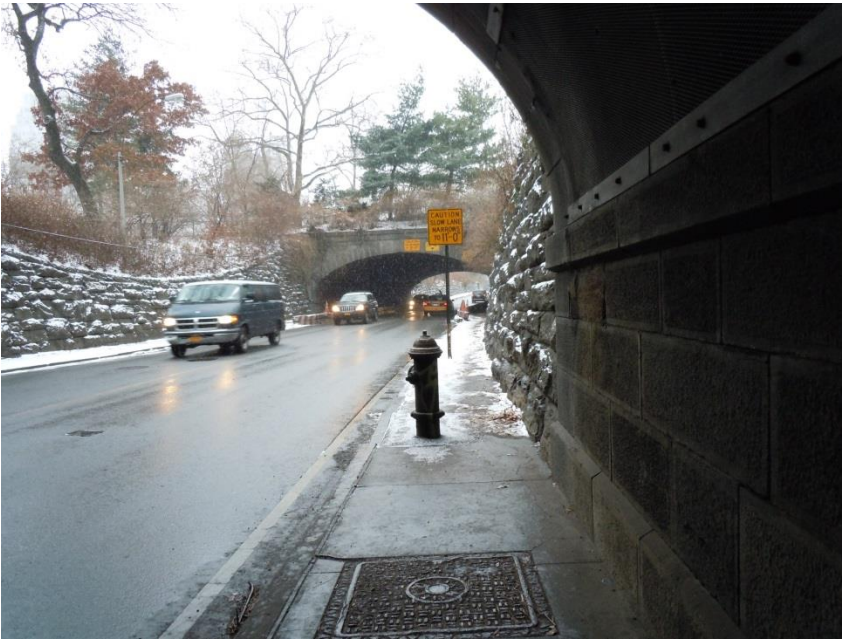
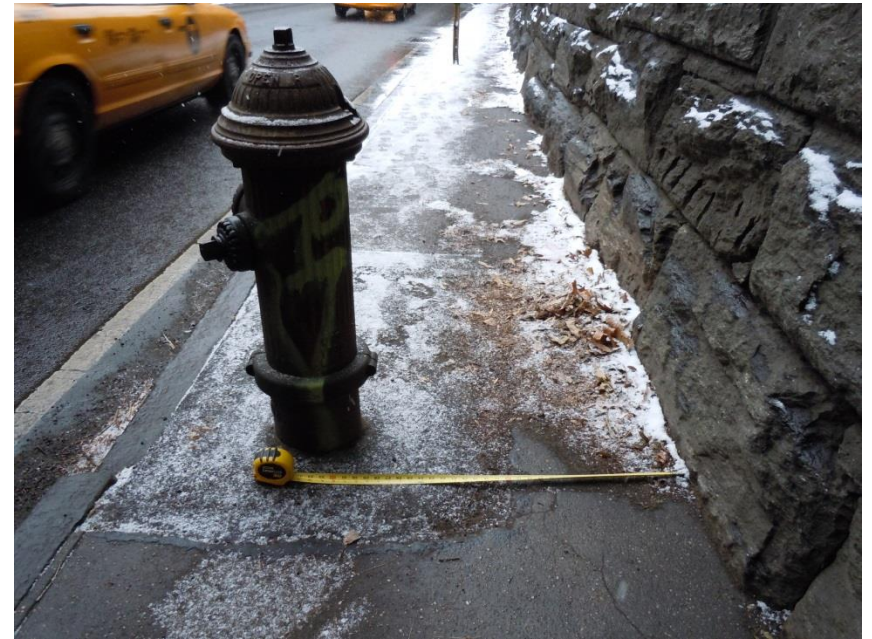
Attempting to gain access to Central Park using the Transverse

- Walkway used frequently by walkers, runners and people with disabilities but when you get to the bottom of the hill the pathway is so narrow and non-compliant, the pathway is impassible for many due to the narrow distance to the retaining wall
- The pathway narrows to 29 inches wide at the fire hydrant
- Room is available on the retaining wall to make the pathway wider and compliant to the ADA, the ADA requires 32 inches wide (minimum)

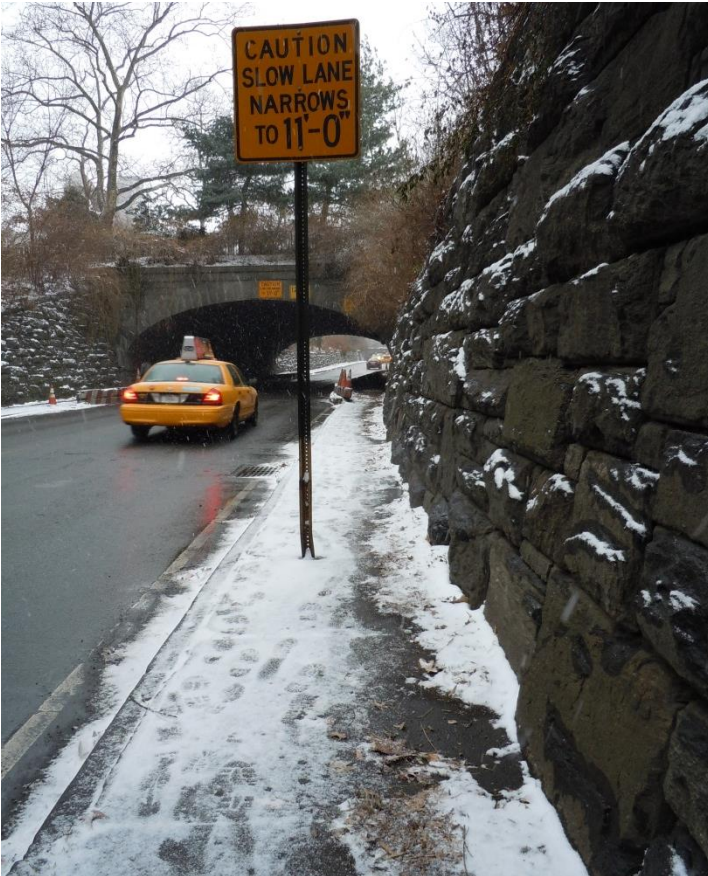
Attempting to gain access to Central Park using the Transverse

Next barrier encountered reduced the width of the path of travel to 28 ½ inches wide at the sign post

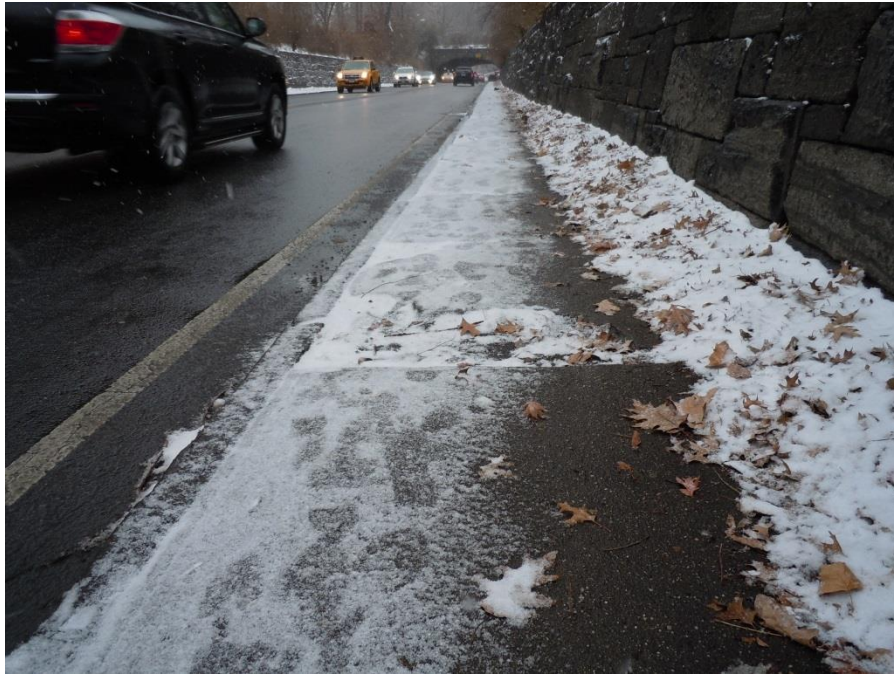
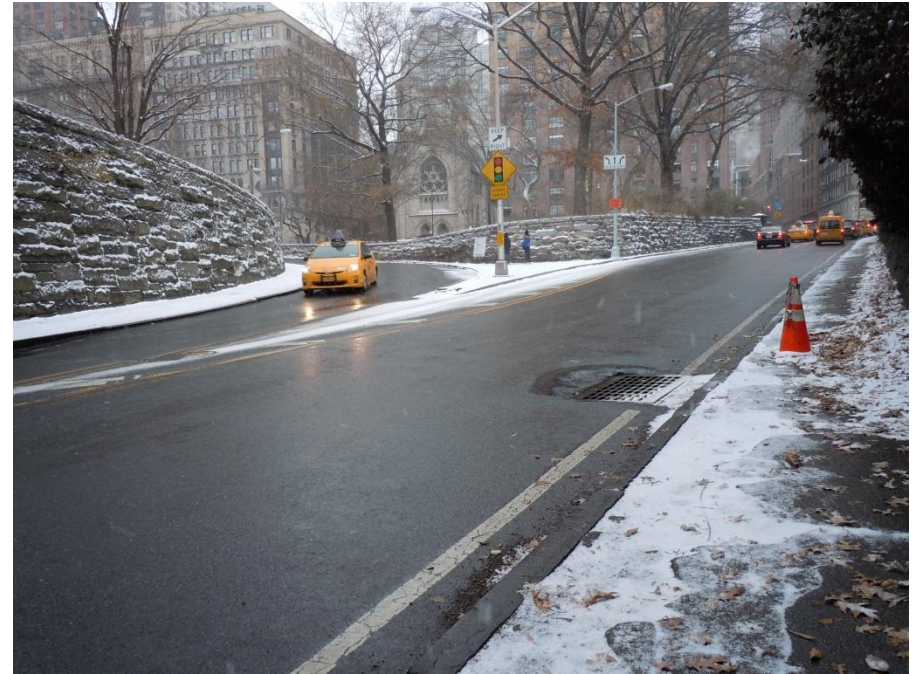
Attempting to gain access to Central Park using the Transverse

Large sections of missing concrete at various locations along path of travel

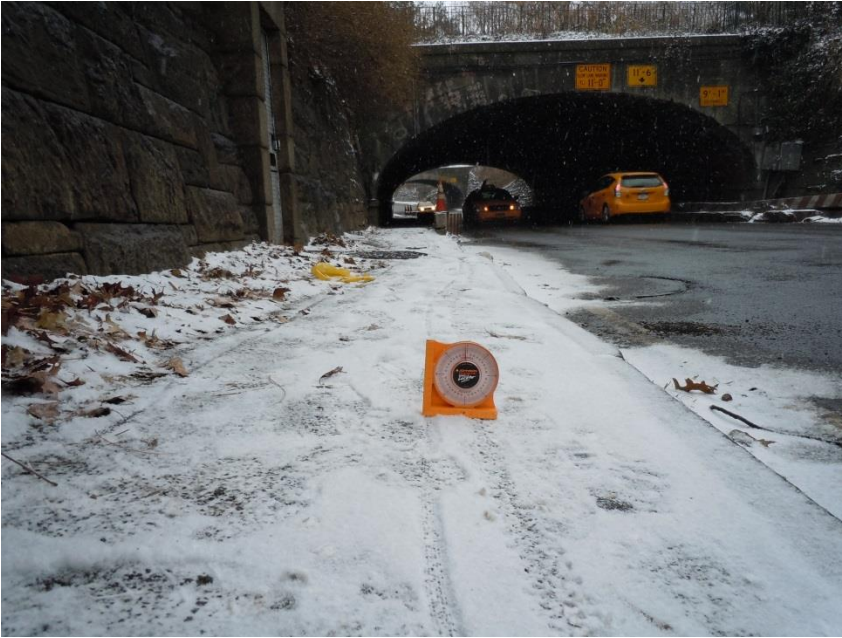
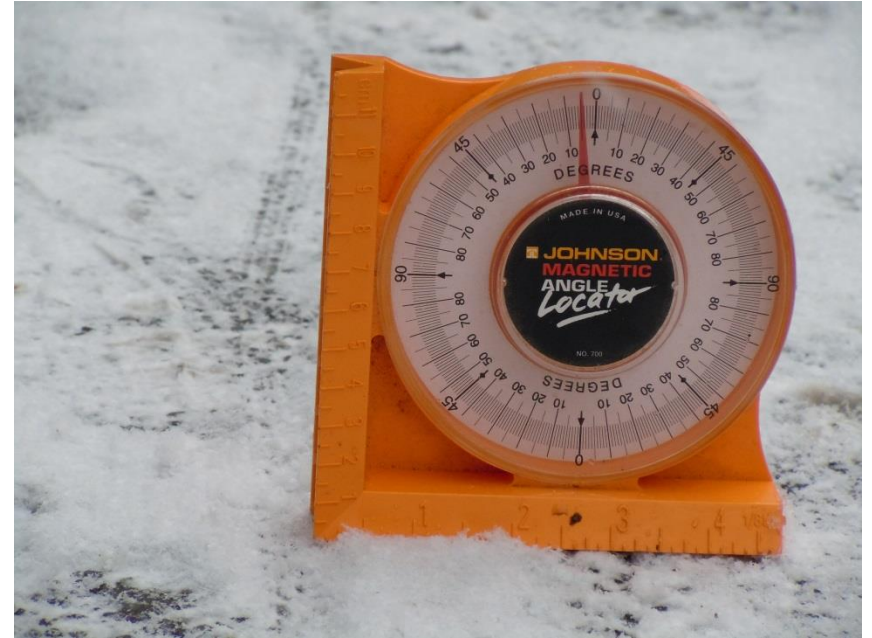
Attempting to gain access to Central Park using the Transverse

- Various sections with excessive cross slope along path of travel; 6 degrees of cross slope measured in several locations
- **6 degrees = 10.51% slope**
- **ADA Maximum allowable cross slope = 2%**

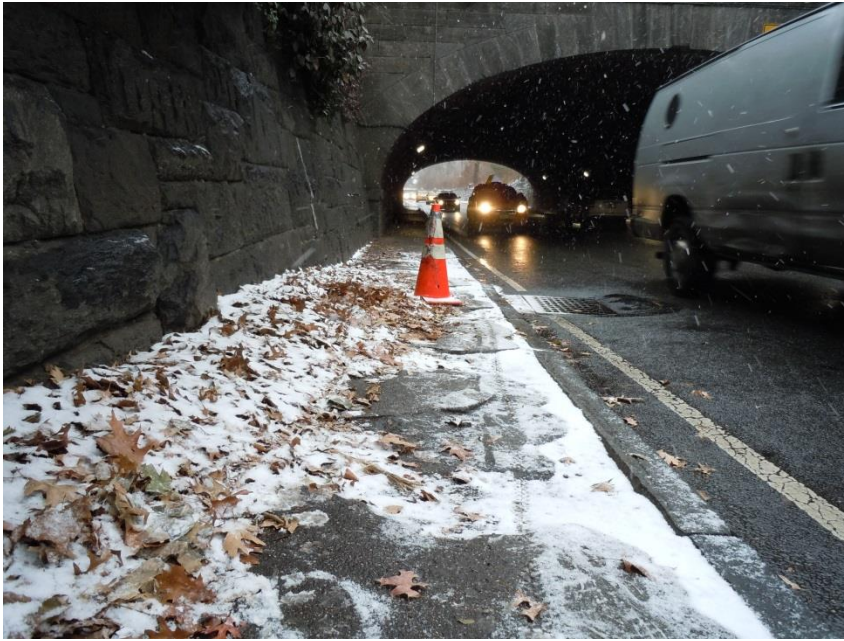
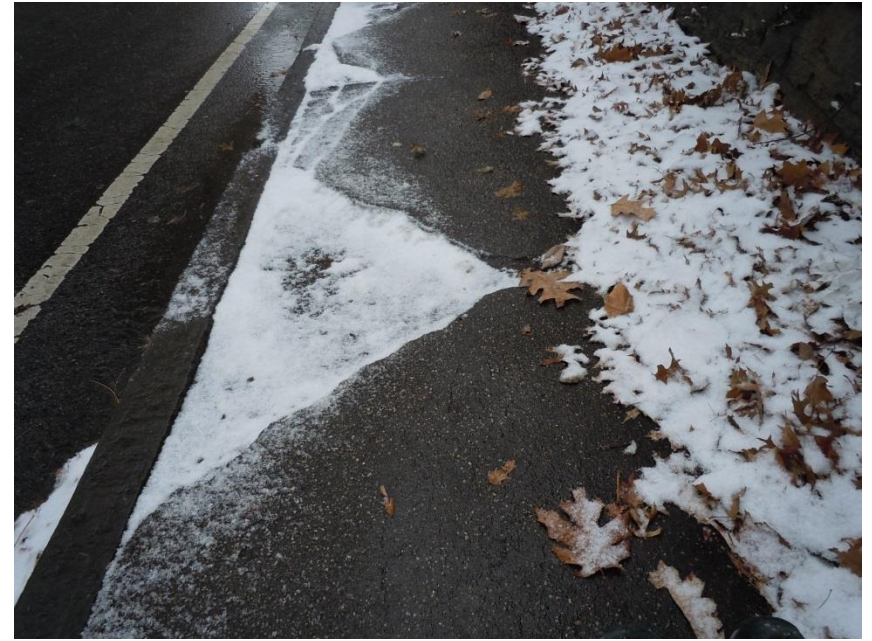
Attempting to gain access to Central Park using the Transverse

- Large sections of missing concrete at various locations
- Leaves and debris along entire path of travel makes the path even narrower
- No option to turn around, no option to get off the sidewalk down to street level

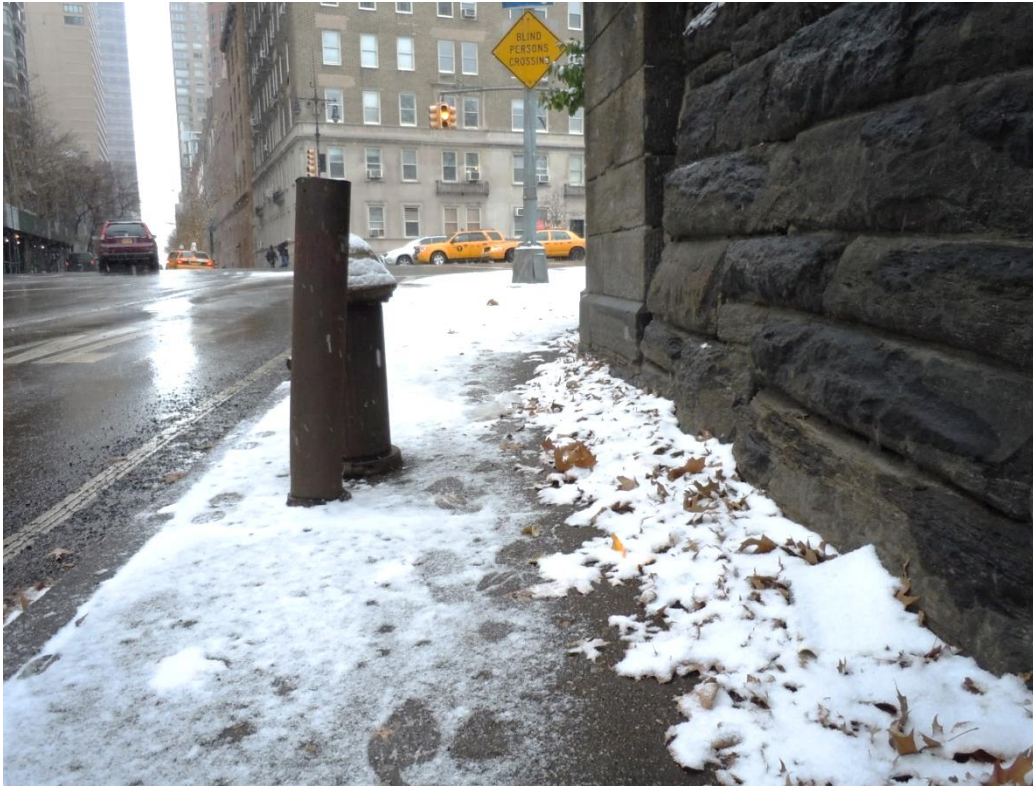
Attempting to gain access to Central Park using the Transverse

- Reduced width of the path of travel at post, less than 20 inches of clear width due to post/fire hydrant and debris, etc., makes passing difficult for some and impossible for others
- No curb ramp and/or crosswalk to get off the sidewalk, down to street level

- 32 inch minimum clear width
- Level change device when vertical distance exceeds 5/8 inch
- When curb ramps are used they must include a detectable warning
- Crosswalks must be provided when pedestrian traffic crosses an active roadway
- Signalized crossings should be provided when no vehicle traffic, higher speeds, curves, inclines, etc.
- When signalized crossings are provided as new construction or alteration, automated pedestrian signals shall be provided

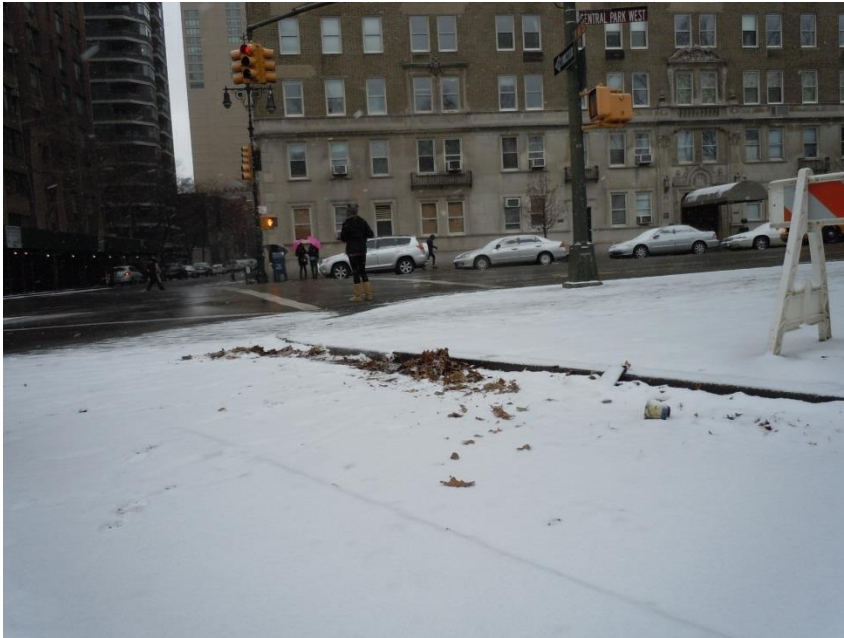
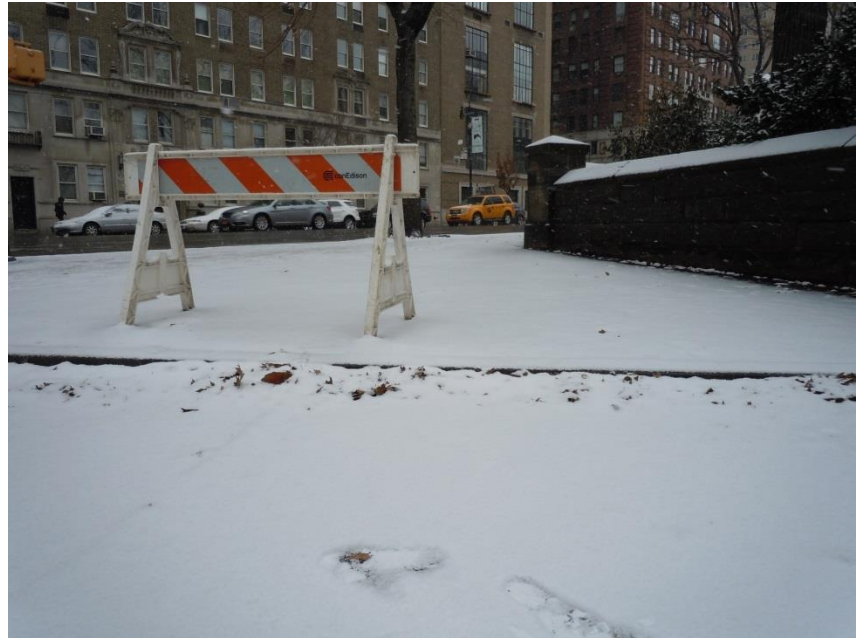
Attempting to gain access to Central Park using the Transverse

- **Missing curb ramp along the street that connects to the accessible route**
- **No curb ramp along entire curb face**

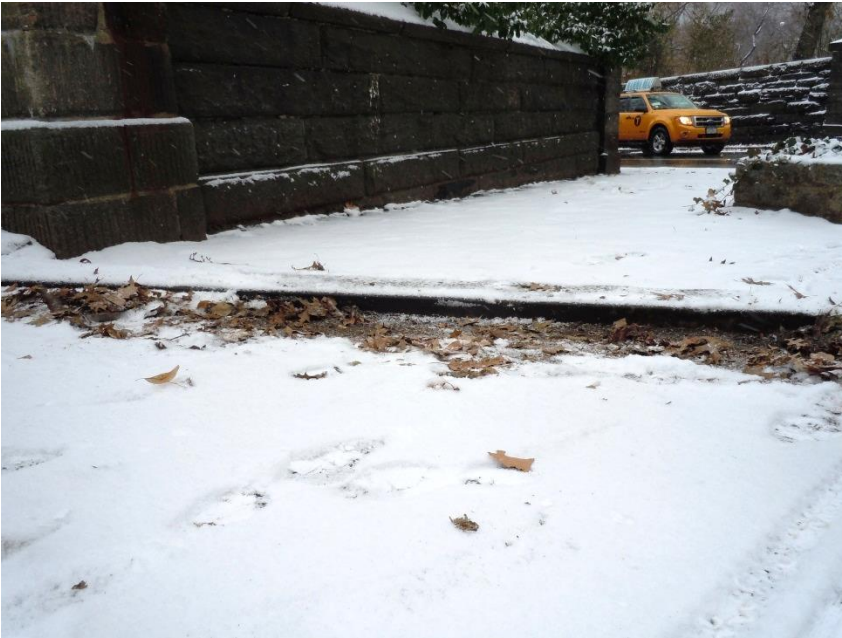
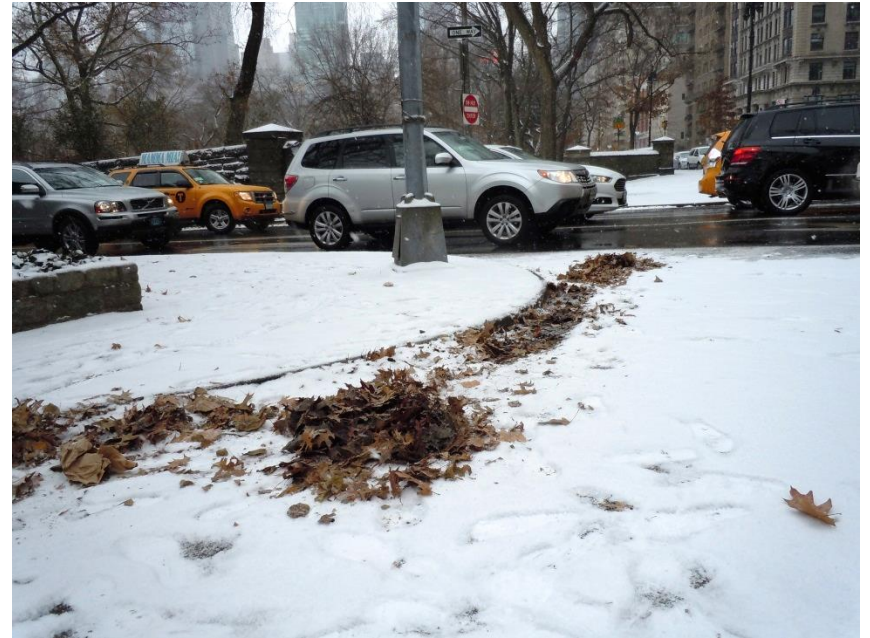
Attempting to gain access to Central Park using the Transverse

- **Missing curb ramp across the street that connects to the accessible route**
- **No curb ramp along entire curb**

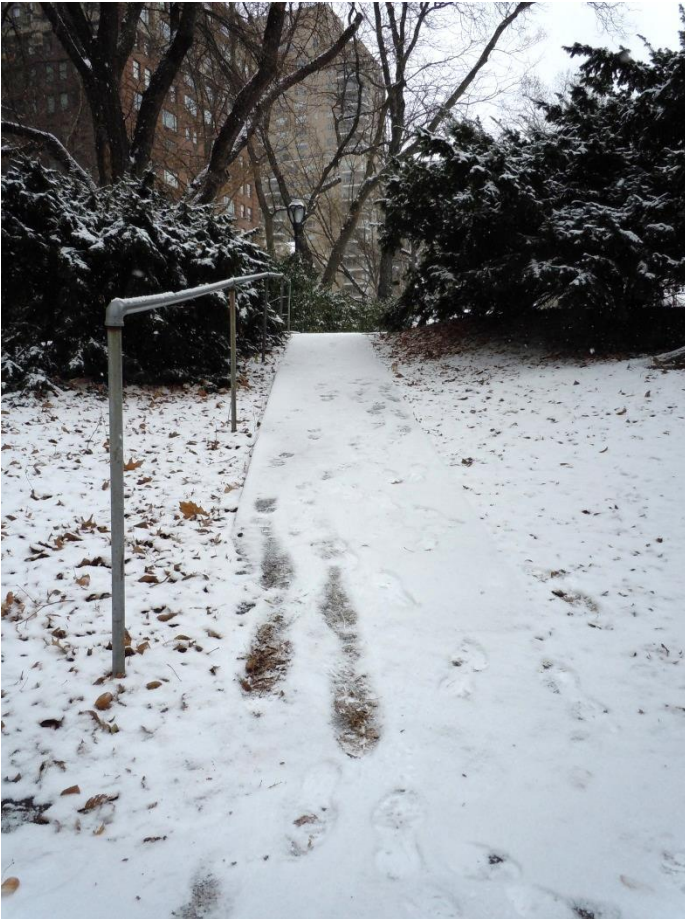
Ramp/stair to enter Park

- ADA requires maximum allowable slope 1:12 (8.3%), level landing along the ramp every 30 inches of rise and compliant handrails both sides

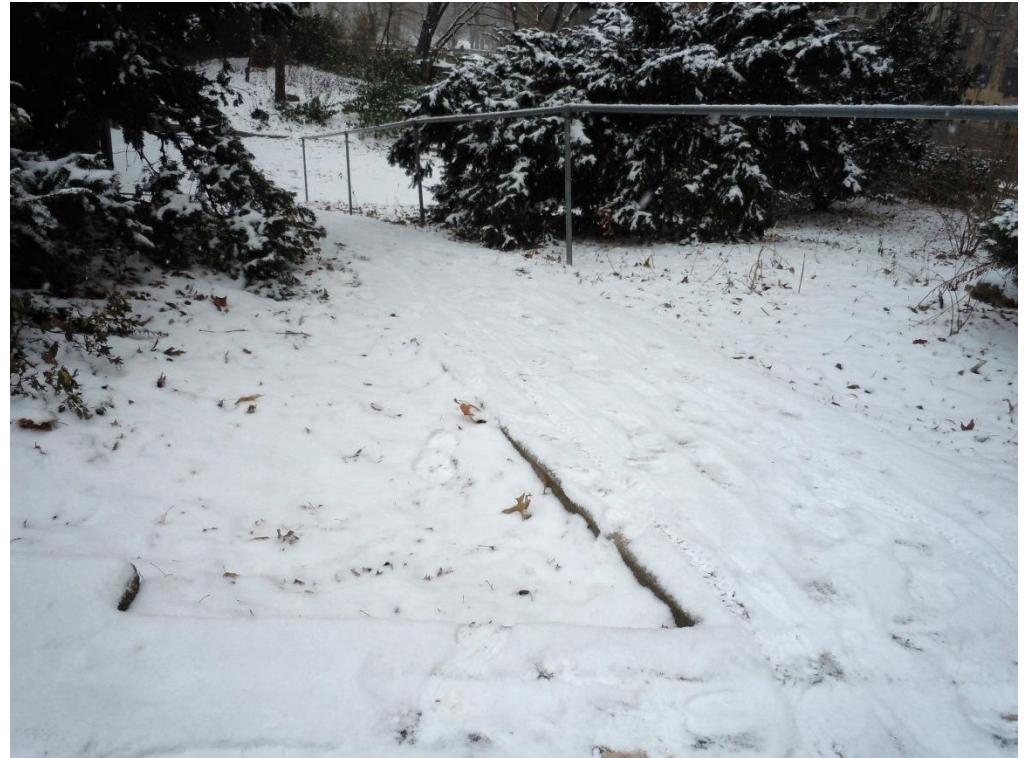
- Looking down ramp, excessive and non-compliant slope on ramp, excess of 10 degrees slope = 17.6 % slope, non-compliant handrail, missing handrail on left side (looking down)

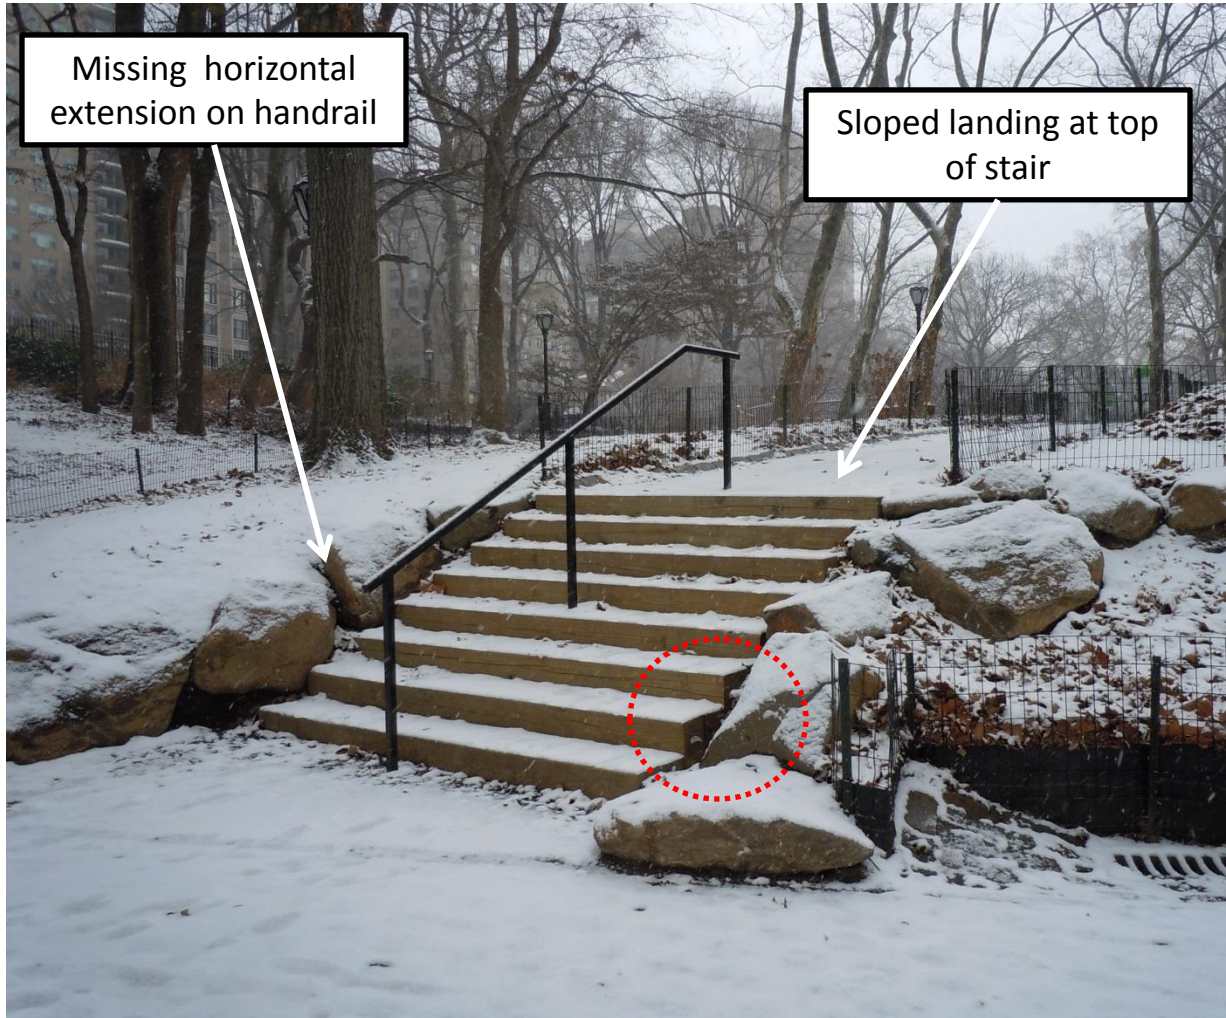
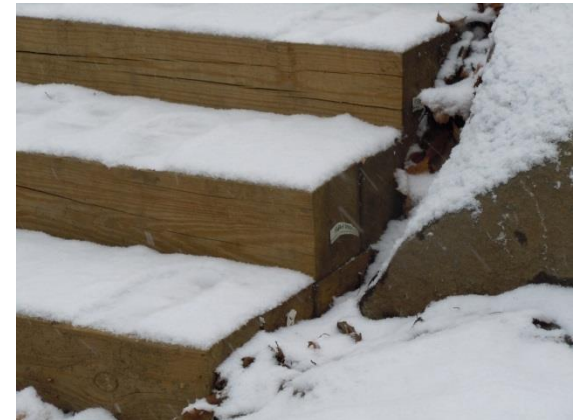
Stair (new) and Ramp Inside Park

New lumber

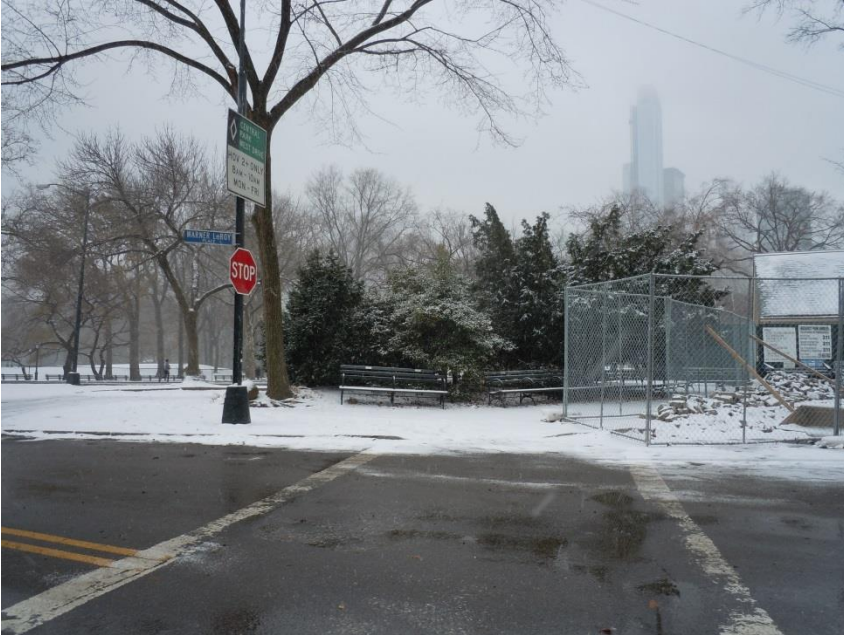
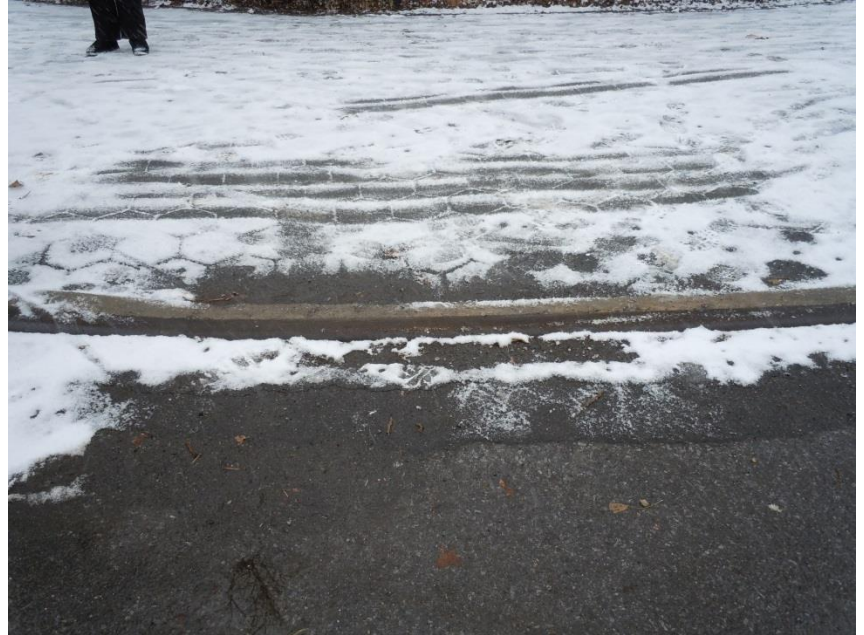
Entrance to Park

- **Crosswalk missing curb ramps and detectable warnings on both sides of street**
- **Vertical elevation changes at curb line exceed maximum allowable (compliant curb(s) ramp would eliminate non-compliance)**

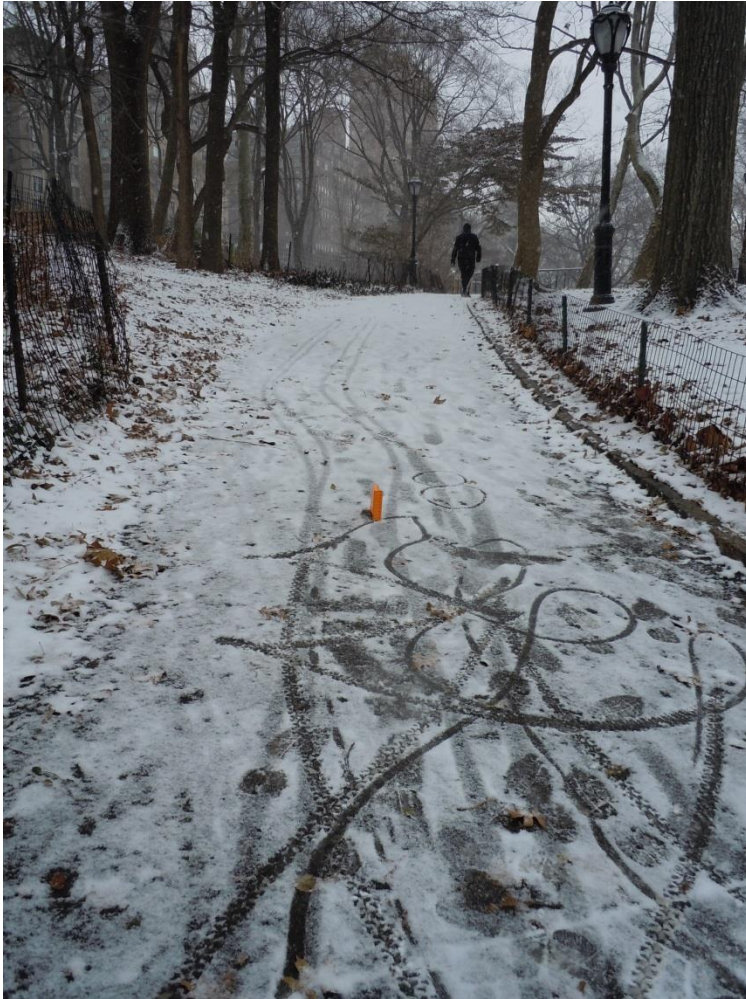
Ramp Inside Park

- Ramp rise exceeds 30 inches
- Lack of level landings every 30 inches of rise
- Lack of handrails both sides
- Slope exceeds maximum allowable
- Measured 8 degrees = 14.05 %
- ADA requires a maximum slope of 1:12 (8.33%)

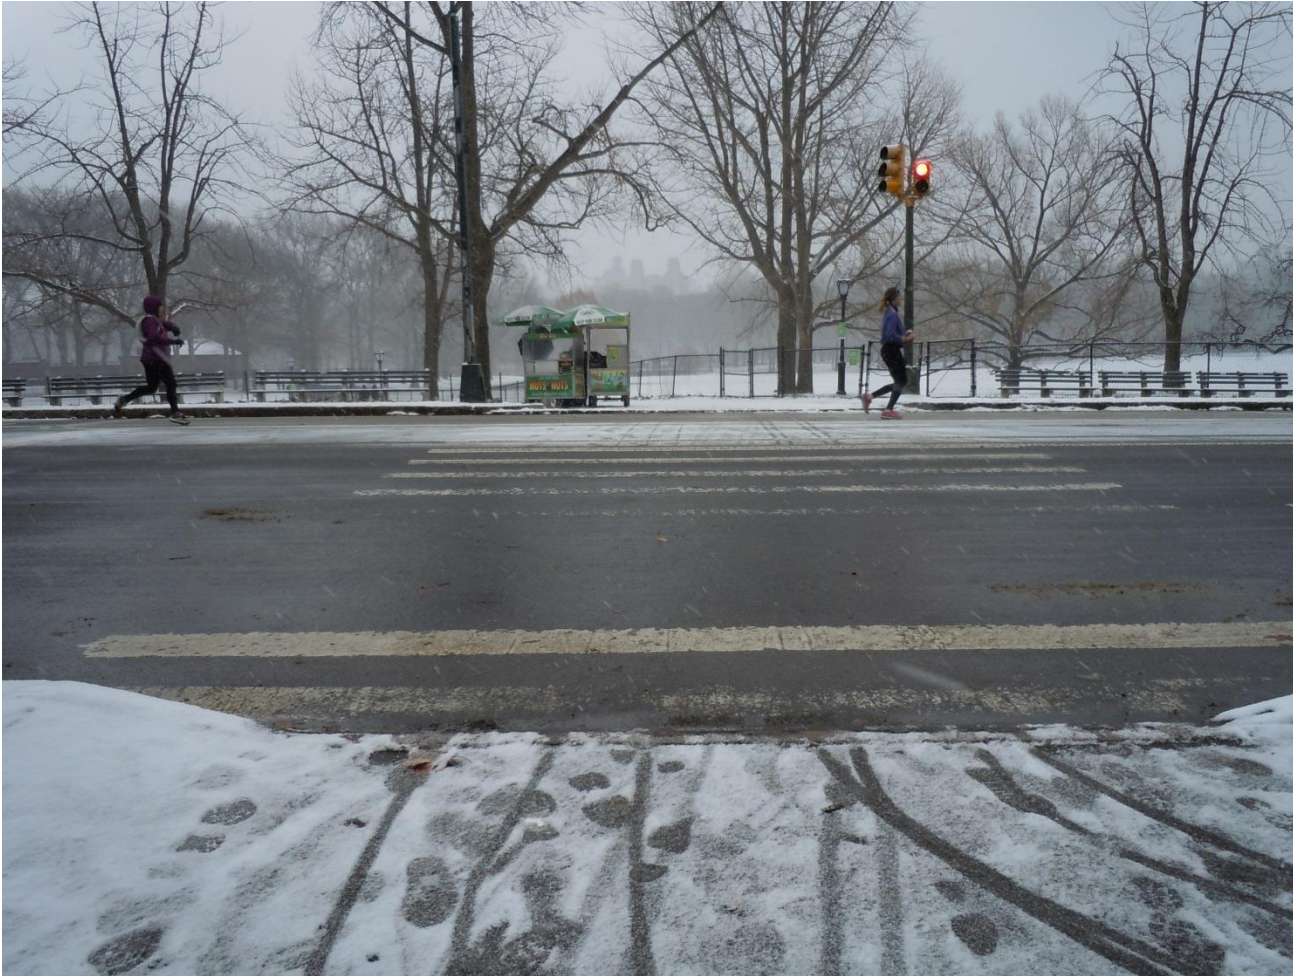
Signalized Street Crossing and Cross Walk Inside Park

- Crosswalk is missing curb ramps
- Missing detectable warnings
- Missing automated pedestrian signals

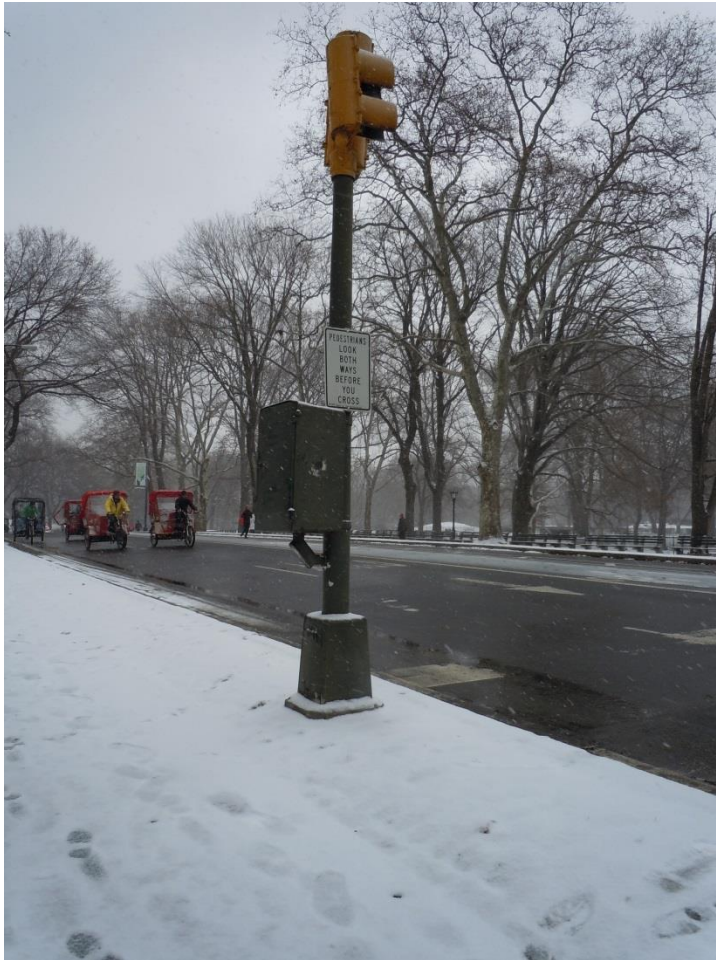
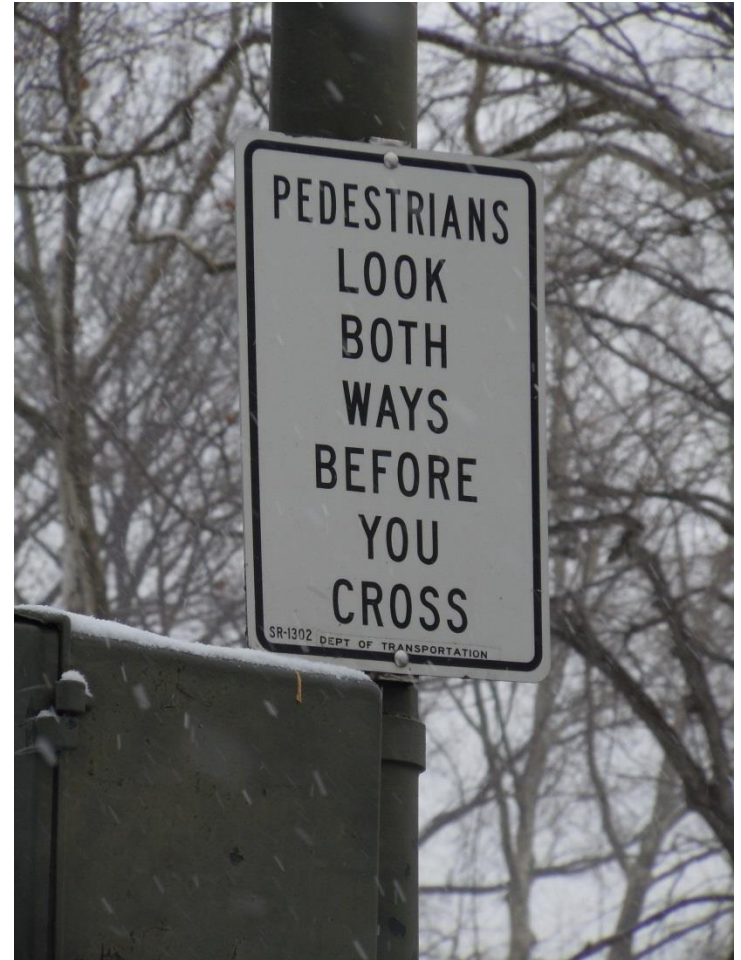
Signalized Street Crossing and Cross Walk Inside Park

- Sign informs pedestrians to look both ways before crossing street
- How do pedestrians who are blind or vision impaired safely cross the street?

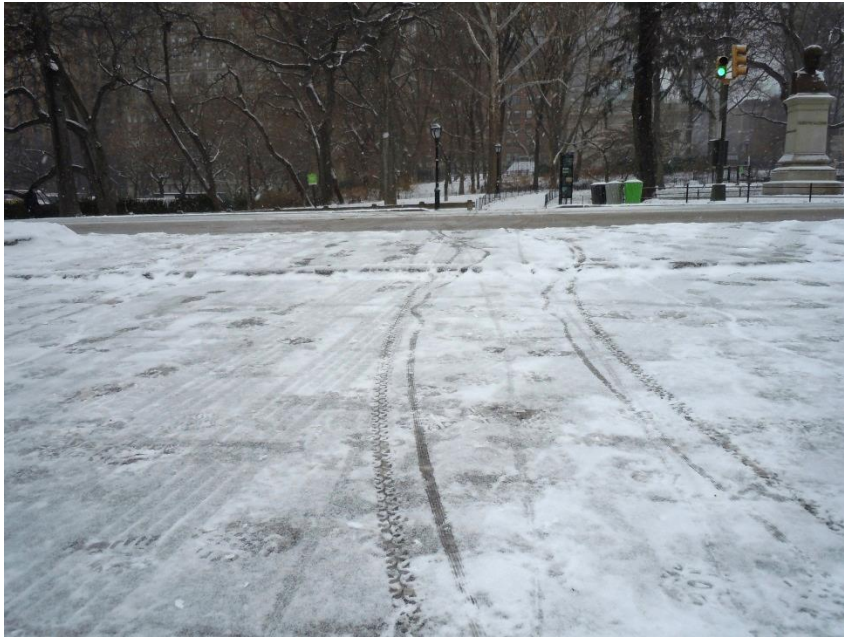
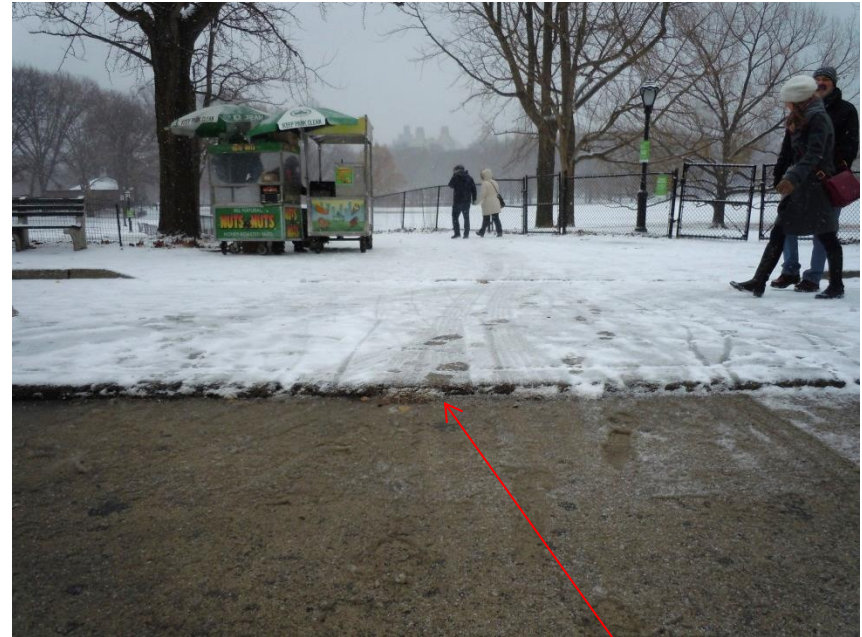
Signalized Street Crossing and Cross Walk Inside Park

Elevated concrete in the crosswalk with no curb ramps or detectable warnings

- **Crosswalks missing curb ramps and detectable warnings on both sides of street**
- **Vertical elevation changes at curb line exceed maximum allowable (compliant curb(s) ramp would eliminate non-compliance)**
- **Missing Automated Pedestrian Signals**

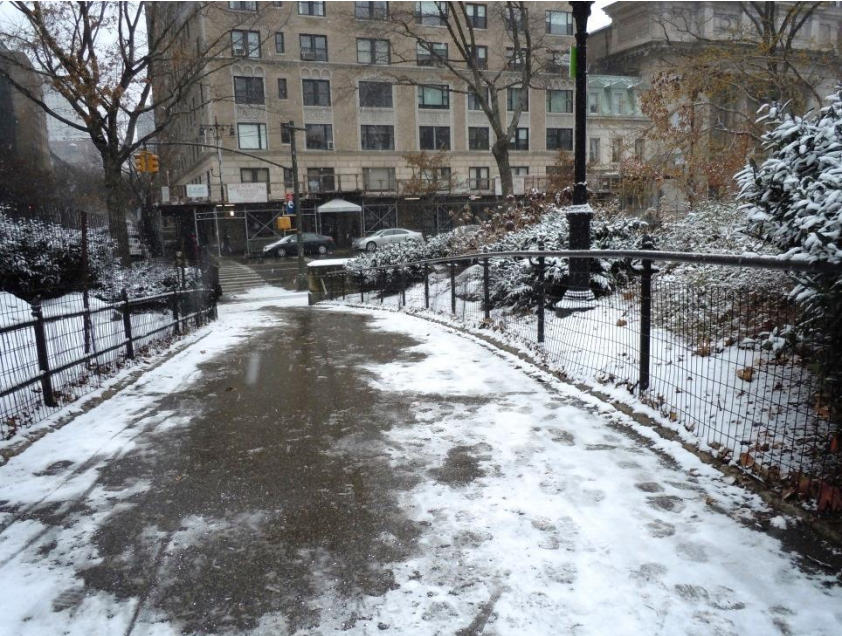
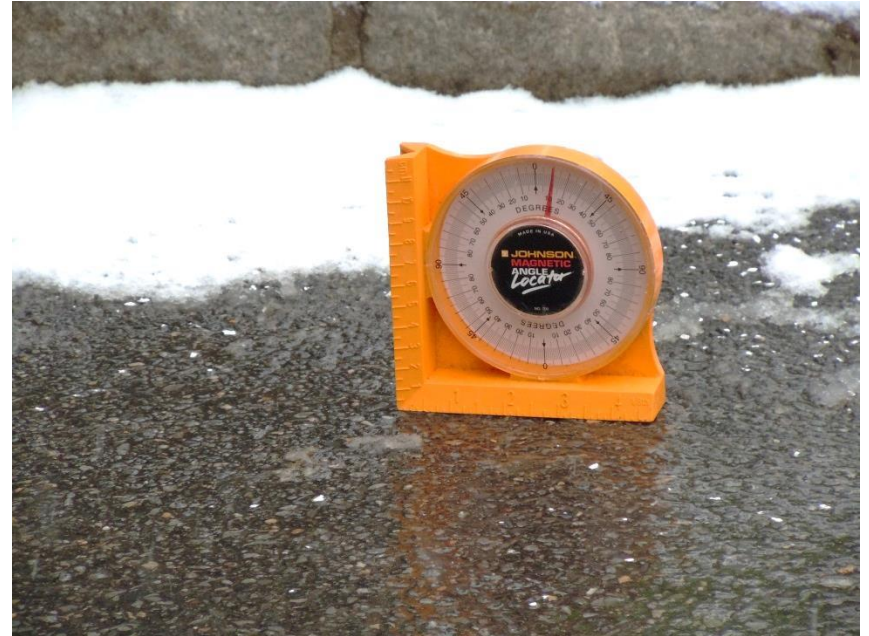
Ramp Inside Park

- Excessive slope in excess of 10 degrees slope = 17.6 % slope
- Missing handrail left side (looking down)
- Missing level landings (required every 30 inches of vertical rise)

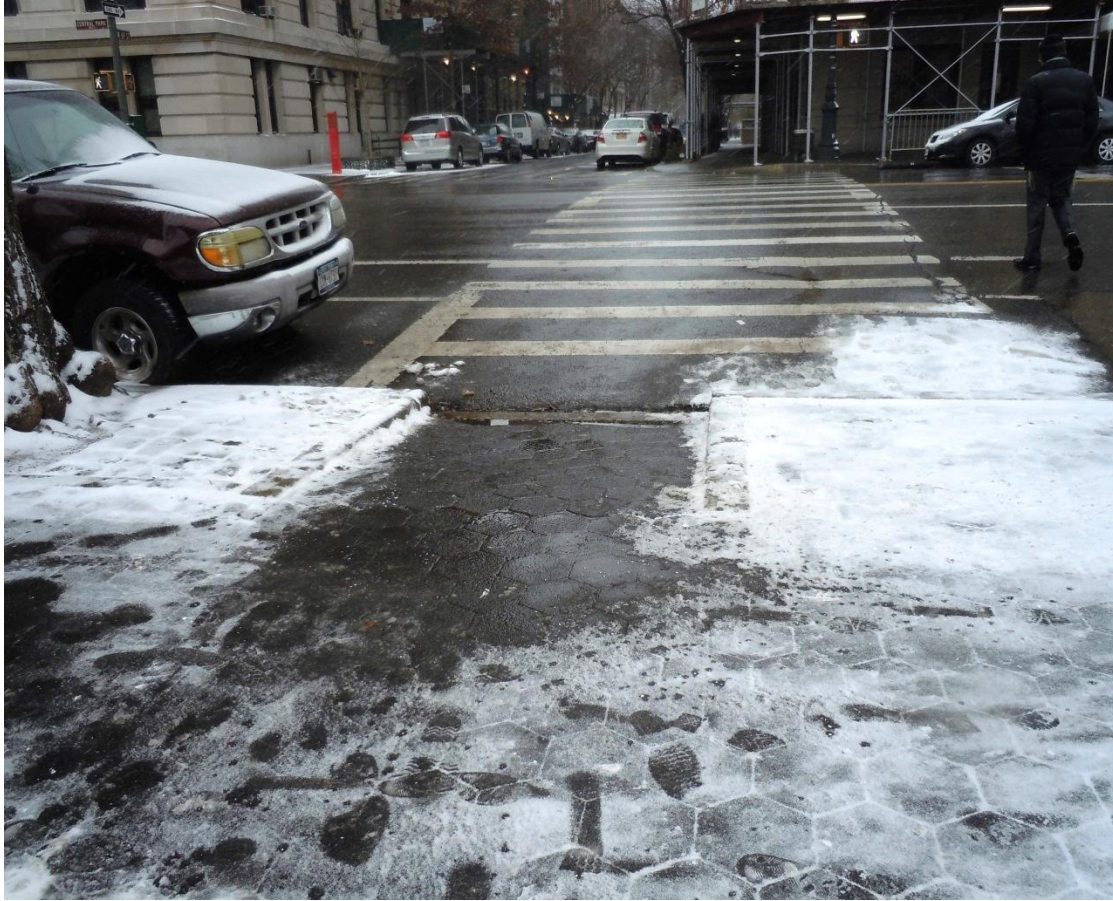
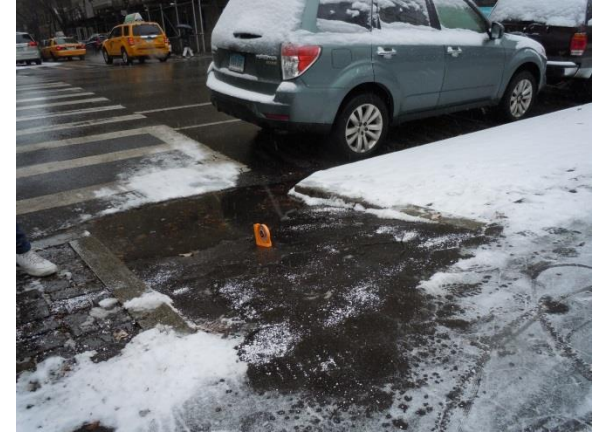
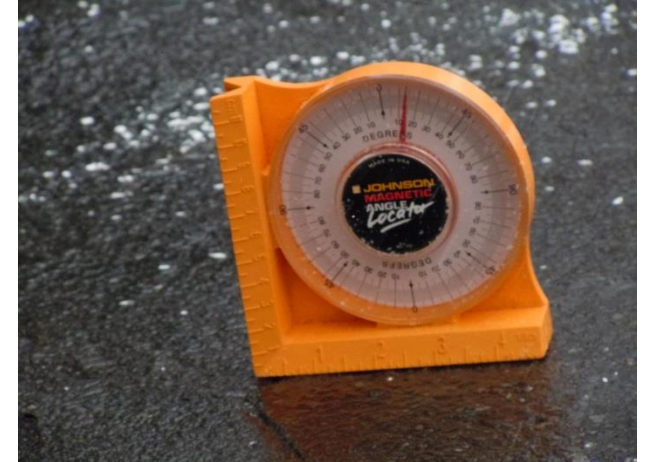
Signalized Crosswalk to Enter Park

- Curb ramp excessive slope, in excess of 10 degrees slope = 17.6 %
- Missing detectable warning
- Missing automated pedestrian signal (APS)

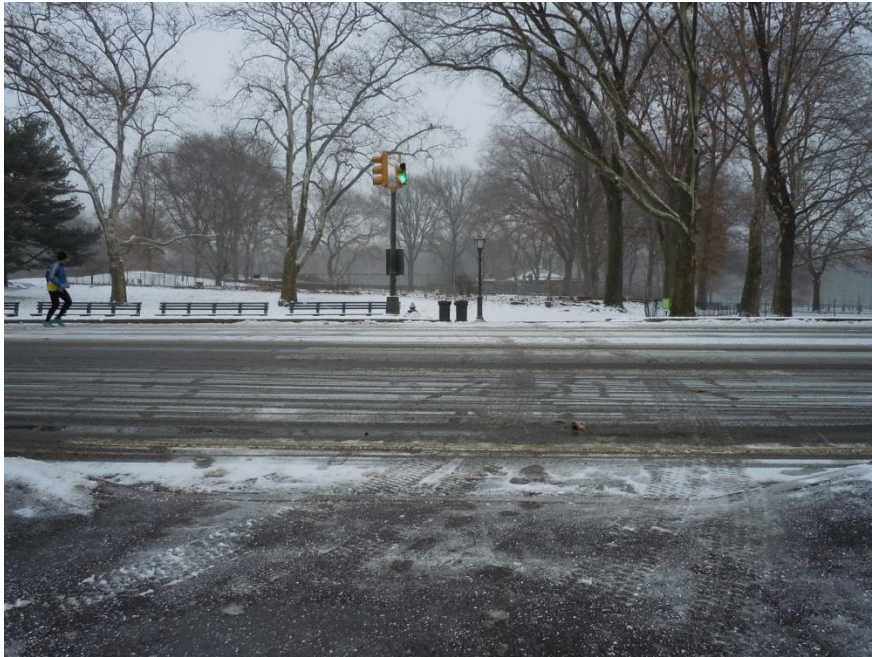
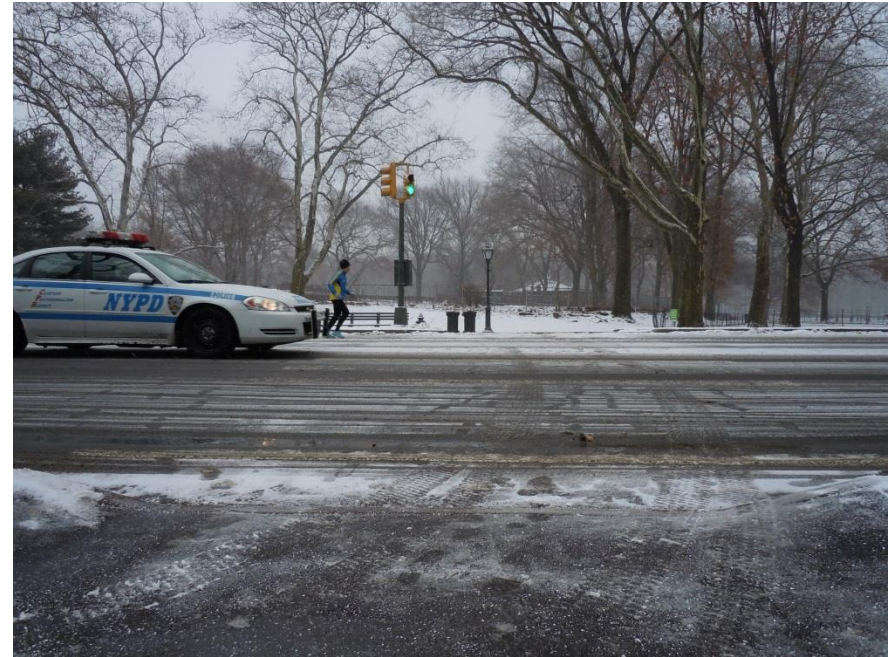
Signalized Crosswalk in Park

- **Crosswalk missing curb ramps and detectable warnings on both sides of street**
- **Vertical elevation changes at curb line exceed maximum allowable (compliant curb(s) ramp would eliminate non-compliance)**
- **Police car ran red-light during picture and bicycles ignore signalized crossing(s) making crossing very dangerous**

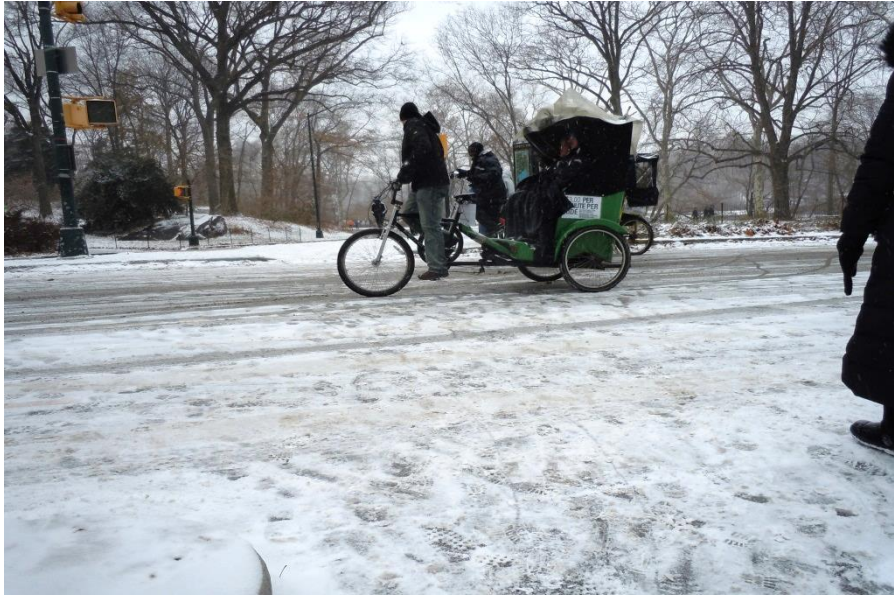
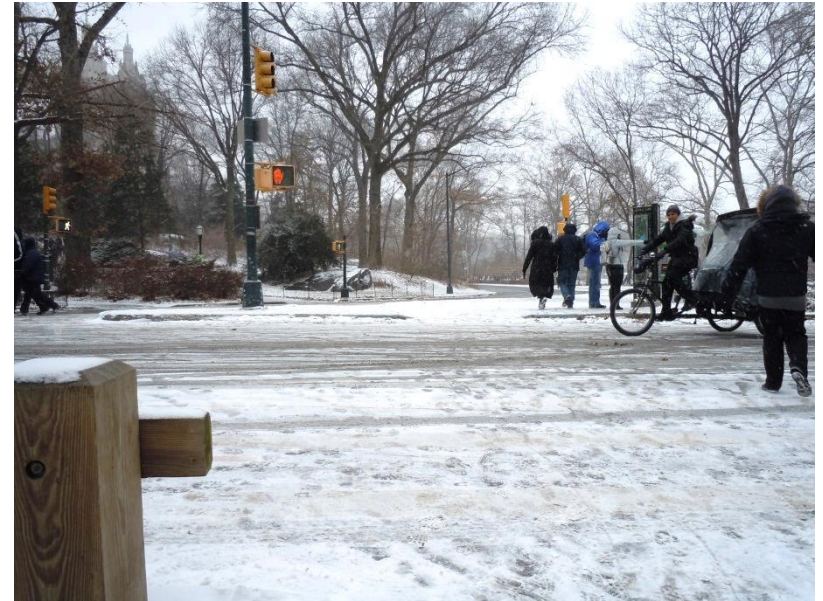
Signalized Crosswalk in Park

- **Police cars, Bicycles, etc. Ignore signalized crossing(s) making crossing very dangerous**
- **ADA Required Automated Pedestrian Signals would make crossings much safer**
