Preliminary ADA Assessment at New York Central Park

Gary Talbot

12-14-2013

Major ADA Violations Found at Every Location Assessed

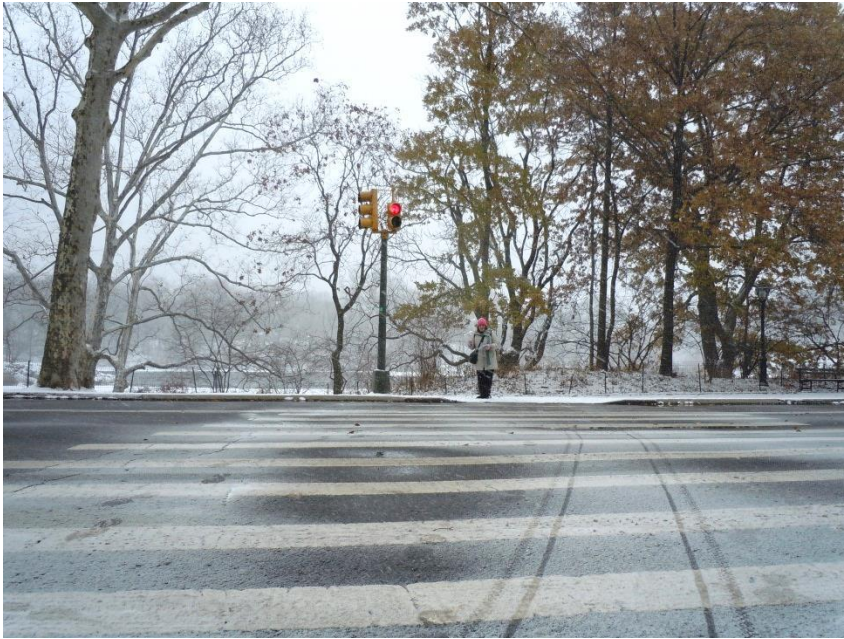
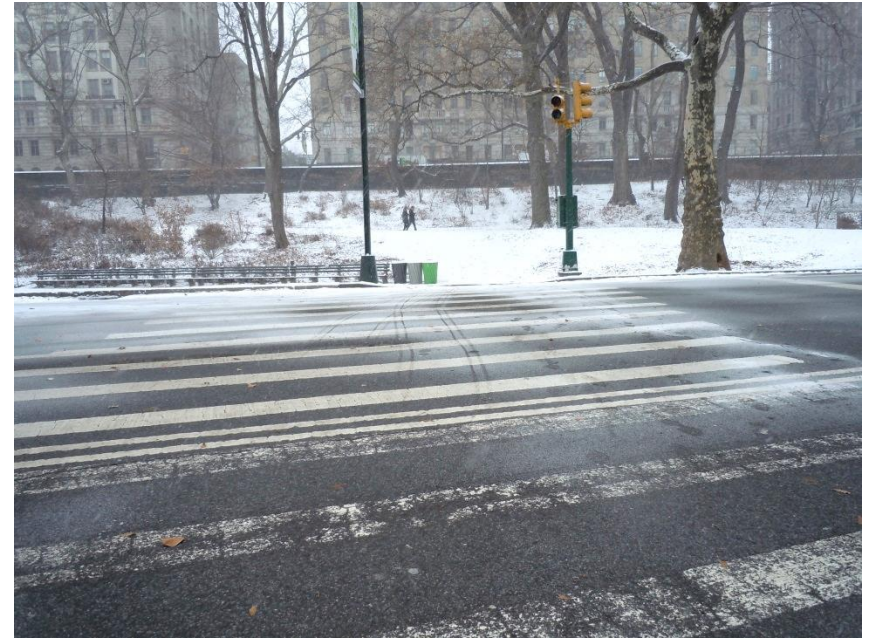
Signalized Crosswalk in Park

- **Crosswalk missing curb ramps and detectable warnings on both sides of street**
- **Vertical elevation changes at curb line exceed maximum allowable (compliant curb(s) ramp would eliminate non-compliance)**
- **All Signalized Crossings Assessed are Missing Automated Pedestrian Signals (APS)**

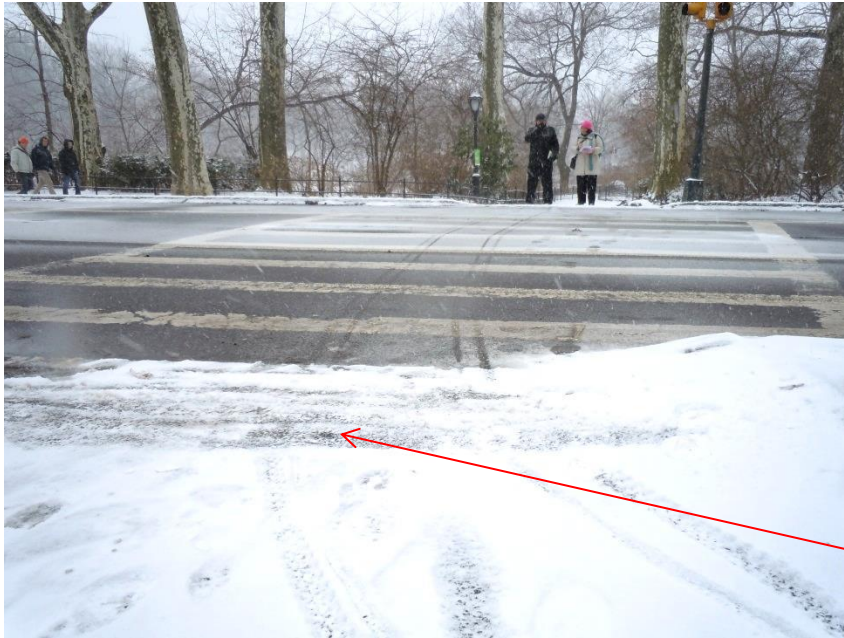
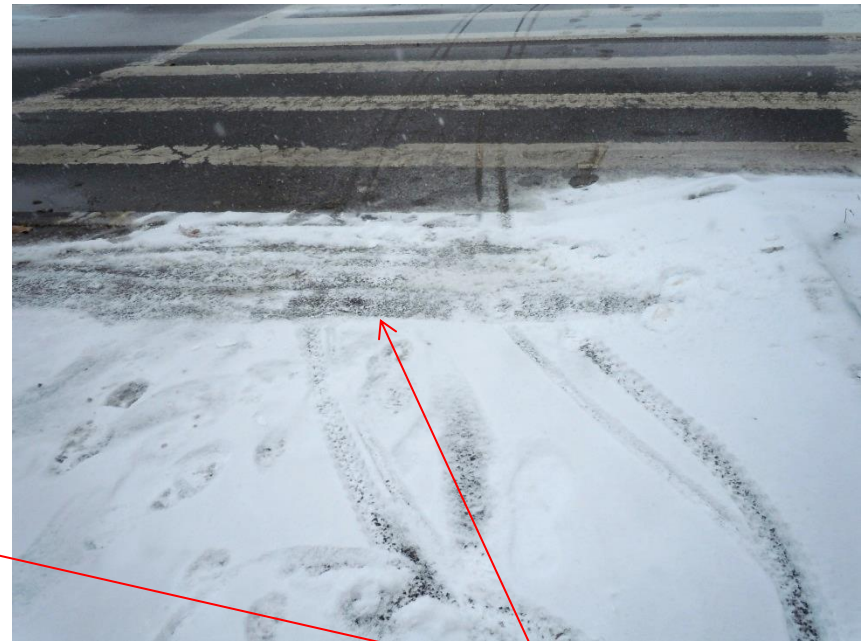
Signalized Crosswalk in Park

Missing Detectable Warnings

- **Crosswalk missing curb ramps and detectable warnings on both sides of street**
- **Vertical elevation changes at curb line exceed maximum allowable (compliant curb(s) ramp would eliminate non-compliance)**
- **All Signalized Crossings Assessed are Missing Automated Pedestrian Signals (APS)**

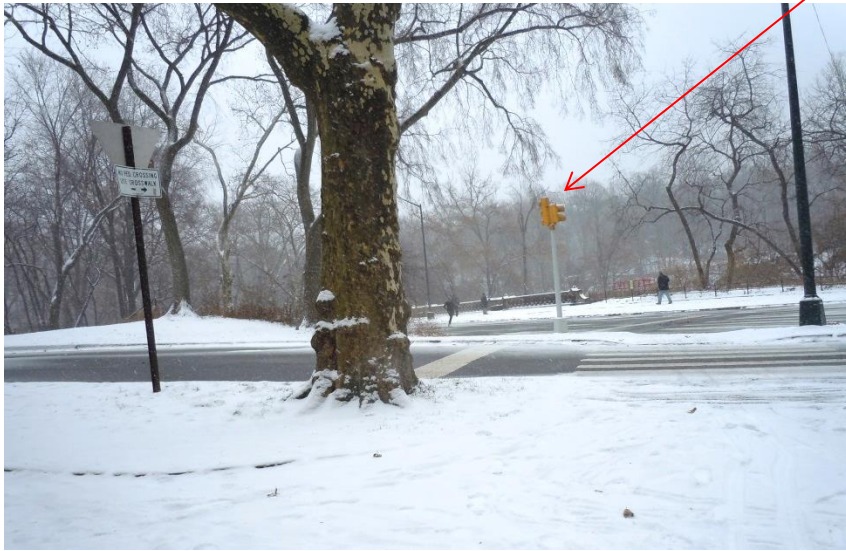
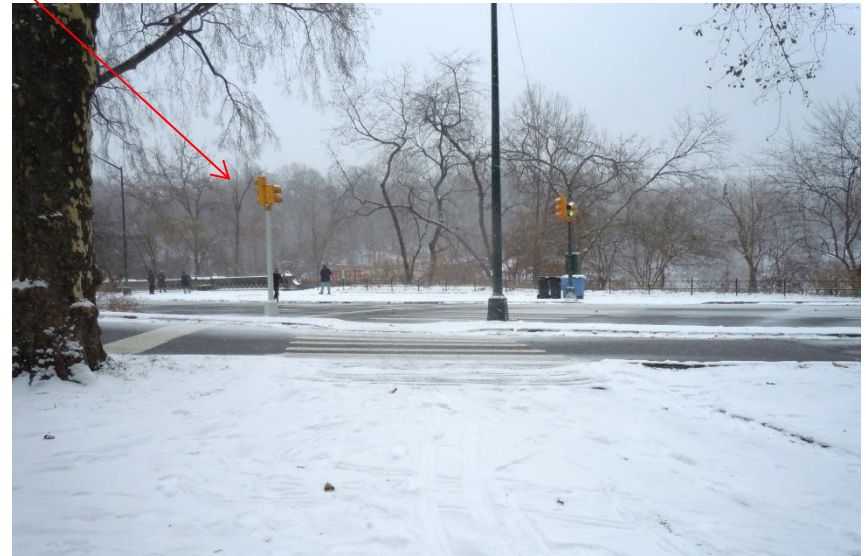
Signalized Crosswalk in Park with Island

Missing Crossing Signal

- **Crosswalk missing curb ramps and detectable warnings on both sides of street**
- **Vertical elevation changes at curb line exceed maximum allowable (compliant curb(s) ramp would eliminate non-compliance)**
- **Missing Signal for this Crossing (no signal) and Missing Automated Pedestrian Signals (APS)**

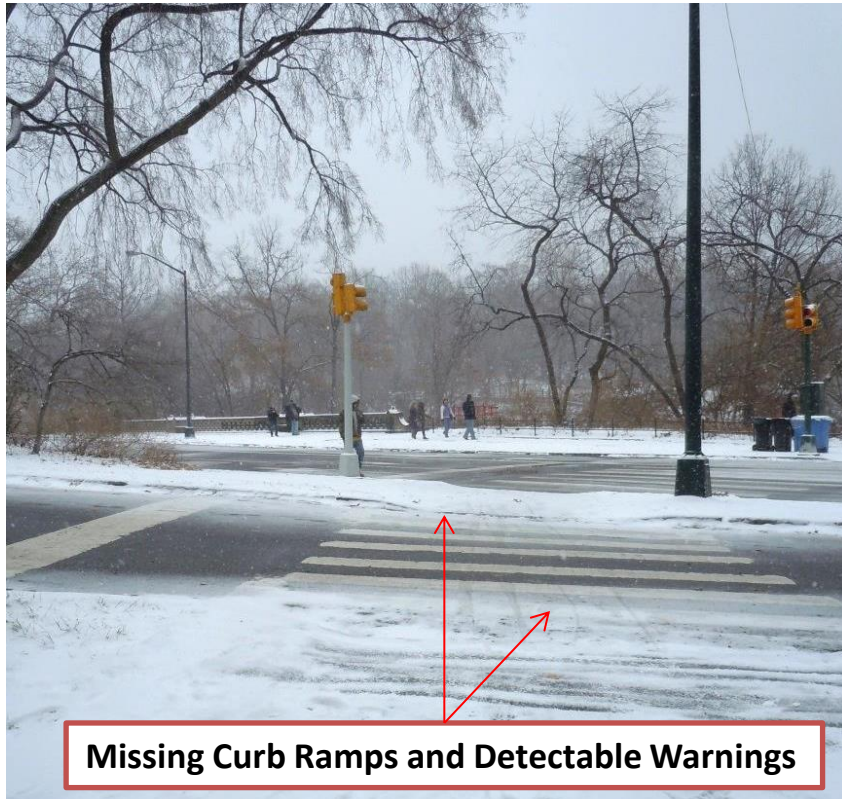
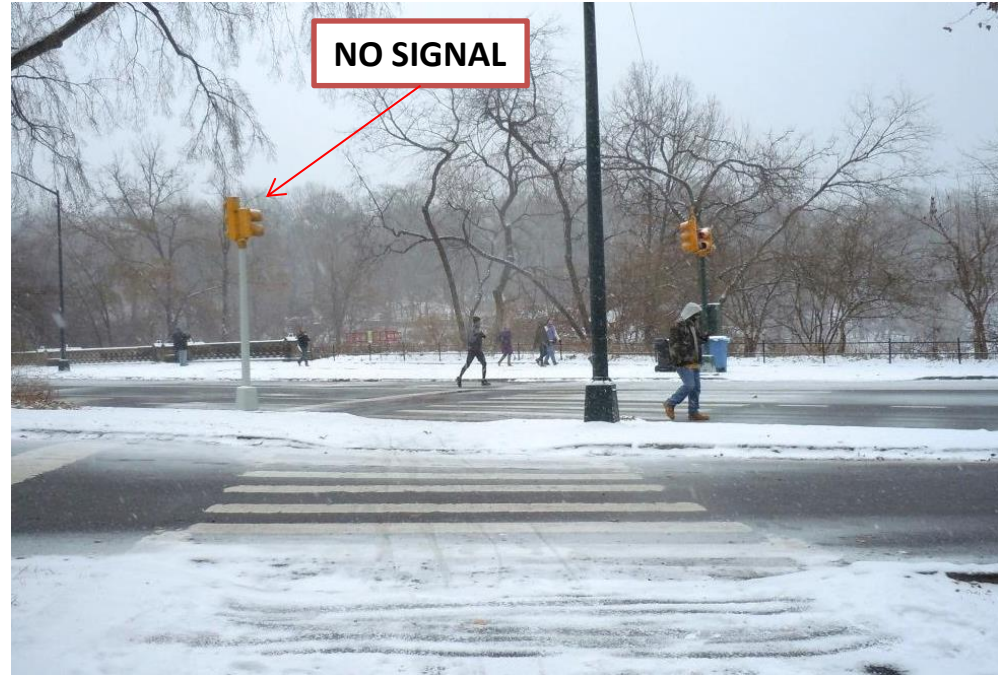
Signalized Crosswalk in Park with Island

- **Missing Signal for this Crossing (no signal) and Missing Automated Pedestrian Signals (APS)**
- **Missing curb ramps, missing detectable warnings**

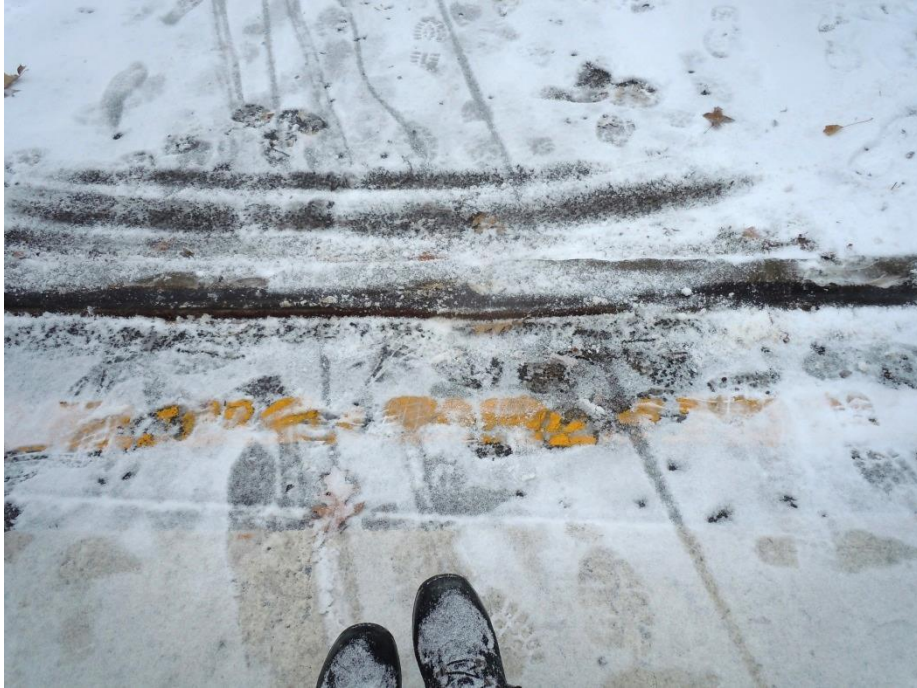
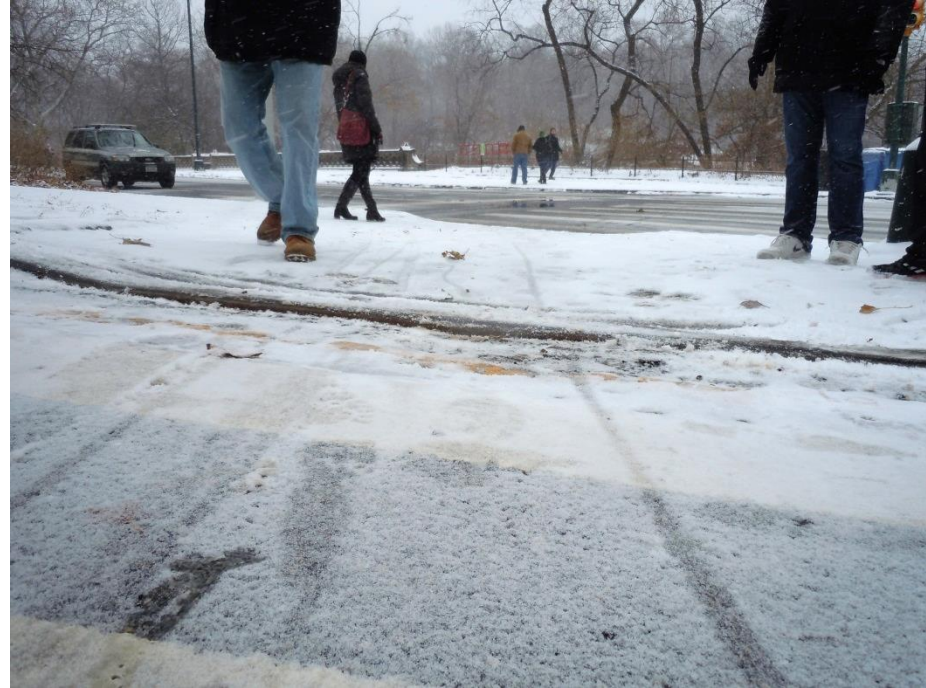
Signalized Crosswalk in Park with Island

- **Missing Signal for this Crossing (no signal) and Missing Automated Pedestrian Signals (APS)**
- **Missing curb ramps and missing detectable warnings**

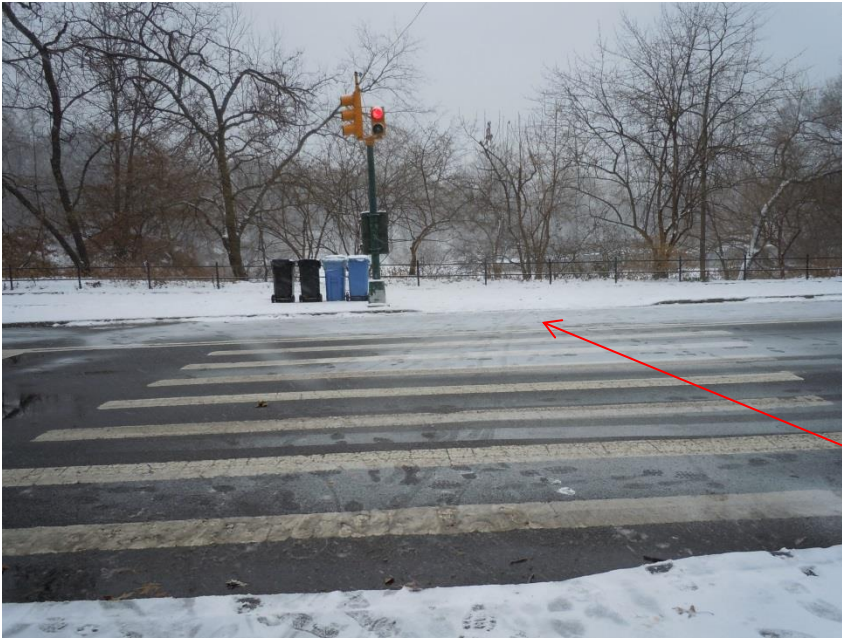
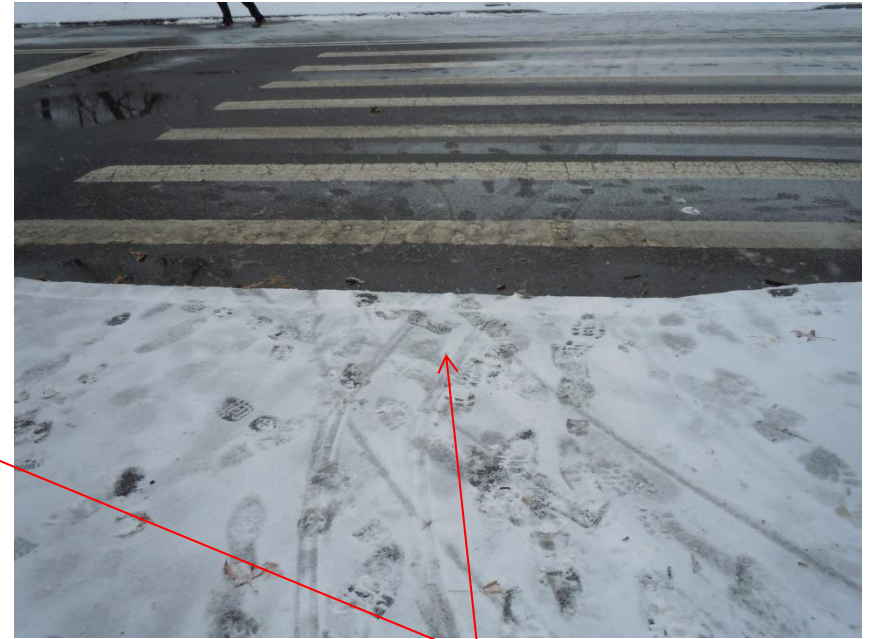
Signalized Crosswalk in Park

Missing Curb Ramps and Detectable Warnings

- **Missing Automated Pedestrian Signals (APS)**
- **Missing curb ramps and missing detectable warnings**

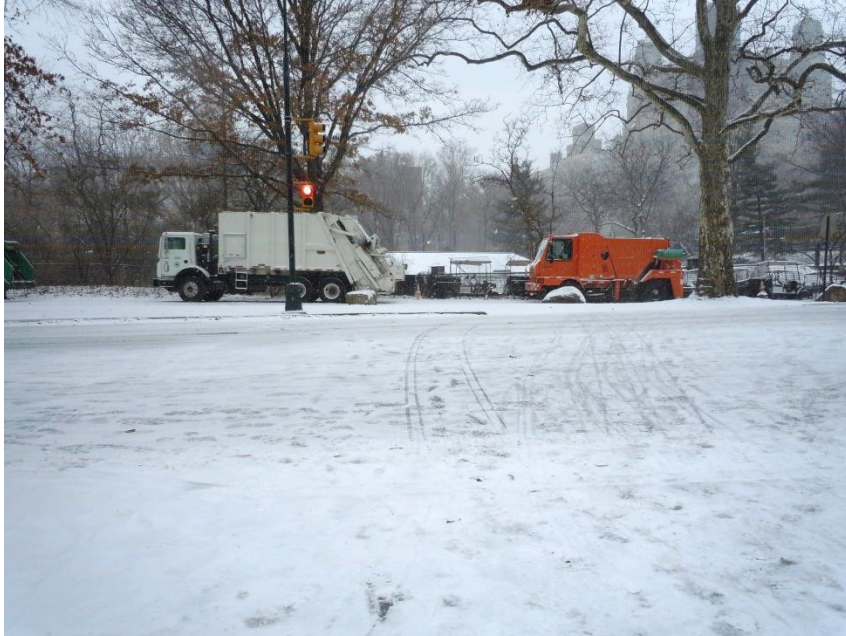
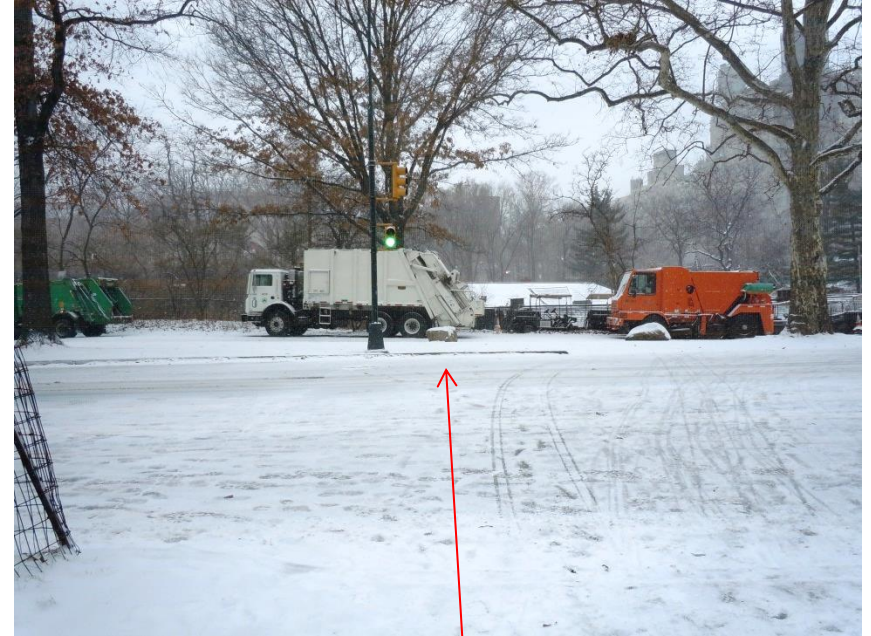
Signalized Crosswalk in Park

Missing Curb Ramps and Detectable Warnings

- **Missing Automated Pedestrian Signals (APS)**
- **Missing curb ramps and missing detectable warnings**
