Subject: Champlain Towers South Condominium Collapse
Victim Identification Report:
Theresa Velasquez
Valeria G. Barth

In the aftermath of the Champlain Towers South Condominium collapse, Miami-Dade Fire Rescue (MDFR) has conducted several reviews as part of its after-action assessment. This report documents the actions taken and the testimonial and physical evidence gathered leading to identifying the female voice under the rubble as that of Theresa Velasquez.

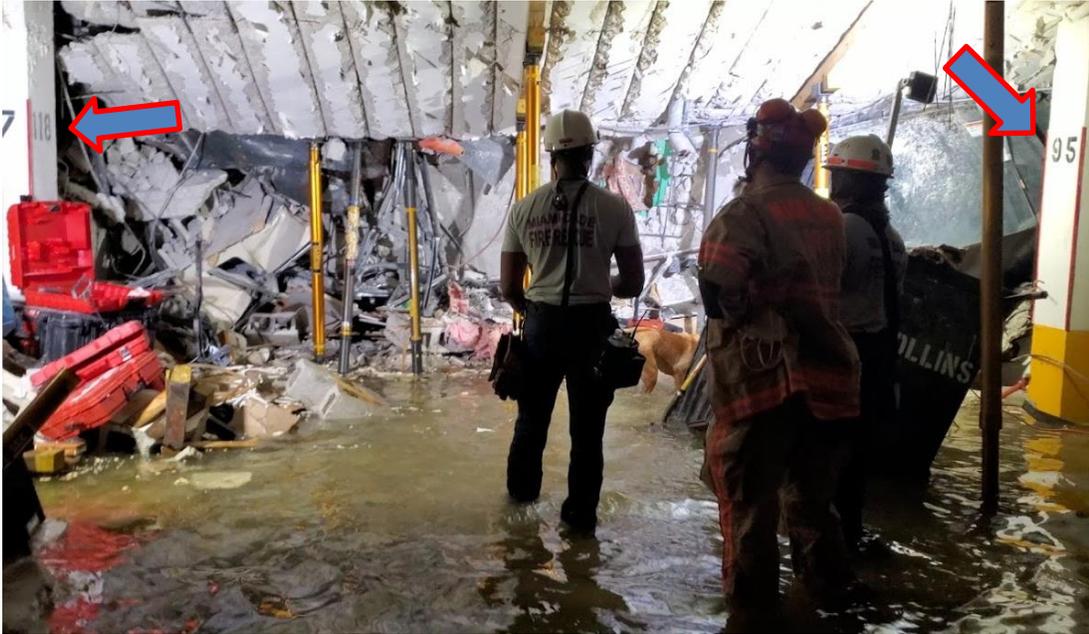
Image 1: Rescue Crew operating between parking columns 95 and 118

minutes. According to the technical rescue crews, the power generator's closest location was on the south side of the Champlain Towers South building, approximately 300'-400' from where the work was conducted. According to rescue crews, their operation was located on the extreme far north side of the building. As seen in *Image 1*, the area our rescue crews were working was between parking spots 95 and 118, as seen on the vertical columns.

5. On July 8th, Ms. Velasquez's remains were located and removed by one of the FEMA taskforces. On July 12th, FEMA taskforce crews were able to retrieve two Paratech pneumatic shores that were left underneath the parking garage where initial rescue crews made entry to conduct operations, as seen in *Image 1*. These two Paratechs were too risky to remove on June 24th, and

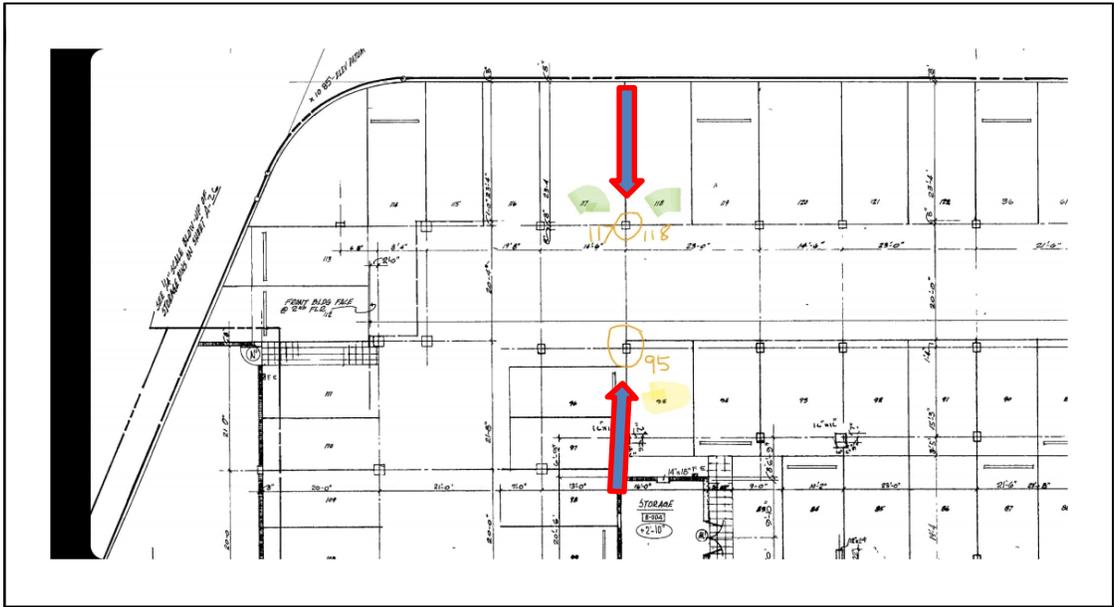
Illustration 1: Location of parking columns 95 and 118 in the parking garage.

By reviewing *Illustration 1*, a floor plan of the garage area, the two vertical columns are noted as being on the far north side of the property. As a result of the distance, crews exceeded the tool manufacturer's recommended cord length at times by 300'. However, our rescue crews would adapt and overcome.

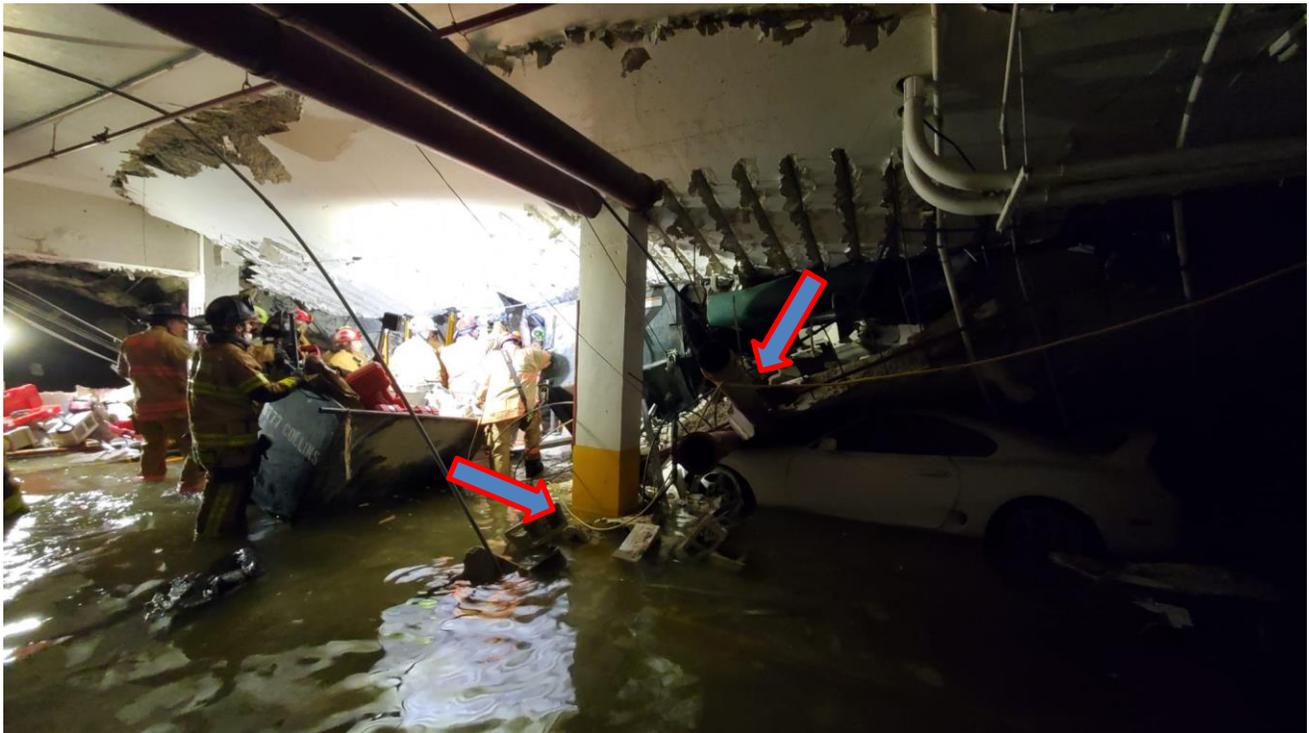
Image 3 - Electrical cords were daisy-chained

In addition, electrical cords were daisy-chained on hanging rebar and on top of vehicles to avoid the cords from getting wet, as seen in *Image 3*.

While working in standing water, rescue crews were electrically shocked as they operated the jackhammers due to the moisture in the electrical lines. These issues were one of many complexities

that rescuers constantly encountered as water and moisture continued to affect electrical cords further tripping the ground fault circuit indicators (GFCI). The GFCI could not be reset until the electrical cords were dry or moisture-free. Though the USA Today article correctly identified some issues that rescuers encountered, as noted above; however, the reasons why our rescue crews had these issues, as stated in the newspaper article, are not factual.

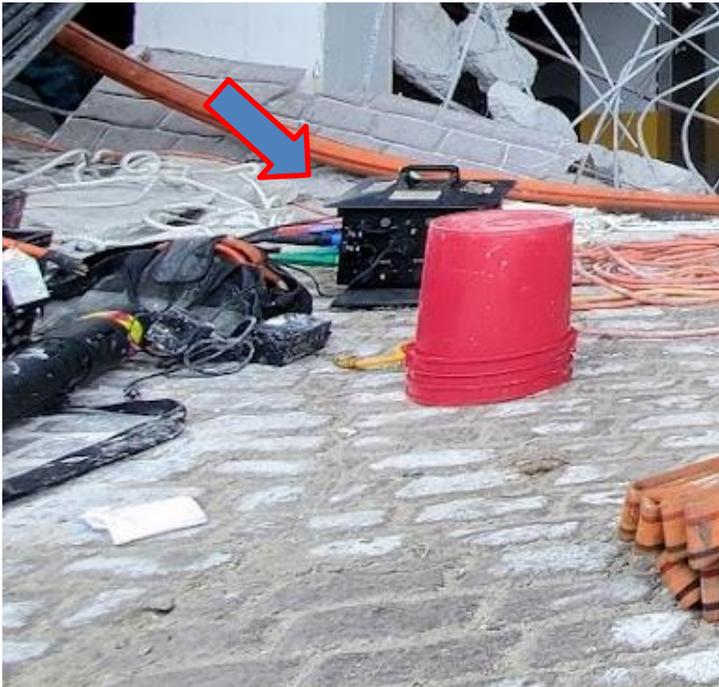
Image 3: Portable distribution box

The rescuers advised that the claim made by the reporter that the rescuers lacked proper tools to handle the search and rescue operations is baseless and nonfactual. According to the rescuers, all technical rescue equipment necessary for immediate breaching and breaking was available at their request, in excellent working order. The interviewed rescuers advised that the USAR Hackney apparatus was onsite with the necessary heavy hand tools (to view the cache in the Hackney, click this [Hackney Equipment List link](#)). As the rescuers explained repeatedly, it was not an equipment issue but rather a moisture and voltage issue that could not be resolved due to the conditions of the collapse that were not in the control of the rescuers. The power cords, at times were beyond the manufacturer's recommendation, reducing the necessary voltage needed for the tool to run optimally, and moisture continued to trip the GFCI. A search for openings on the west and north sides of the building to bring the generators closer to the working area and reduce the length of power cords were unsuccessful. Several portable distribution boxes, as seen in *Image 3*, were used to safely distribute electricity from the generator to other devices in a circuit. It typically has one input and multiple outputs, allowing several devices to be connected to the distribution box rather than directly to the power source. This makes things safer, more efficient and more convenient.

Additionally, one of its key advantages is that it reduces the chances of blown fuses or even dangerous short-outs. However, the rescue crews continued to encounter tripped GFCIs as moisture got into the electrical lines. Additionally, the rescuers advised that the search camera batteries did run out momentarily; however, a charged battery was inserted within minutes.

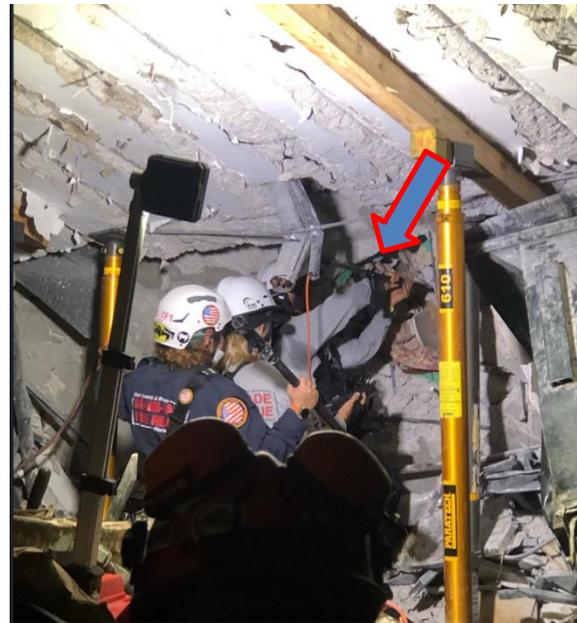
Image 4: Search camera used to view behind the slab.

The slab that the crews were breaching and cutting in *Image 4* shows our rescue crews utilizing cameras to inspect the area behind the slab. Radio communications reported a mattress was behind the slab after the camera inspected the area behind the slab.

There was no report of a victim, alive or deceased. Locating a patient, alive or deceased, is a department benchmark that would have been communicated over the radio. Additionally, the rescue crews reaffirmed that there were no victims behind the slab during the interviews, just a mattress. The circular saws with the water line connection the newspaper reporter claimed that MDRF was lacking are also nonfactual. MDRF had a Stanley Twin Circuit Portable Hydraulic unit on hand, one version of the saw the reporter erroneously reported we were not equipped with. However, the water spigot was 600' away, so a water line was not an option. Additionally, these saws are used to cut concrete in a straight precision line and reduce concrete dust when water is used. Therefore, these saws may be utilized without water connections when necessary. Finally, these saws are not designed for cutting large gauge rebar, as the water would destroy the hot blade. To summarize, even if a water line was used on a Stanley saw, rescue crews would still need to switch saws to utilize a metal cutting blade to cut through the large gauge rebar. The assets of the Hackney may be viewed in the by accessing the [Hackney Equipment List link](#).

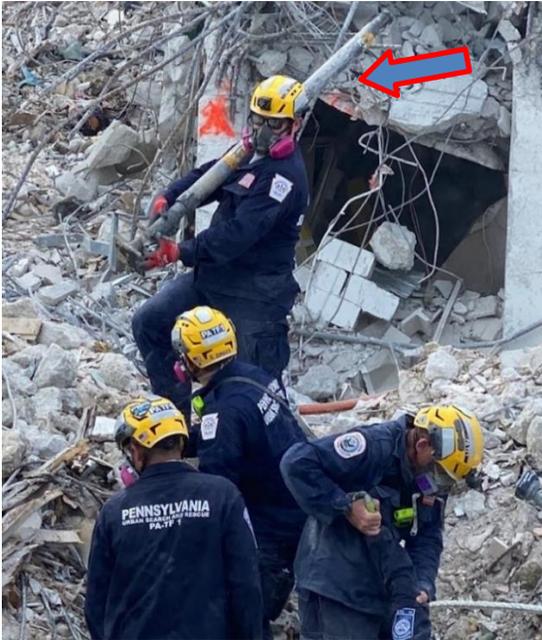
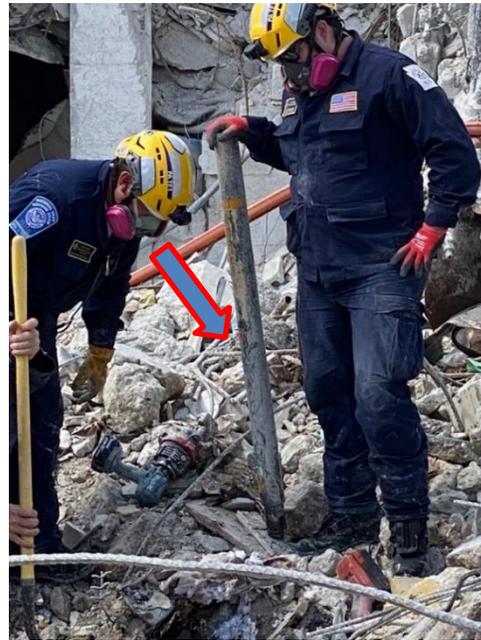
Image 5: Paratech devices removed near Theresa Velasquez. Image 6: Paratech devices removed near Theresa Velasquez

the decision was made to leave them behind. The Paratechs were found approximately 15' from where Ms. Velasquez's remains were found. This is physical evidence that the equipment was located within the boundaries described by the rescuers and in accordance with where Ms. Velasquez remains were ultimately located (see *Image 5 and 6*).
