Baltimore Gas and Electric Company

Major Outage Event Report

June Derecho - June 29 through July 8, 2012

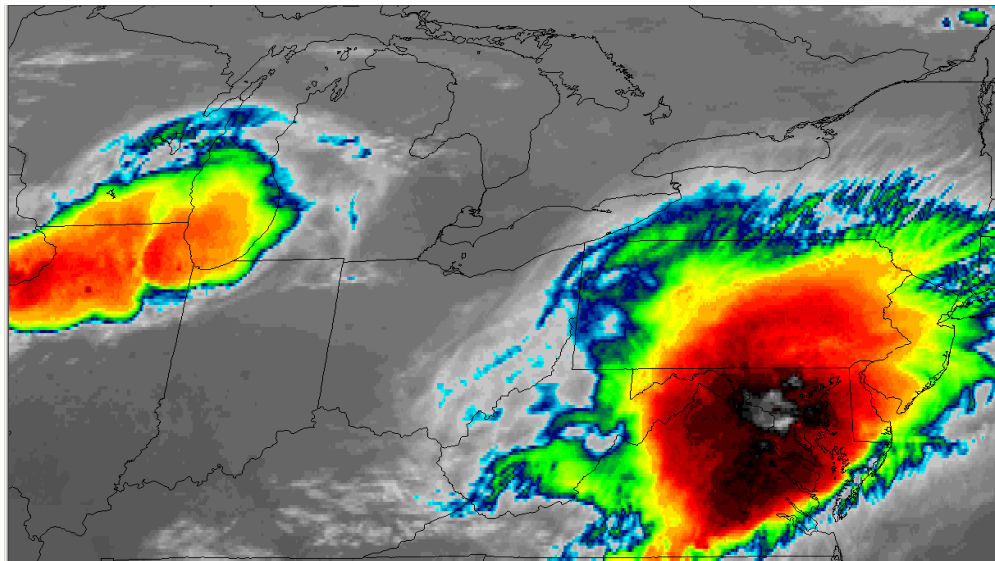
Figure 1 - Infrared Image of the June Derecho Over Central Maryland.²

² The color scale depicts cloud-top temperatures. Thunderstorms show up in the darker red-to black-to gray. See University of Wisconsin-Madison, Space Science and Engineering Center (2012). Retrieved at http://cimss.ssec.wisc.edu/goes/blog/wp-content/uploads/2012/06/120629-30_g13_ir_derecho_anim.gif

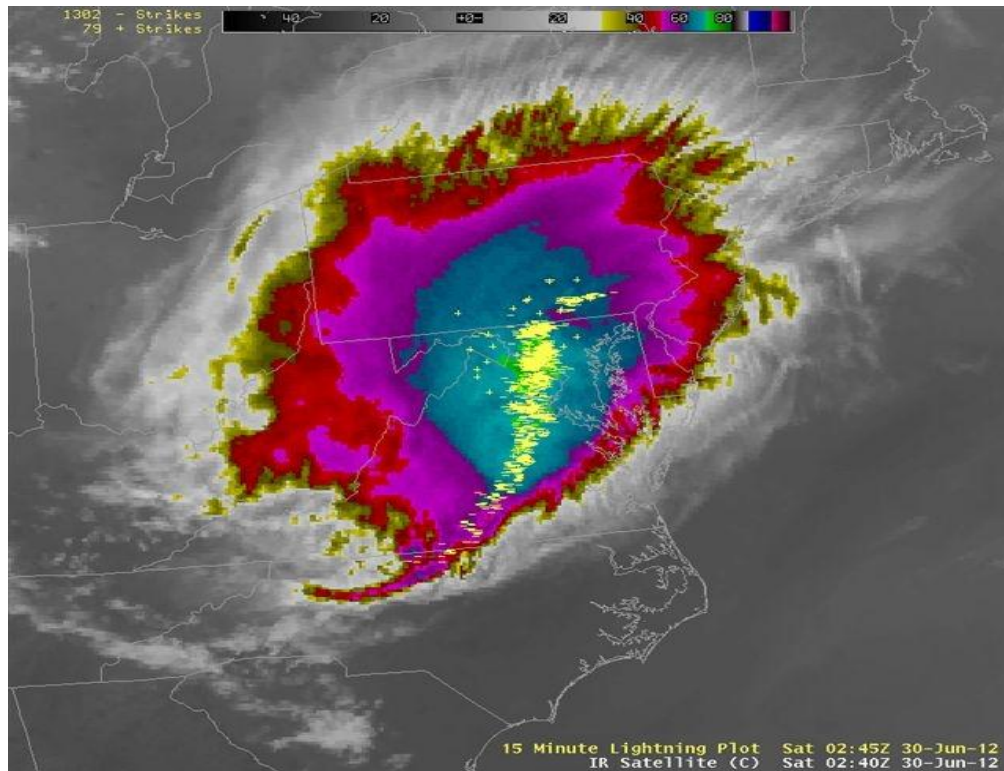
Figure 2 – Region Lightning Activity for the June Derecho³

While there was much lightning associated with this event, the most system damage was caused by high winds that accompanied this unique weather system. A sample of the reported wind gusts include:

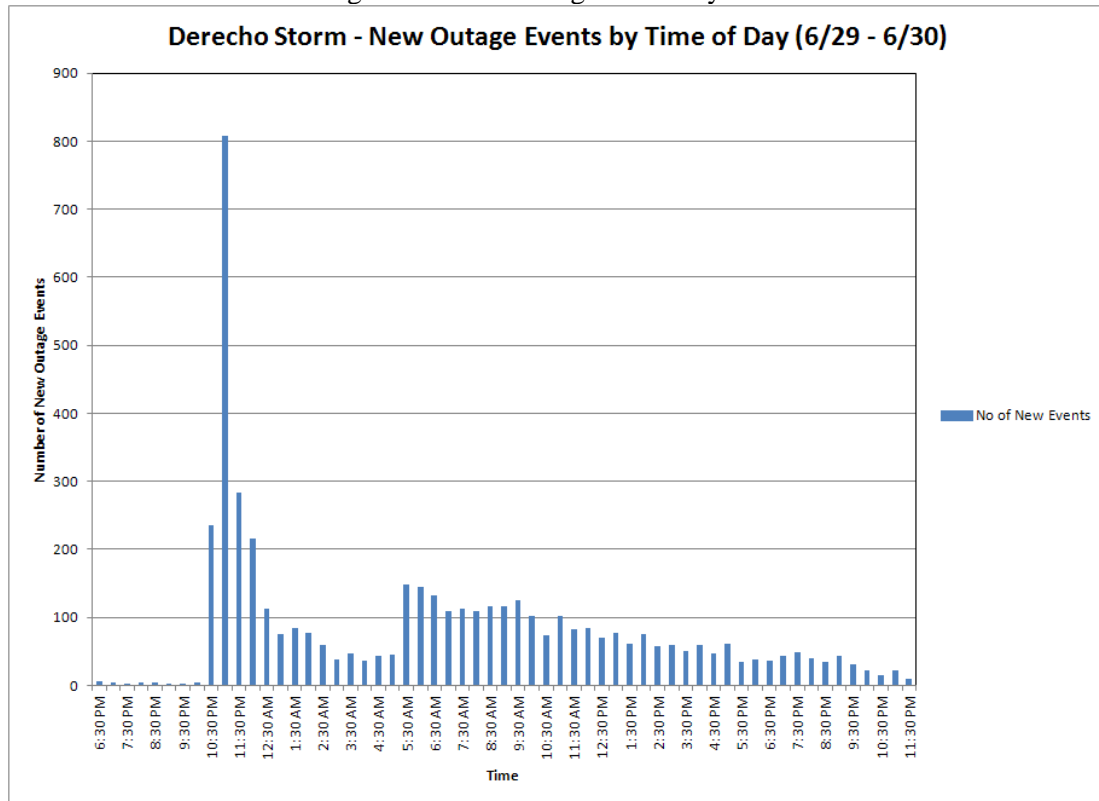
Figure 3 – New Outage Events by Time

Unlike a hurricane or other similar severe impact storm where damage is inflicted by the storm's energy over a period of time, the June Derecho's damaging effects hit the system quickly and just as quickly moved through, and then out of, BGE's service area. Figure 3 shows how rapidly the storm's impact resulted in system damage and resulting power outages. The burst of outage events/jobs began around 10:30 PM with a significant step change increase of more than 800 new outages around the 11:00 PM timeframe. As customers woke Saturday morning, another series of new outages were generated from new customer calls beginning around 5:30 AM.

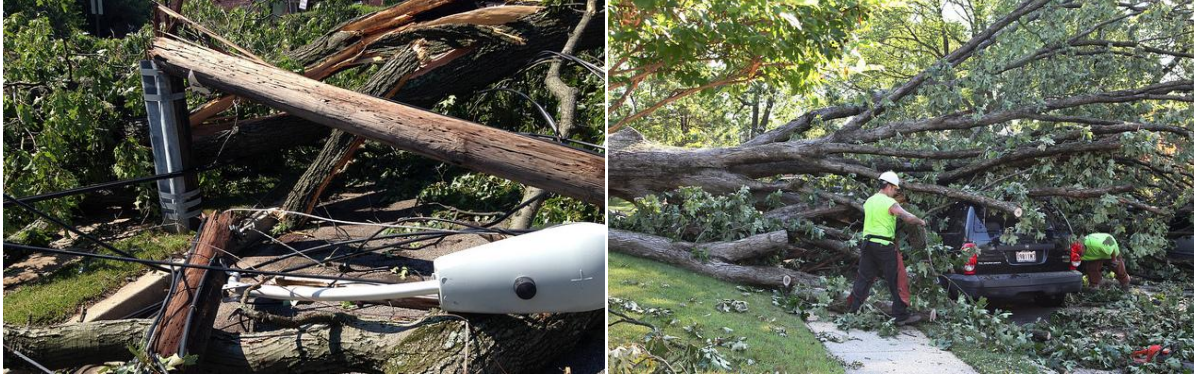
Figures 4 and 5 – Storm Damage

Gusts were widespread but the most devastating gusts impacted the central and southern portions of the BGE system. See BGE’s square mile grid map – Figure 6. Whole trees were uprooted and many others had their massive limbs twisted and snapped while countless branches were blown clear of trees, resulting in downed poles, power lines and damage to other pieces of equipment system wide. See Figures 4 and 5; see also Attachment 7 for pictures reflecting the storm damage. Ultimately, approximately 760,000 BGE customers would lose power as a direct or indirect result of the June Derecho’s damaging winds, follow-on storms and extreme heat that were experienced over the eight-and-a-half day restoration. Throughout the event, some of our customers experienced multiple outages due to the severity of the initial and follow-on damage. Despite these challenges, BGE crews successfully restored service to the customers then affected by outages, approximately 47 percent within 36 hours and were able, in conjunction with the mutual assistance crews, to restore 84 percent within 4 days.

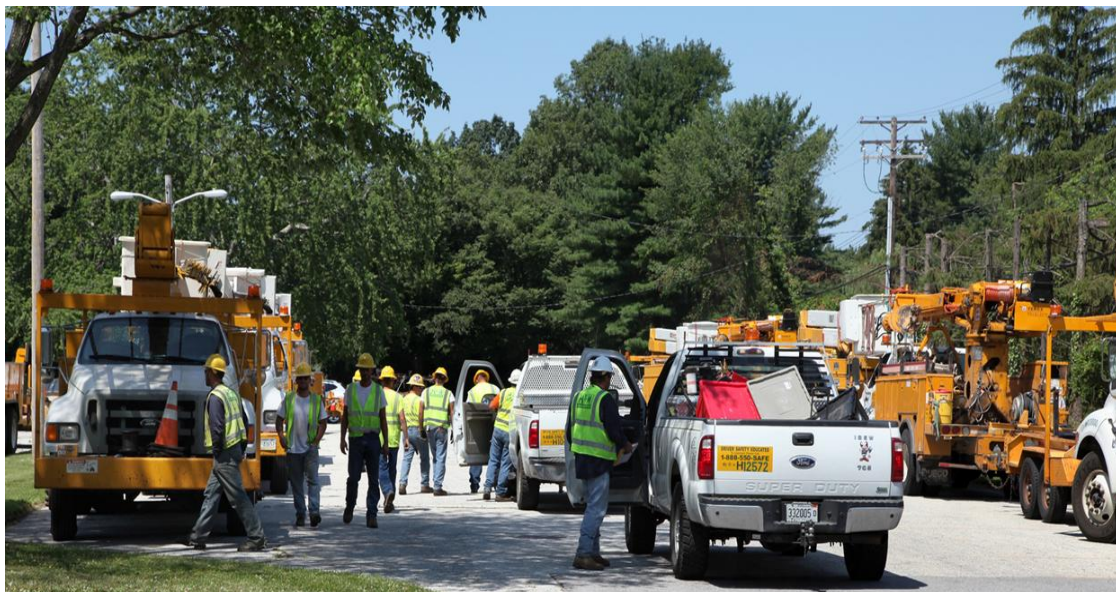
Figure 7 – Pods of Crews Assemble at a Job Site for Feeder-Based Restoration

With the arrival of a significant amount of mutual assistance crews on Monday, July 2, BGE fully implemented its feeder-based approach to service restoration. A feeder-based restoration approach is called for in response to a severe impact storm, and is much different than the restoration practice normally employed in response to thunderstorms and most other major storms. This is necessary due to the numerous cases of heavy damage on feeders requiring coordination of activities at the feeder-level which include tree clearing and reconstruction at many different locations to restore service to all of the customers supplied by a feeder. BGE's process combines 'pods' of overhead line crews, tree crews, damage assessment personnel, loop crews, and public safety stand-by crews, led by a BGE crew guide. This caravan is deployed to the areas of worst reported damage; begins at the BGE substation (feeder source) and ensures public safety; identifies damage; and initiates repairs for the entire feeder. These pods (see Figure 7) could include up to 20 vehicles deployed to a concentrated area, where repairs of many feeders took multiple days.

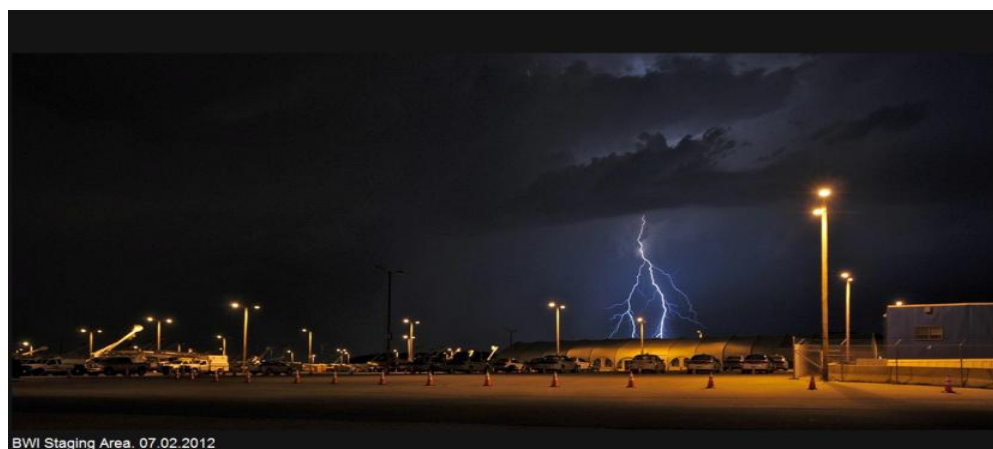
Figure 8 – Storm Impacting BWI Staging Area Monday

Adding to the challenge, just as BGE had ramped up our feeder-based service restoration approach, BGE's service area was impacted by yet another storm Monday evening. See Figure 8. Approximately 10,000 additional customers lost service from this storm.

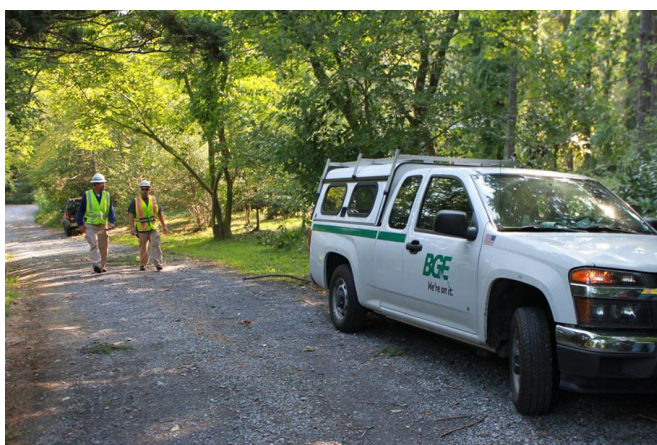
Figure 9 - Thorough Damage Assessment Often Includes Patrolling on Foot

While much of a main feeder line can be observed from roads or from rights-of-way, these inspections often required the crews to walk several miles in rugged terrain to inspect the taps or lateral branches into communities. Data from the assessments was gathered to identify resource, equipment and material requirements for repairs, as well as to plan repairs throughout the restoration activity days and help establish feeder and system-wide estimated times of restoration. A total of 402 entire feeders were assessed for damage.

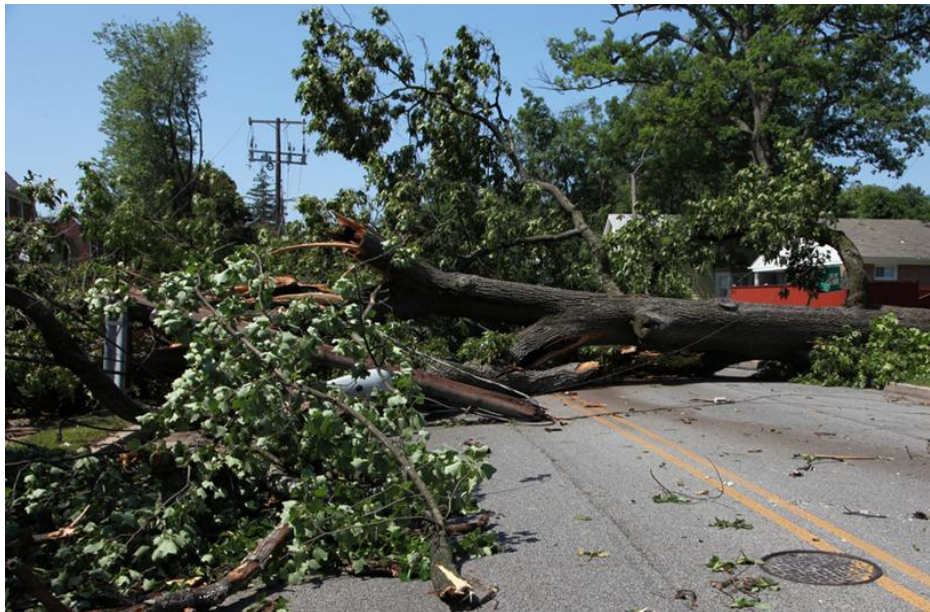
Figure 9 – Road Closed by Fallen Trees and System Damage

During the June Derecho storm restoration effort, BGE used its existing process to coordinate response to road closures in the BGE service area caused by whole trees and large limbs that fell across roads and brought down BGE wires. The road closure e-mail mailbox was used to provide a standardized way for county departments of public works and county highway employees to communicate information on roads that were blocked by wires. This process helped centralize information, and the mailbox was continuously monitored by BGE storm personnel. These personnel worked with BGE's public safety patrollers to provide a coordinated response and determine the appropriate crews, equipment, and materials needed to address the blocked road and repair the damage. Once the site was made safe, BGE called and sent emails to county agencies to advise them that roadways could be re-opened. This process was invaluable to ensure that BGE downed wire jobs blocking municipal roadways received prompt attention.

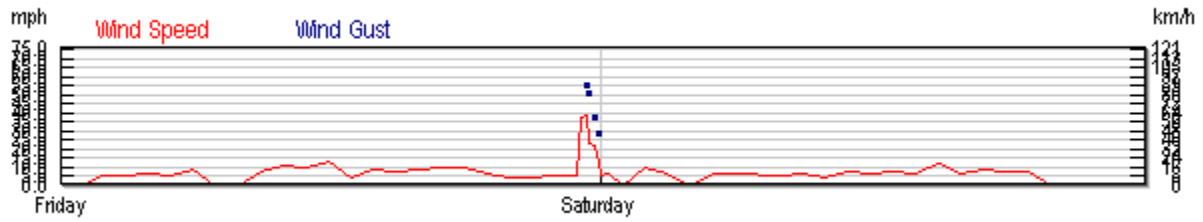
Attachment 2 - Wind Speeds

Wind Speed	6 mph (West)
Max Wind Speed	47 mph
Max Gust Speed	66 mph
Visibility	9 miles
Events	Rain , Thunderstorm
