Allision of the Passenger Vessel *Seastreak Wall Street*
with Pier 11, Lower Manhattan,
New York, New York
January 9, 2013

NTSB/MAR-14/01
PB2014-105712

**National
Transportation
Safety Board**

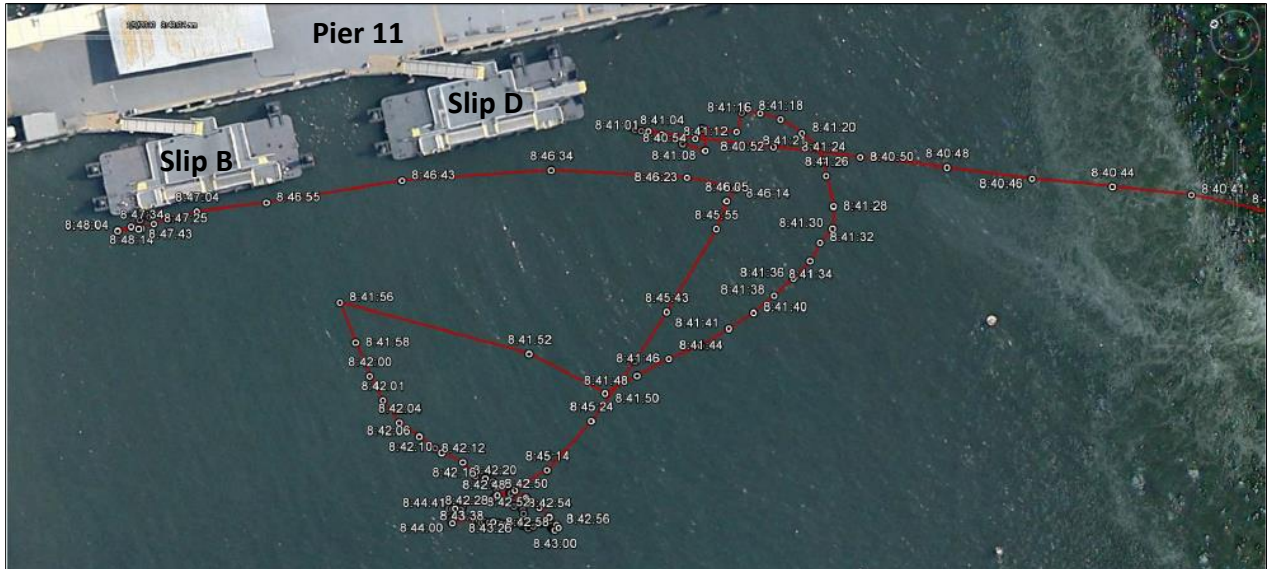
After impact, both main propulsion engines continued running for about 68 seconds, consistent with the time the vessel ran aground in shallow water near the pier. The captain said he instructed a crewmember to restart both engines and then maneuvered the vessel to Slip B at Pier 11 about 7 minutes later. Figure 2 depicts the *Seastreak Wall Street*'s route from New Jersey to Manhattan. Figure 3 plots the last 7 minutes of the ferry's voyage.

Figure 3. Automatic information system (AIS) data showing the ferry’s trackline for the last 7 minutes of the accident voyage, including impact with the pier, grounding in shallow water nearby, and finally docking at another pier. Times are shown at locations where this information is available. (Background by Google Earth)

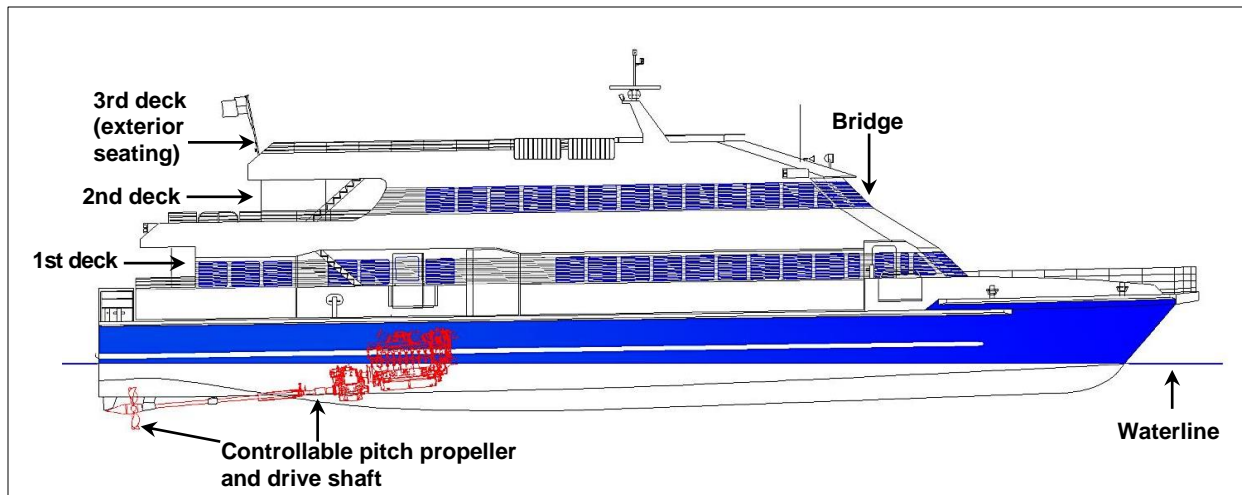
Figure 9. Profile view of the *Seastreak Wall Street* indicating deck levels and location of the bridge. The vessel's controllable pitch propulsion system is highlighted in red from the engine to the propeller. (Vessel drawing provided by Seastreak)

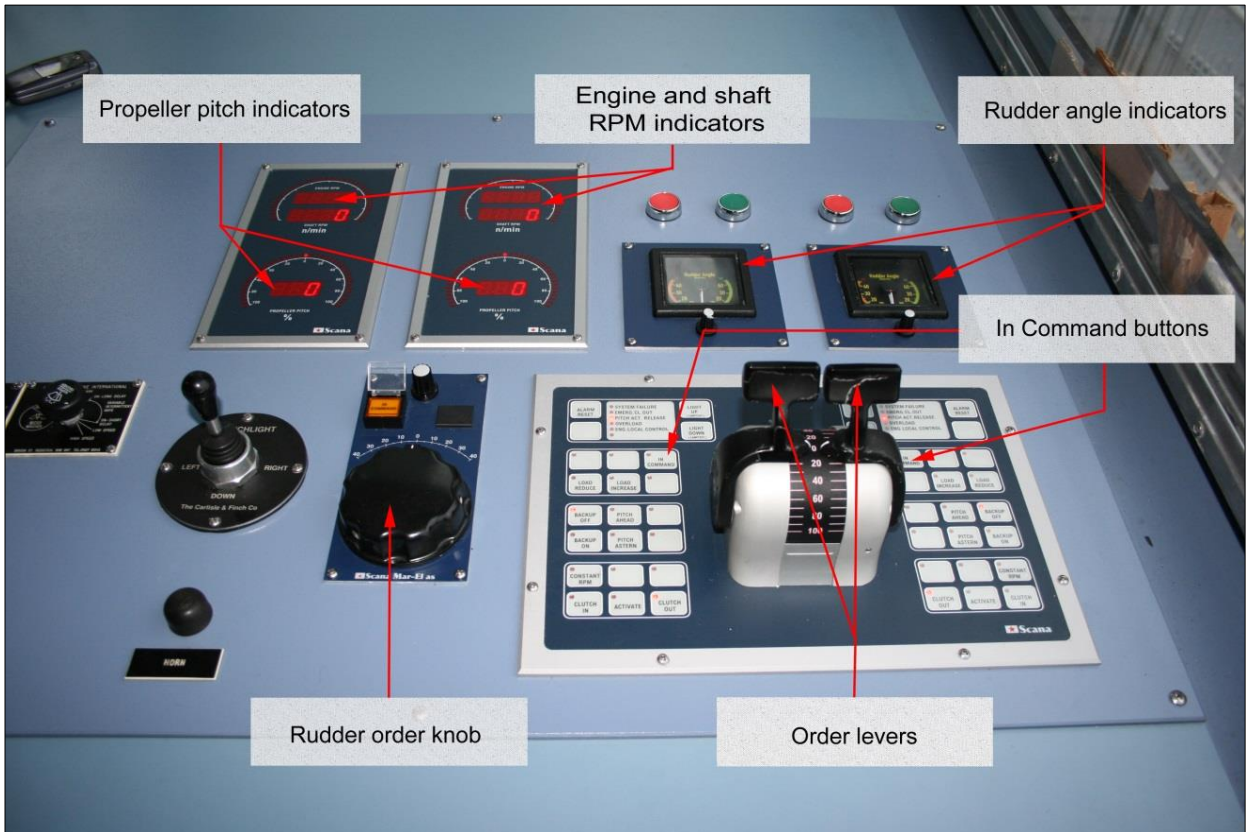
either side of the order levers, two analog rudder angle indicators, two digital propeller pitch indicators, and two main propulsion engine and propeller shaft rpm indicators (see figure 12).

Figure 12. Photo of bridge control panel showing order levers, pushbutton controls and alarm displays, and engine and propulsion controls and indicators.

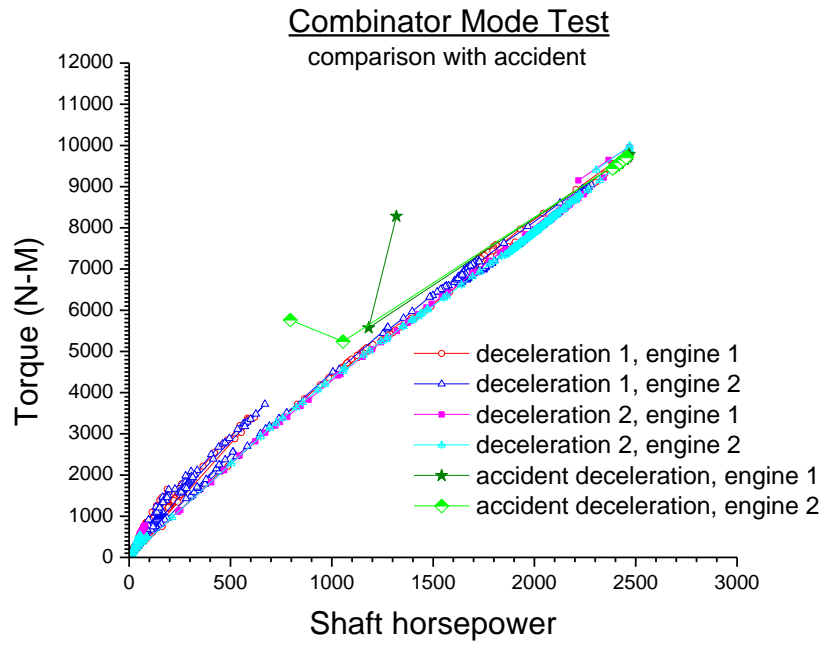
Figure C-2 shows torque as a function of shaft horsepower for two decelerations from 30 knots in Combinator mode.

Figure C-2. Torque versus shaft horsepower in Combinator mode.
