Wabasha Street Rock Slide

Slides prepared by Itasca Consulting Group May 30, 2018

Summarized for presentation by City of Saint Paul Public Works June 1, 2018

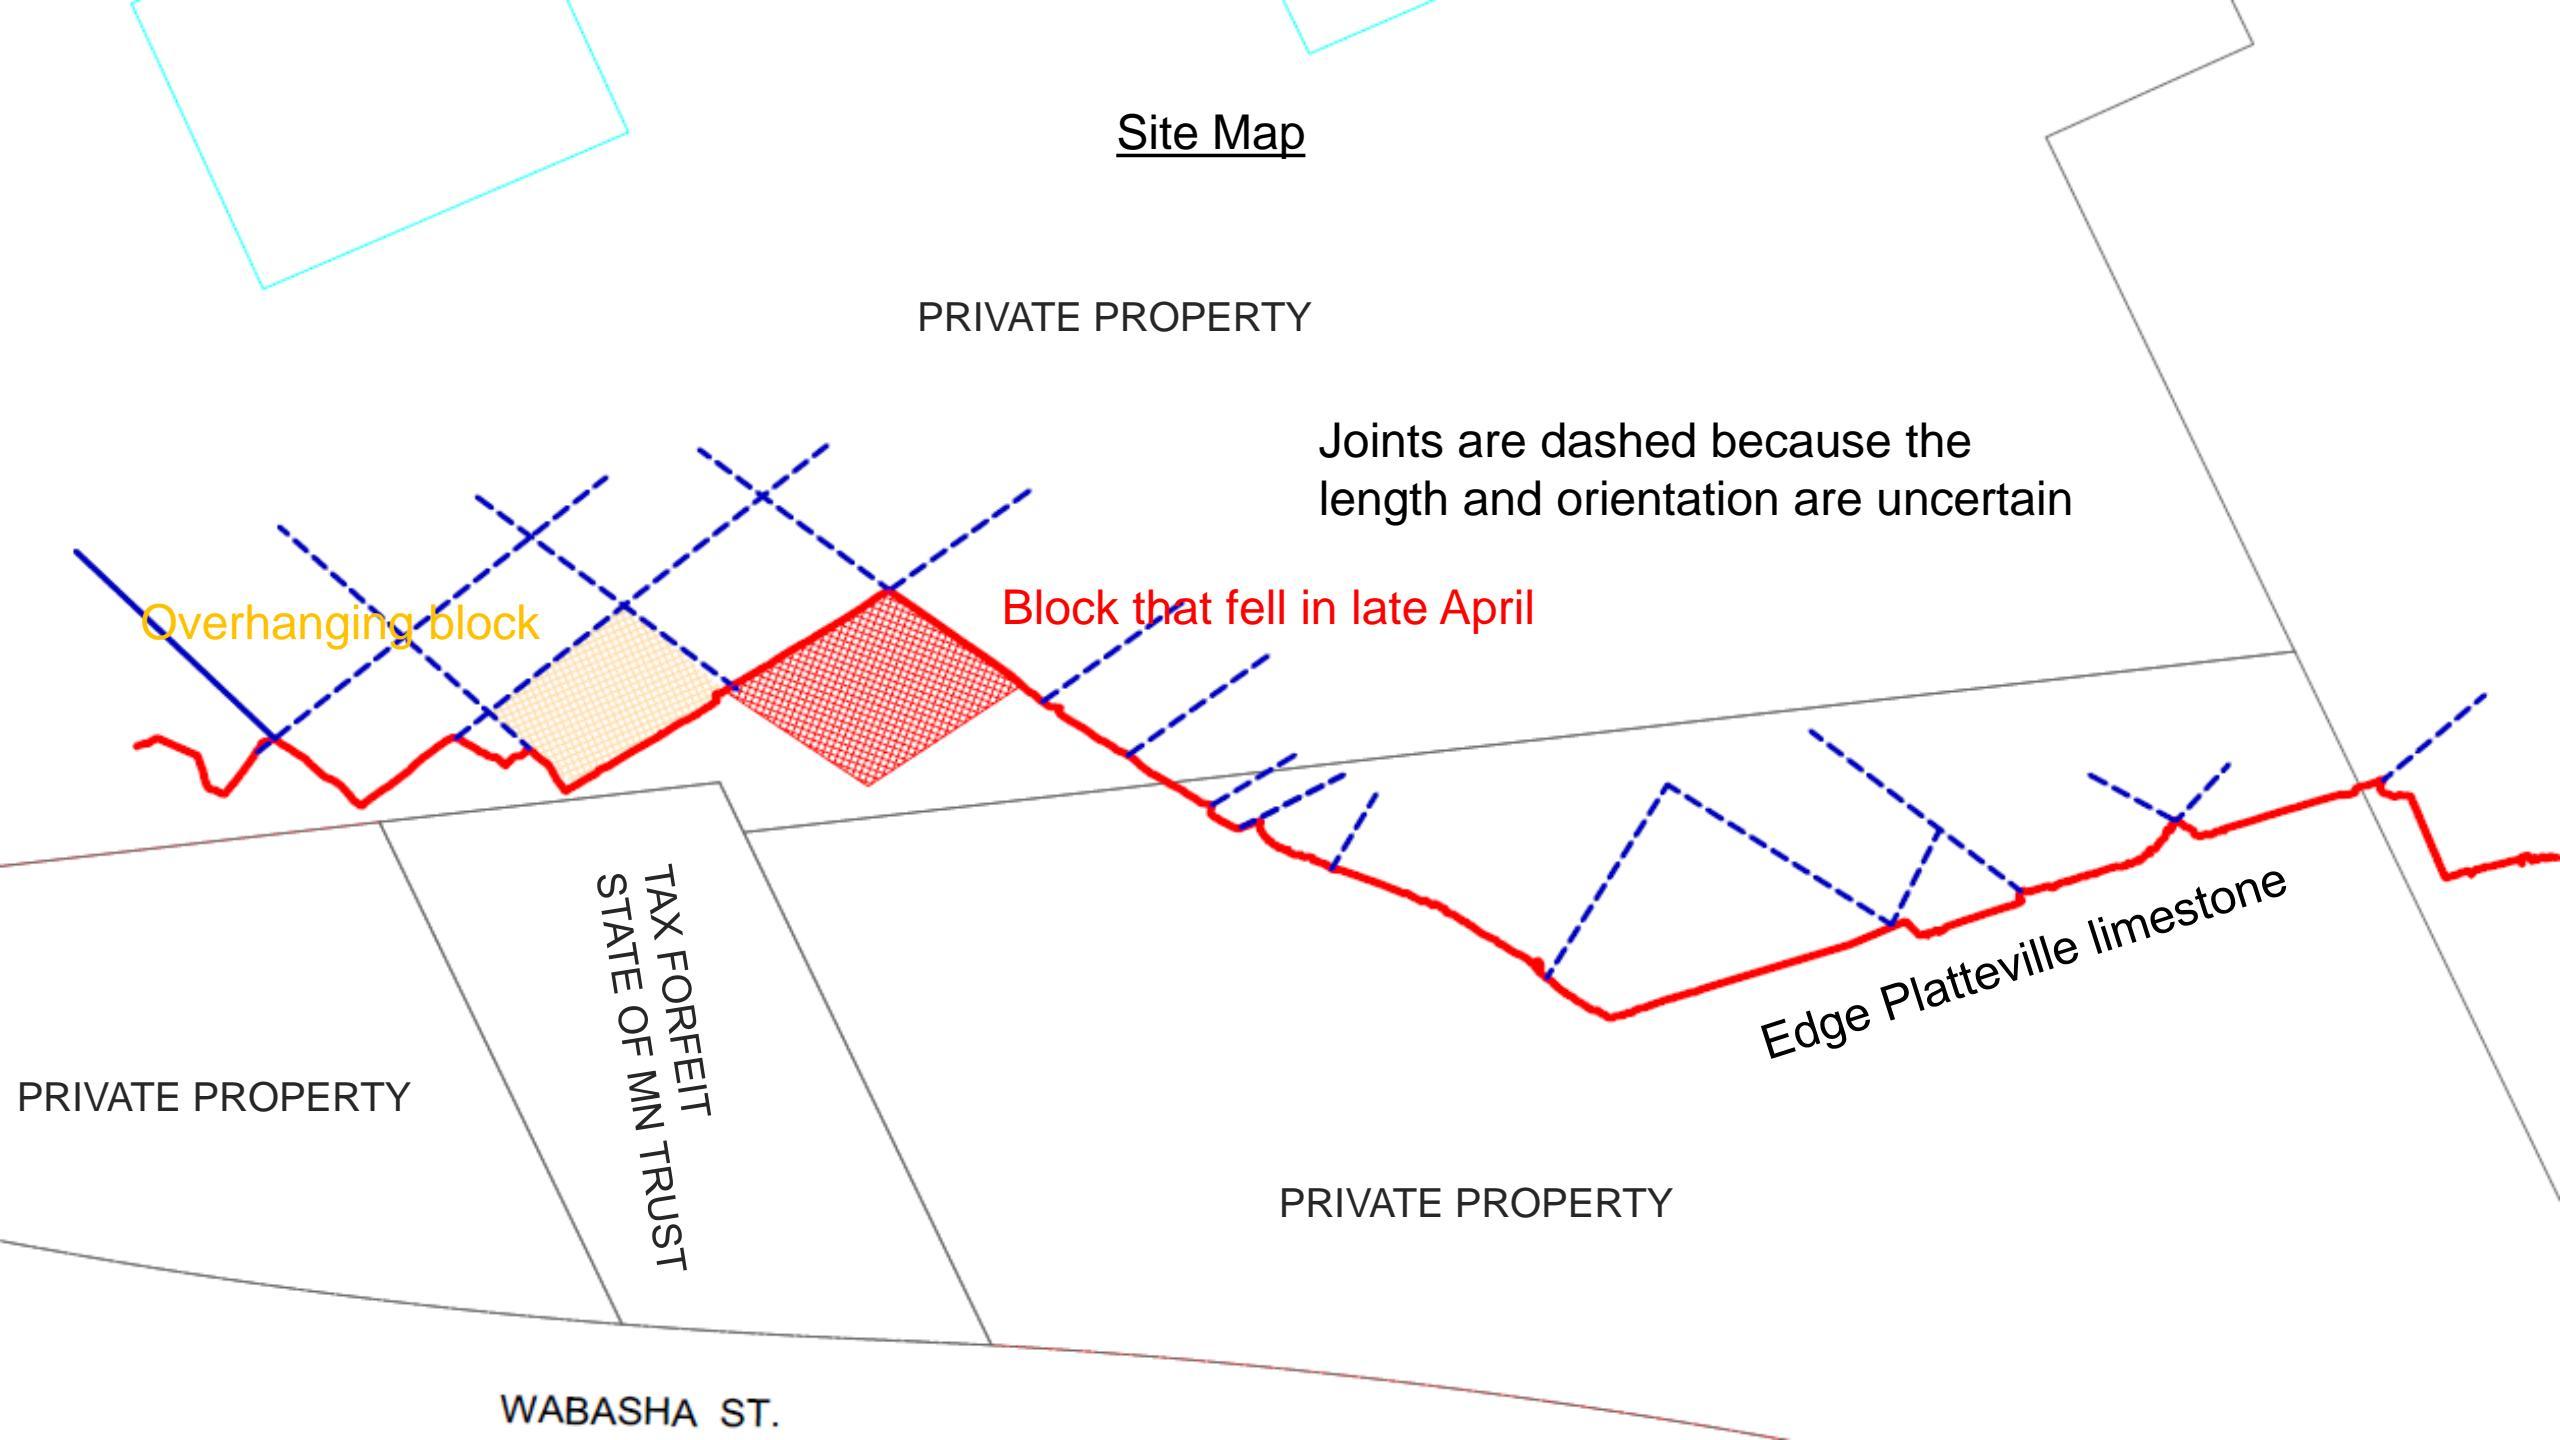
Specific Site Features (Categorized into Types)

- 1. Limestone blocks
- 2. Upper (weathered) limestone
- 3. Limestone-shale-sandstone interface
- 4. Upper Soil
- 5. Lower Soil
- 6. Prior slope stabilization
