**Firefighter Line of Duty Death**

**06/28/2015 Incident 15-0061817**

**06/28/2015 Incident 15-0061833**

**PIA June 28, 2015  
Incident 15-0061817**

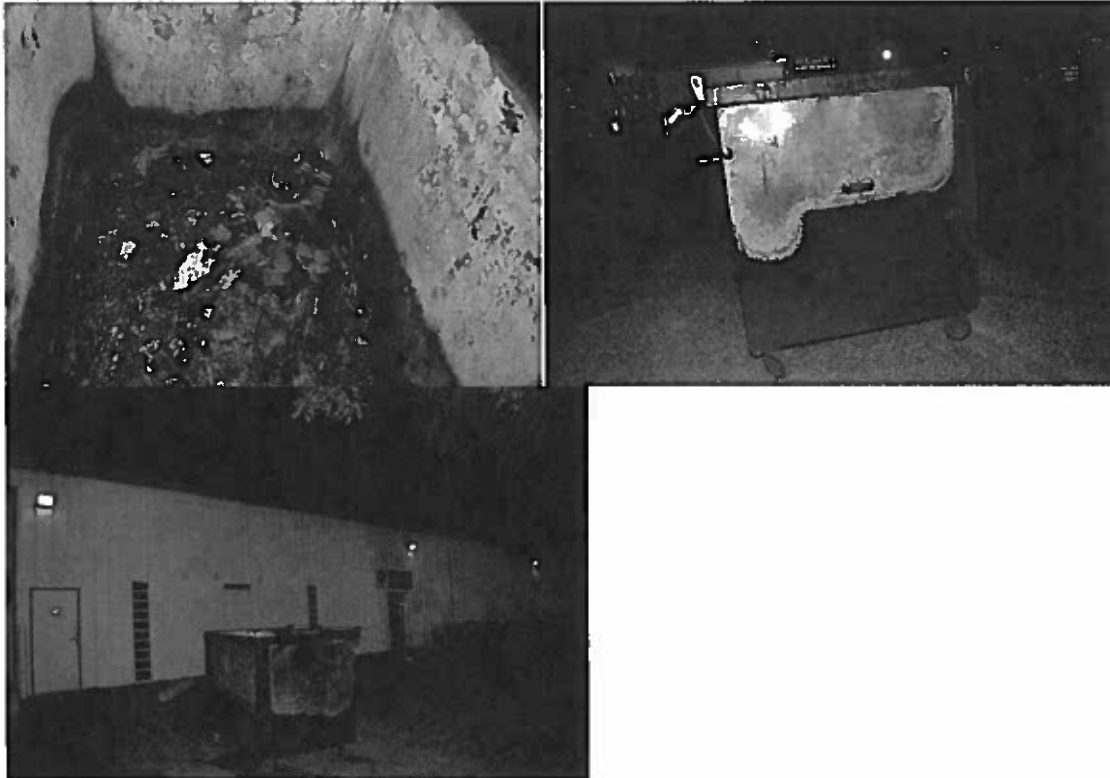
While responding, E09's Company Officer read their MDT notes and after listening to initial radio reports and observing the scene, decided to lay a single 3" line using the Humat valve from 39<sup>th</sup> and Blake Streets. Upon arrival E09 observed a 10 yard dumpster on fire against a single story metal building approximately six feet below a window. E09 pulled a red line from the rear of their apparatus and extinguished the main body of fire in the dumpster and searched through the dumpster with pike poles checking for any hot spots.

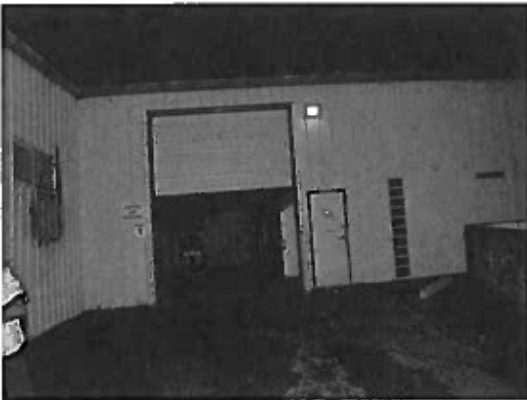
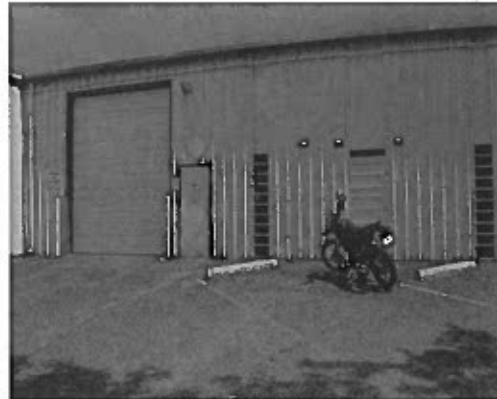
TR9's crew noticed the paint on the outside of the structure where the dumpster was located had scorch marks and was directly below a window. Sizing up the structure, TR9 had the option of a glass man door or an overhead garage door. TR9 crew members chose the large roll-up door to cause the least amount of property damage and because of its proximity to the exposure. TR9 was able to forcibly pry under the roll-up door using a halligan to raise the door approximately 7'.
