Fire at 936 Childs Point Road

**Bureau of Alcohol, Tobacco, Firearms and Explosives
Anne Arundel County Fire Department**

Executive Summary
ATF Investigation # 761010-15-0026 / AAFD Investigation # 15-017
Fire at 936 Childs Point Road, Annapolis, MD

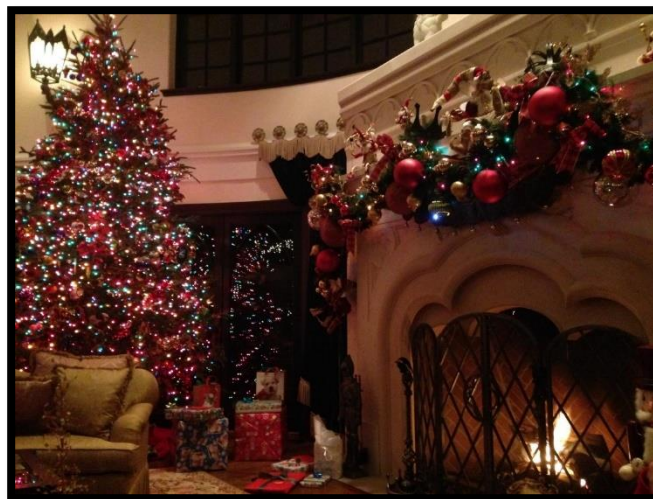
Figure 7 – Decorations in Great Room

The Pyle’s residence had two Christmas trees, a 15-foot Fraser fir tree and a 7-foot Douglas fir tree. The larger tree was kept in the Great Room and the smaller tree was placed in the bar area. The Fraser fir tree in the Great Room is depicted below in Figure 7.

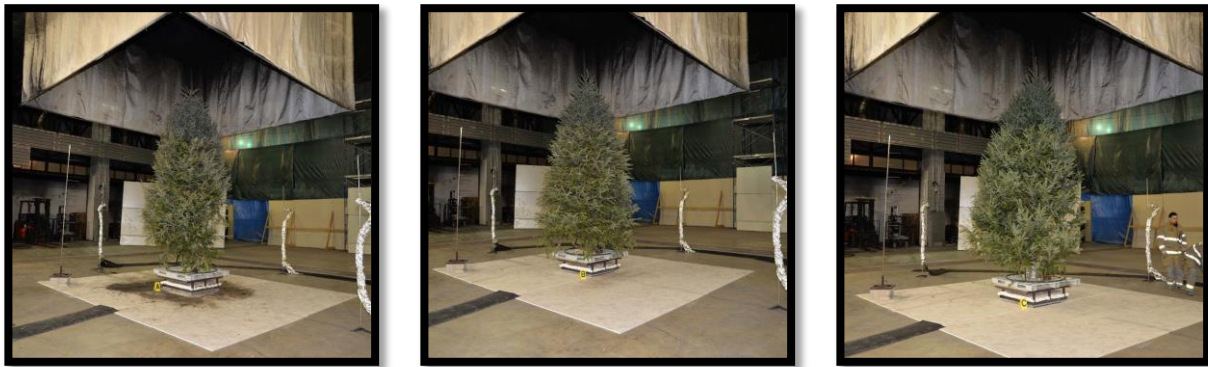
Figure 12 – Trees under Fire Product Collector

Each of the three trees was positioned under a 4 megawatt Fire Product Collector in the ATF Fire Research Lab's Medium Burn Room (Figure 12).

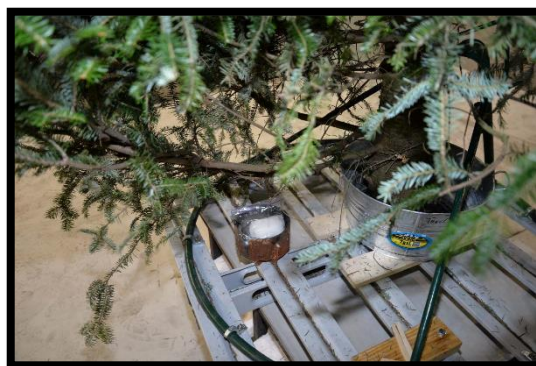
Figure 13 – Ignition package

The trees were then exposed to an open flame from an ignition package placed under the tree (Figure 13). The ignition package had burning characteristics similar to that of a small wastebasket and a burn duration of approximately 10 minutes.
