# Corrosion Testing Laboratories, Inc.

CTL REF #31636

August 18, 2015

## City of Gardner Leaking Copper Coils Failure Investigation

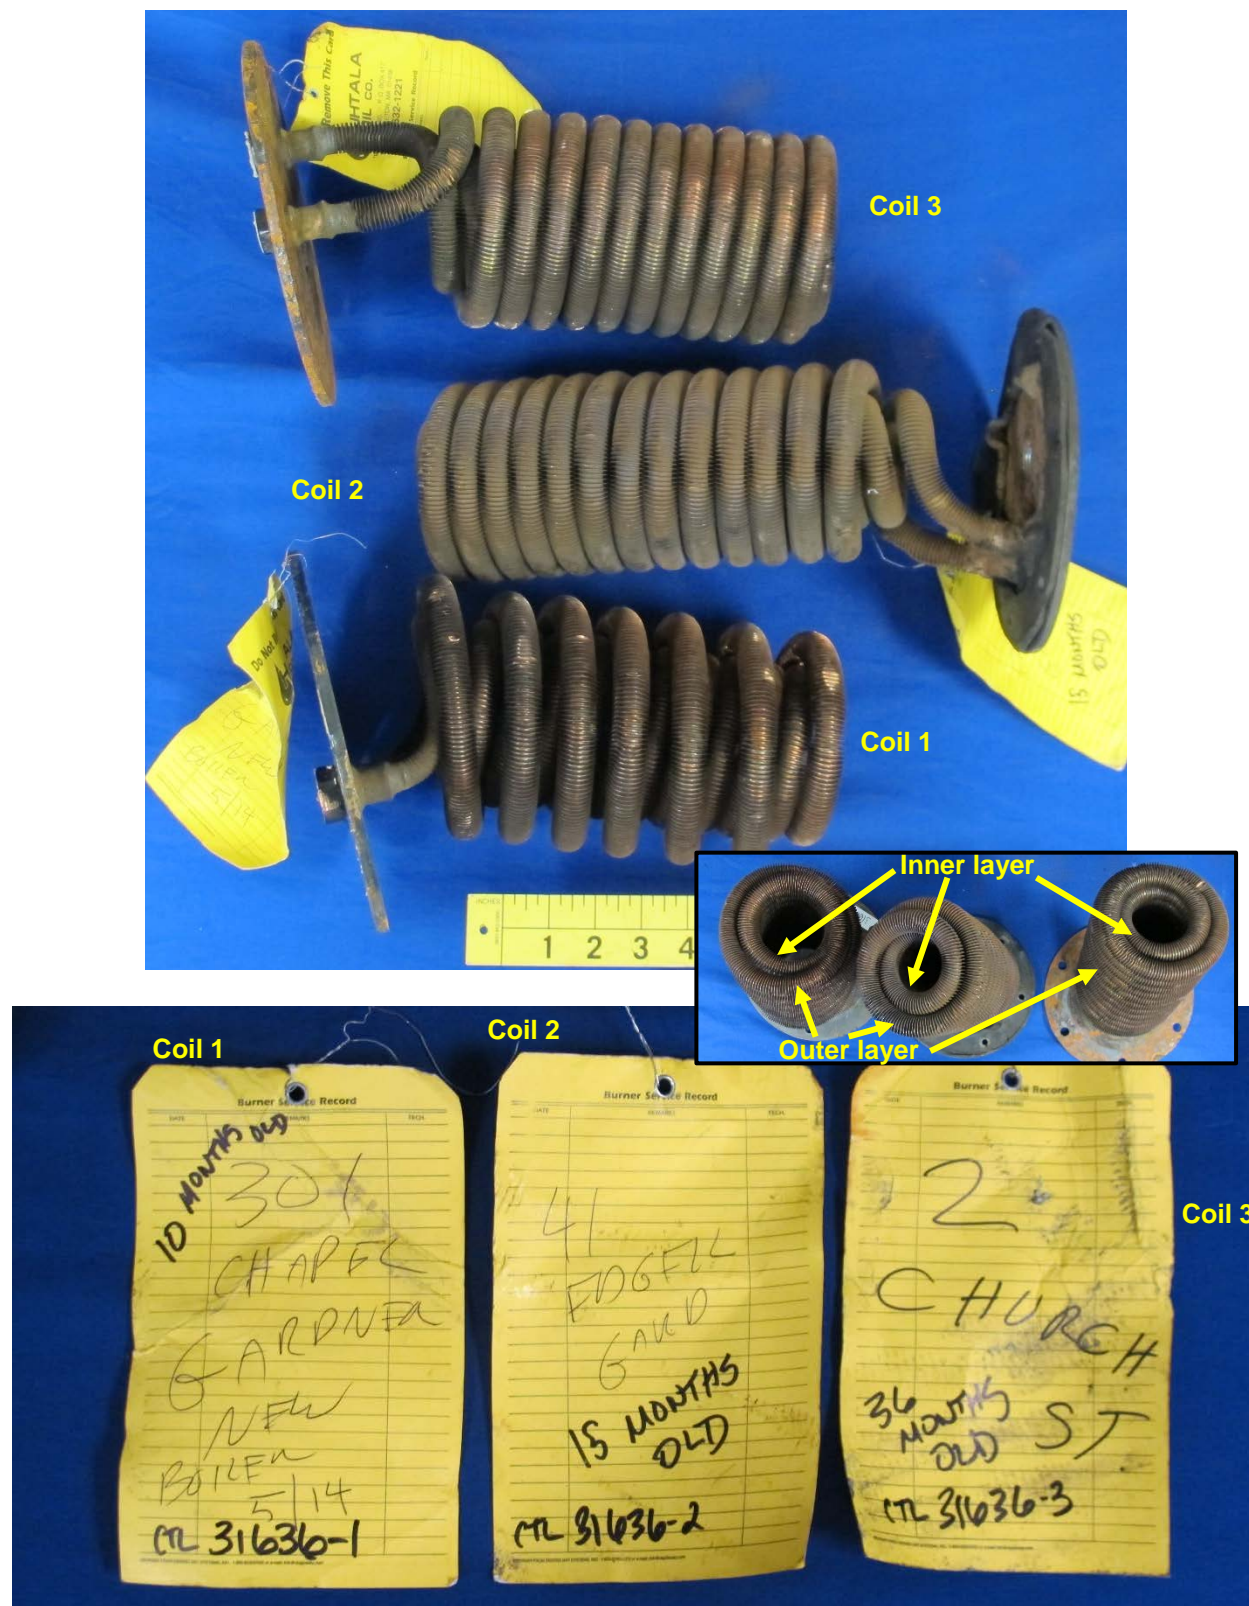
Three failed coils that varied in length of service life prior to failure were provided for analysis, **Figure 2**. Coil 1 (“301 Chapel Gardner”) was in service for 10 months before failure, Coil 2 (“41 Edgfil (?) Gard”, note that this label was not entirely legible) for 15 months, and Coil 3 (“2 Church St.”) for 36 months.

Each coil had two concentric layers of copper piping (an inner and an outer layer, see **Figure 2**) with external fins. The exposed surfaces of the coils were visually examined. The base plates that the copper coils were welded onto appeared corroded, most notably so on Coil 2, **Figure 3**. Deposits from the base plates of Coils 2 and 3 were analyzed for elemental composition by EDS<sup>2</sup>. They were composed primarily of iron and oxygen (i.e., “rust”), with low levels of silicon and, possibly, sulfur.

Figure 2. Coils, as received, and their provided tags.
