NEWS RELEASE

New crash tests: Underride guards on most big rigs leave passenger vehicle occupants at risk in certain crashes

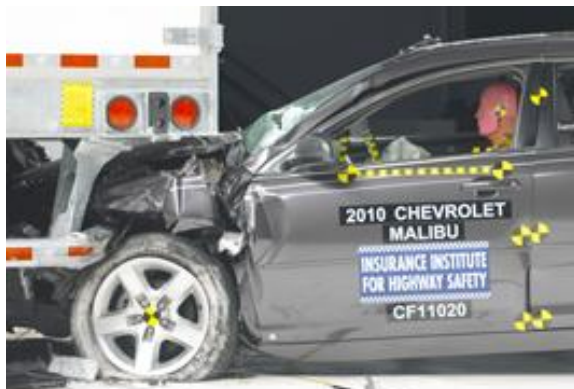
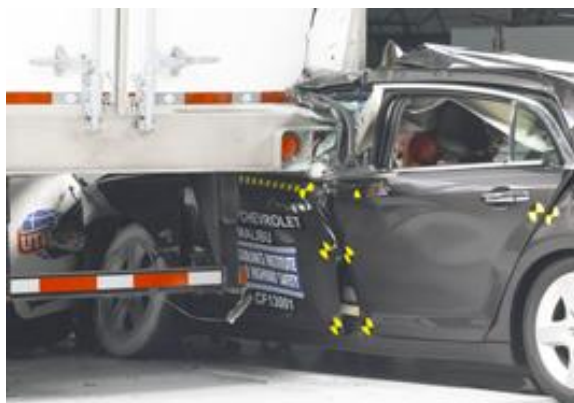
The underride guard on the Manac trailer, above, was the only one of eight tested to prevent underride in a 30 percent overlap crash. The performance of the Utility trailer, below, was more typical.

Manac, the only trailer to pass the 30 percent test, takes a different approach. The supports of its underride guard are attached to a reinforced floor and spaced just 18 inches from the edge. The Malibu and the dummy inside it not only fared better, but the Manac trailer also had damage estimates among the lowest of all the trailers. It required only a replacement underride guard.
